**Re: University of California, Berkeley, Richmond Field Station  
Western Stege Marsh Restoration Project Year 5 Monitoring Report  
And Certification of Compliance of Nationwide Permit**

# **Year 5 Monitoring Report for the Western Stege Marsh Restoration Project**

**University of California, Berkeley  
Richmond Field Station, Richmond, California**

**September 30, 2010**

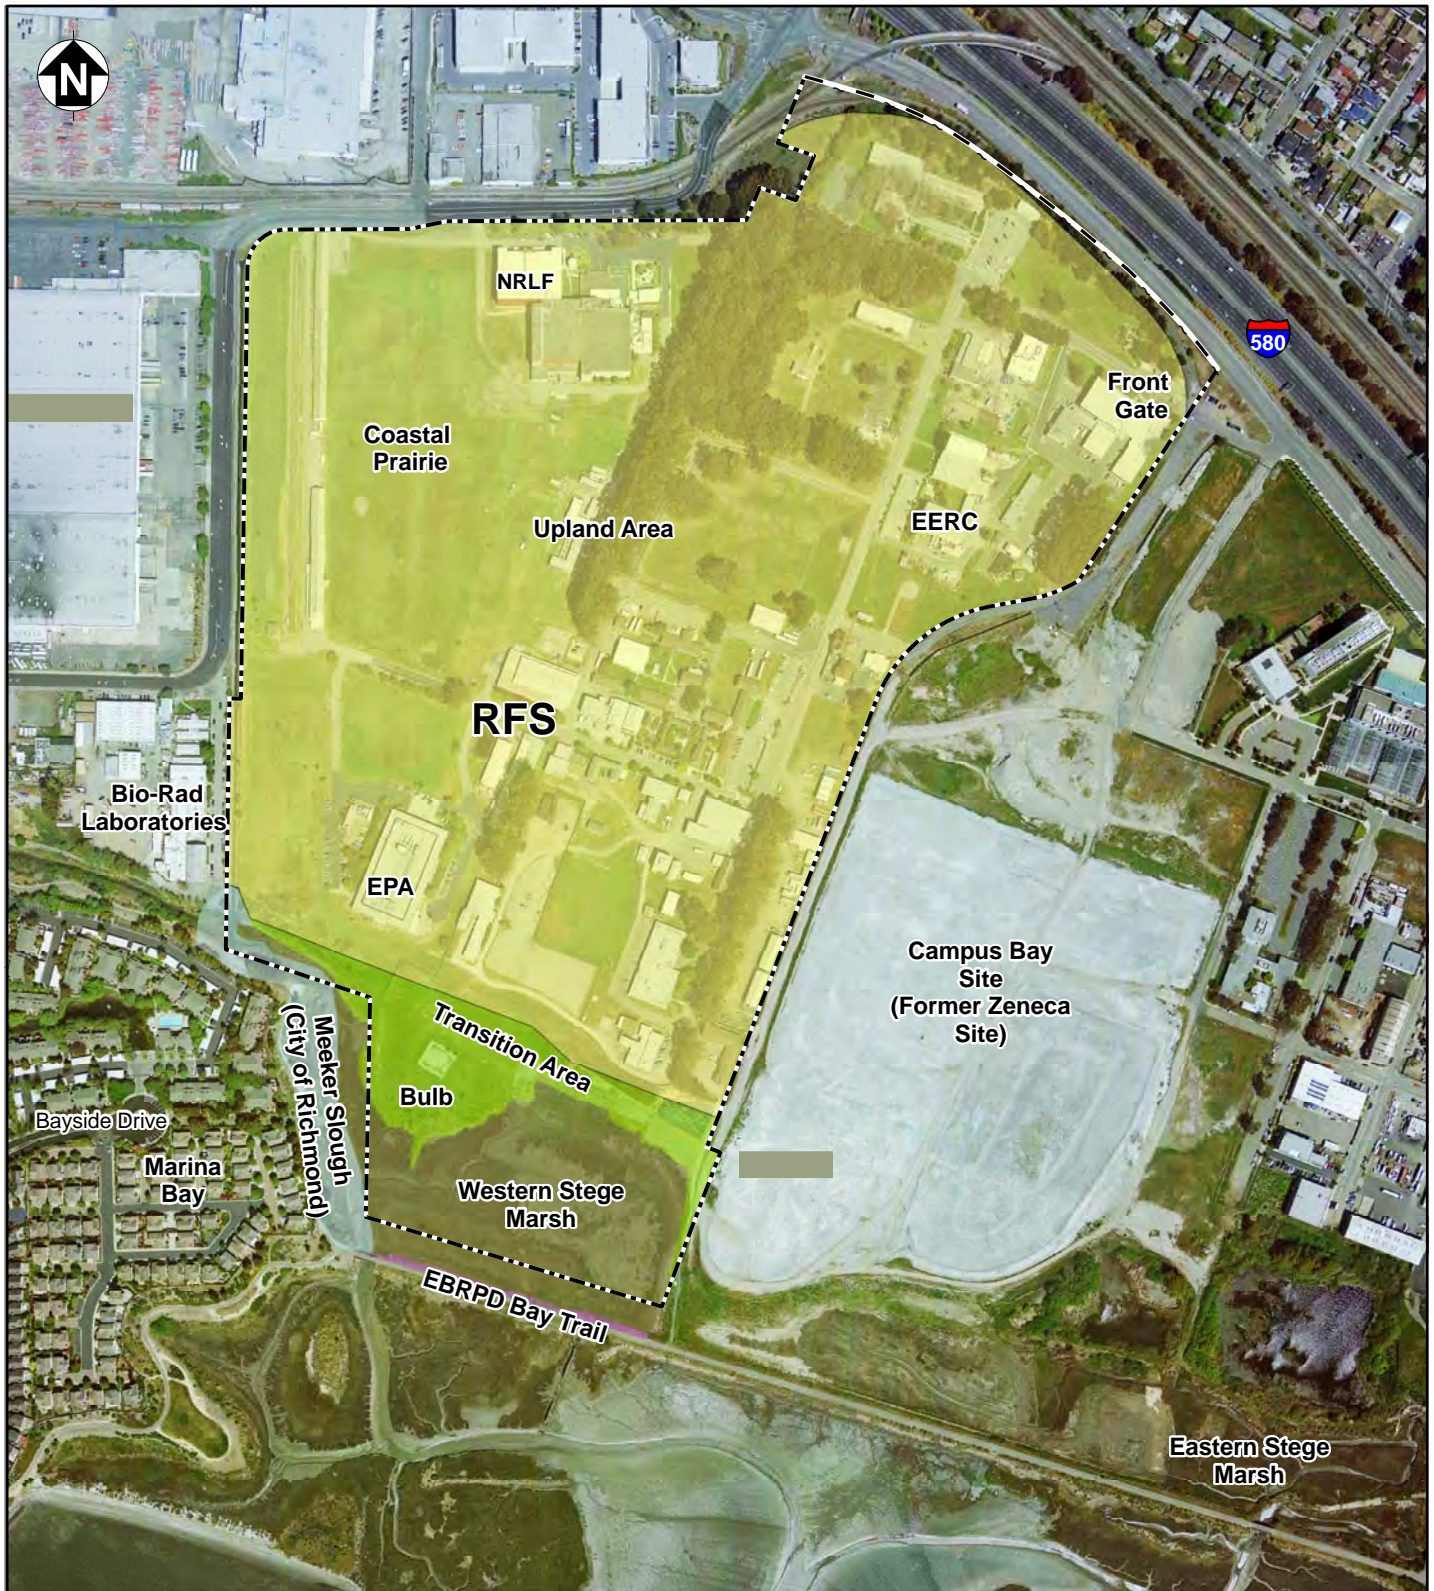
**FIGURE 1**  
**SITE LOCATION MAP**

The RFS is located at 1301 South 46th Street in Richmond, California (see [Figure 1](#)). The RFS is bordered by Meade Street off Interstate 580 to the north, by South 46th Street to the east, by the East Bay Regional Park District Bay Trail (Bay Trail) to the south, and by Meeker Slough and Regatta Boulevard to the west (see [Figure 2](#)). The California Cap Company owned the property and used it for industrial manufacturing of explosives from the late 1800s until 1948. In 1950, UC purchased the property, primarily for research facilities for the College of Engineering; later, other campus departments used portions of the RFS.

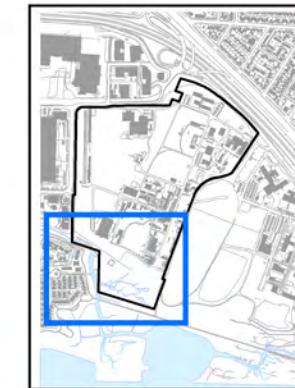
**FIGURE 3  
WESTERN STEGE MARSH  
RESTORATION PROJECT AREA**

The Western Stege Marsh occupies approximately 9 acres and is bounded by the Transition Area to the north, the Connector Trail and Eastern Stege Marsh to the east, the Bay Trail to the south, and Meeker Slough and Marina Bay (a residential community) to the west. The portions of the marsh subject to the WSMRP Monitoring Plan are the 5-acre marsh and ecotone area created during 2002 to 2004 remediation activities (areas formerly designated 2A, M3, and M1a) (see [Figure 3](#)).

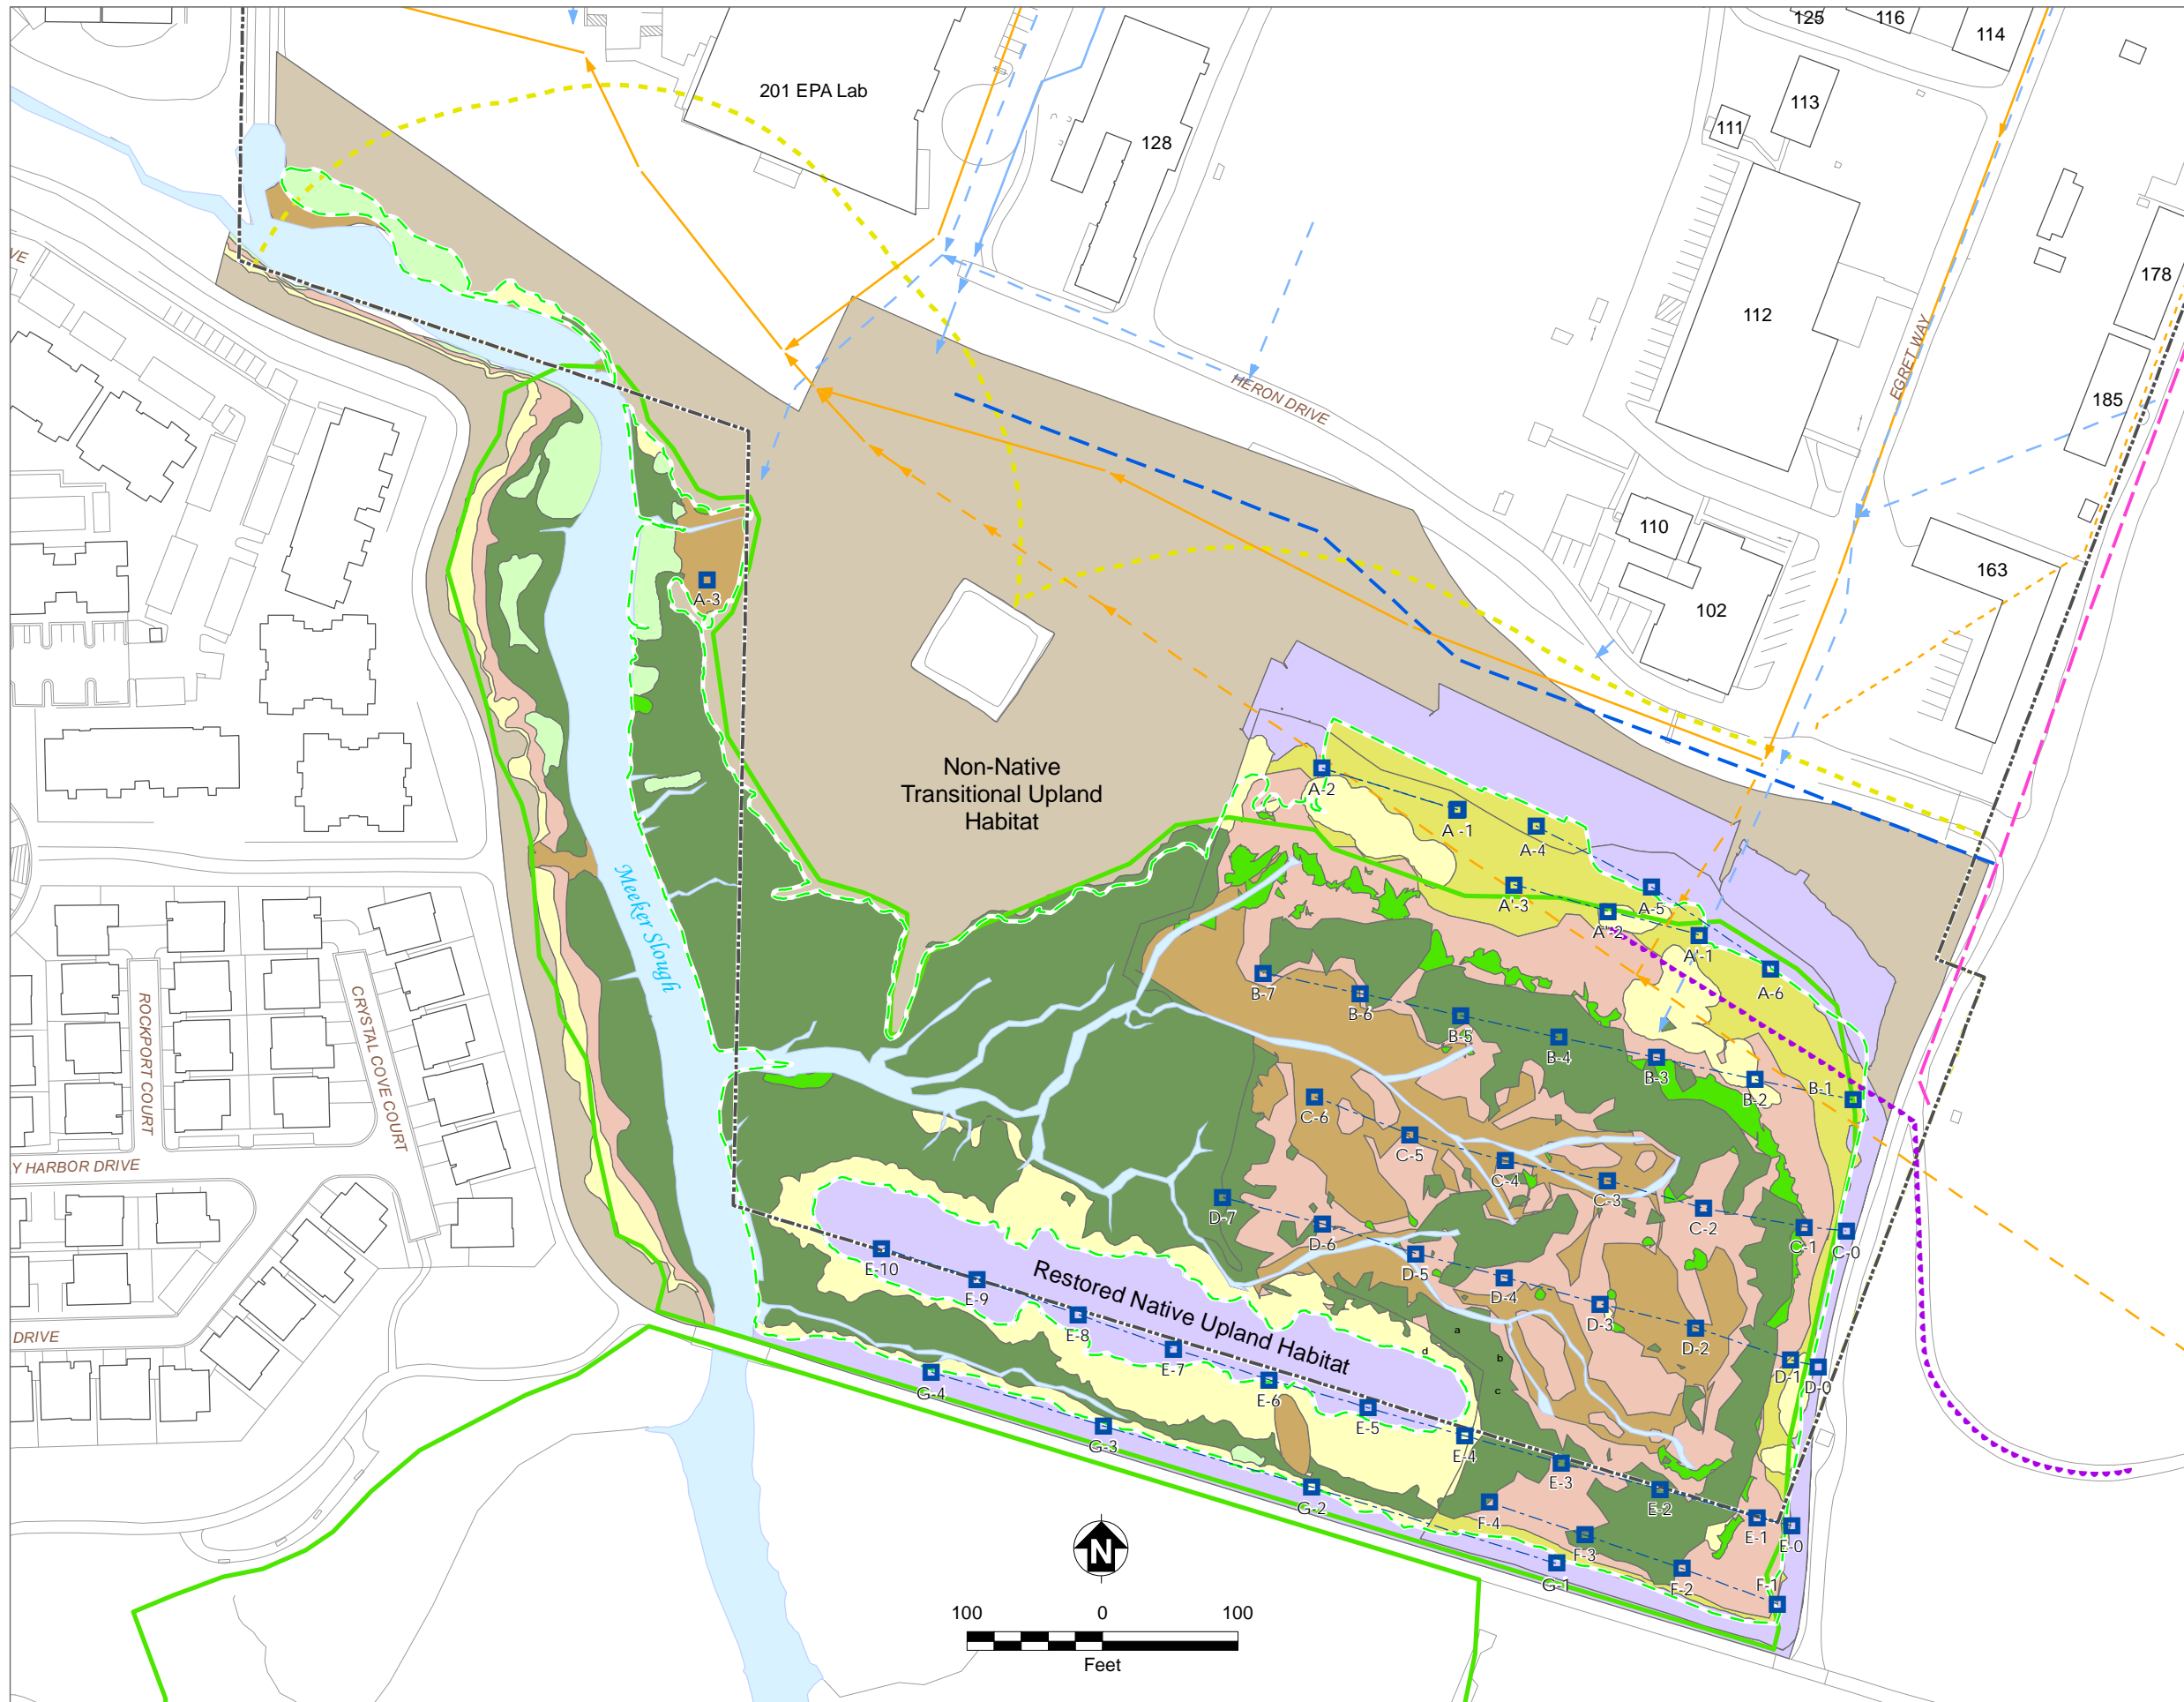
### FIGURE 4 MONITORING LOCATIONS

Surface Water Samples	SW101 SW102 SW103 SW104
Stormwater Samples	STW104 STW105 STW106 STW107 STW108 STW109 STW110
Sediment Samples	SED101 SED102 SED103

Four grab surface water samples and three sediment samples were collected from Western Stege Marsh on April 6, 2009, and again on November 18, 2009 (see Figure 4). Grab surface water samples were collected using a clean dipper pointed in an upstream direction. The dipper was submerged slowly into the surface water to minimize sediment disturbance. Surface water samples were analyzed for metals (both lab-filtered and nonfiltered samples), pH, total dissolved solids, nitrate, total nitrogen, and phosphorus. Per the recommendations of the Year 4 report, the surface water samples were analyzed for PCB congeners using EPA Method 1668. This method yields lower detection limits than EPA Method 8082 used previously for Years 2 to 4. The concentrations of nutrients were measured in surface water for an indication of eutrophication, which can lead to impaired waters by reducing the amount of dissolved oxygen in the water column. Screening criteria for nutrients that are protective of aquatic life do not exist; however, guidance for states and tribes to develop criteria for wetlands using a variety of models was recently published by the EPA (EPA 2008). Phosphorus is generally plentiful in many coastal wetlands, with nitrogen being the limiting nutrient (Zedler 2001). After surface water samples were collected, sediment samples were collected to a depth of 6 inches below ground surface using separate sanitary, disposable scoops for each location. Sediment samples were analyzed for metals, PCBs, and pH. Year 5 sediment samples were not analyzed for pesticides because all results from Years 1 through 4 were non detects.

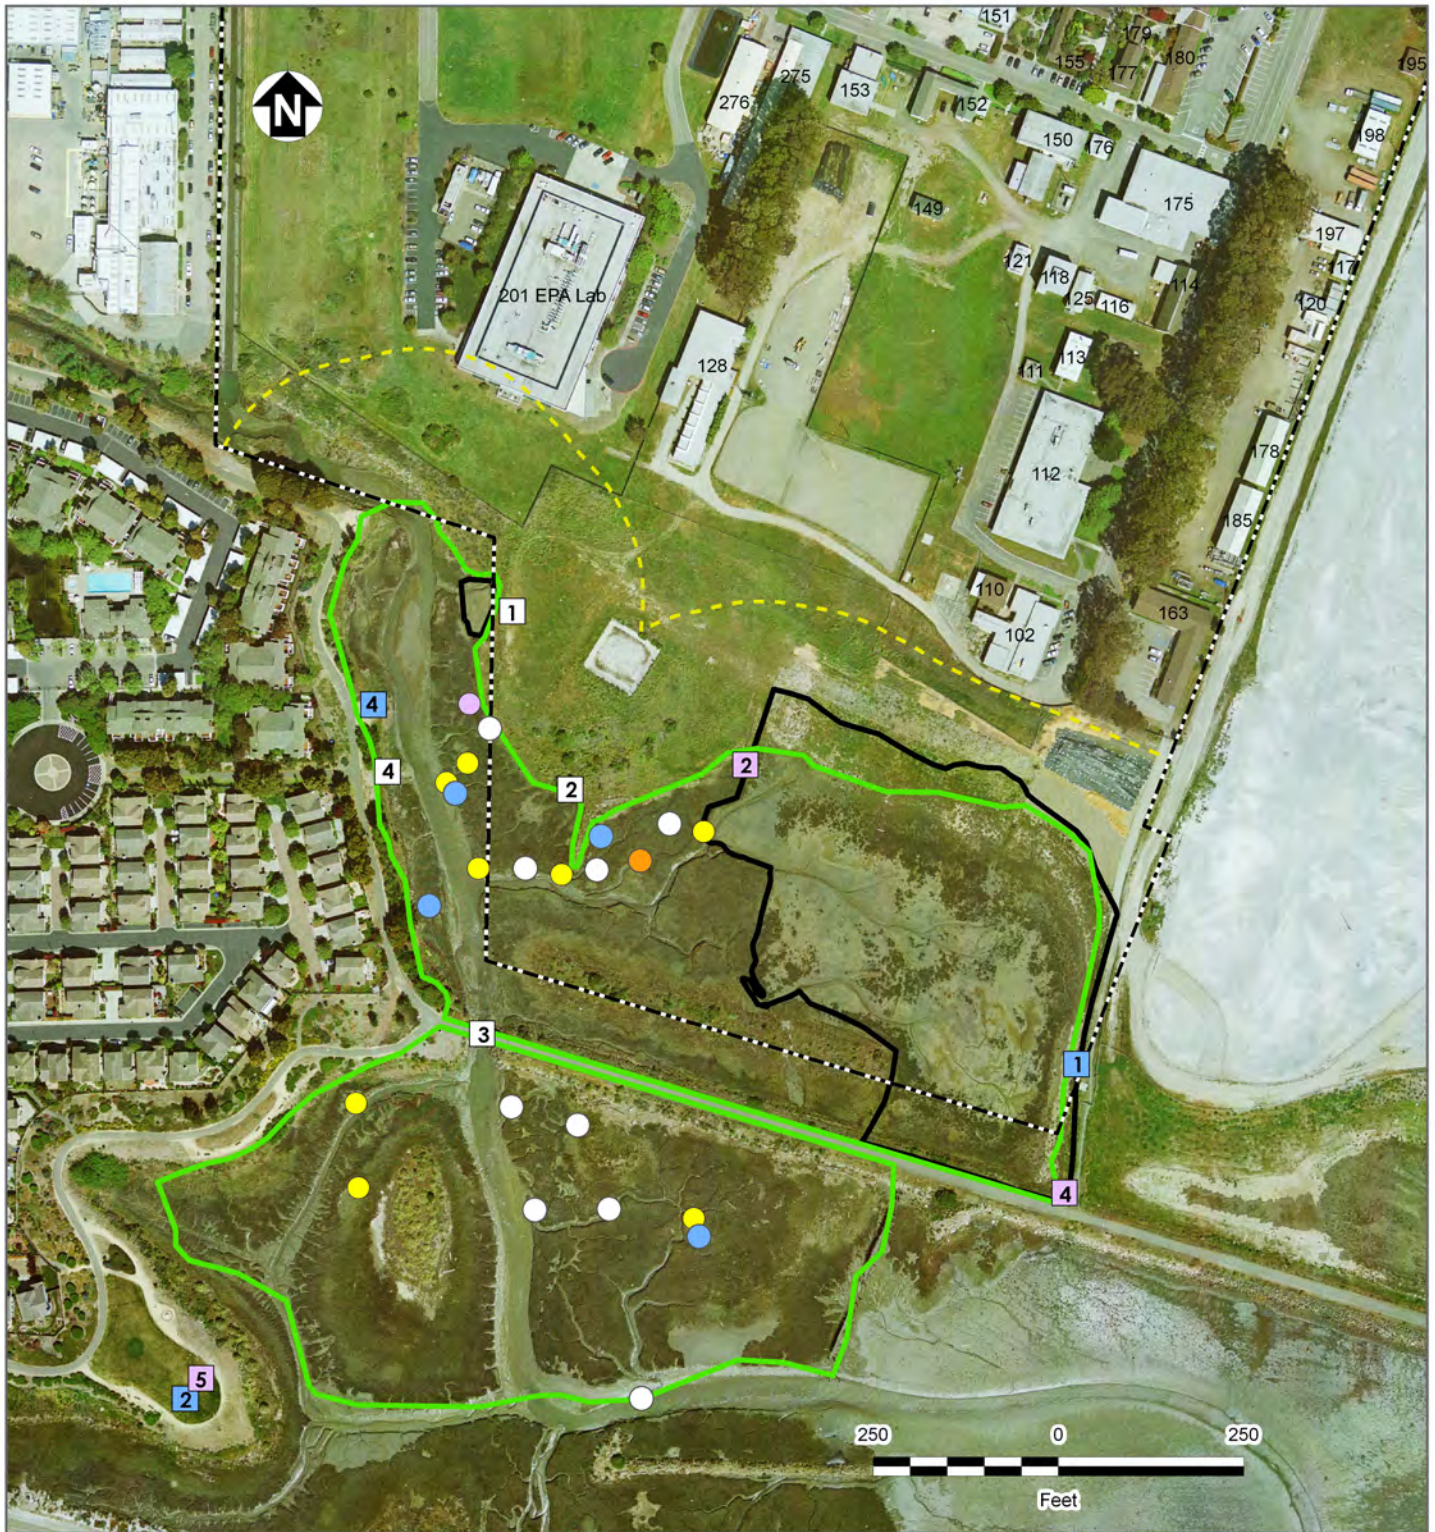
**FIGURE 5**  
**MAJOR PLANT COMMUNITIES**  
**PRESENT AT WESTERN STEGE MARSH**

- Vegetation Sampling Quadrat
- Transect
- Existing Building
- Marsh Area Boundary
- Property Boundary
- Surface Water
- Pacific Cordgrass (*Spartina foliosa*); 3.02 acres
- Salty Susan (*Jaumea carnosa*); 0.2 acres
- Saltgrass (*Distichlis spicata*); 1.20 acres
- Pickleweed (*Salicornia virginica*); 1.74 acres
- Ecotone; 0.686 acres
- Restored Upland; 1.90 acres
- Mud; 1.34 acres
- Non-Native Transitional Upland; 5.24 acres
- Approximate Clapper Rail Habitat Area
- Approximate 200-foot Buffer
- Biologically Active Permeable Barrier Wall
- Former Seawall (Approximate)
- Slurry Wall
- Road Edge and Other Landscape Feature
- Storm Drain Lines:
- ▶ Open Swale
- ▶ Underground Culvert
- Sanitary Sewer Lines:
- ▶ Existing Sewer Line
- ▶ Removed Sewer Line
- Abandoned Sewer Line
