Subject: University of California, Berkeley, Richmond Field Station  
Wetland Determination, Western Stege Marsh

# Wetland Determination, Western Stege Marsh

University of California, Berkeley

Richmond Field Station, Richmond, California

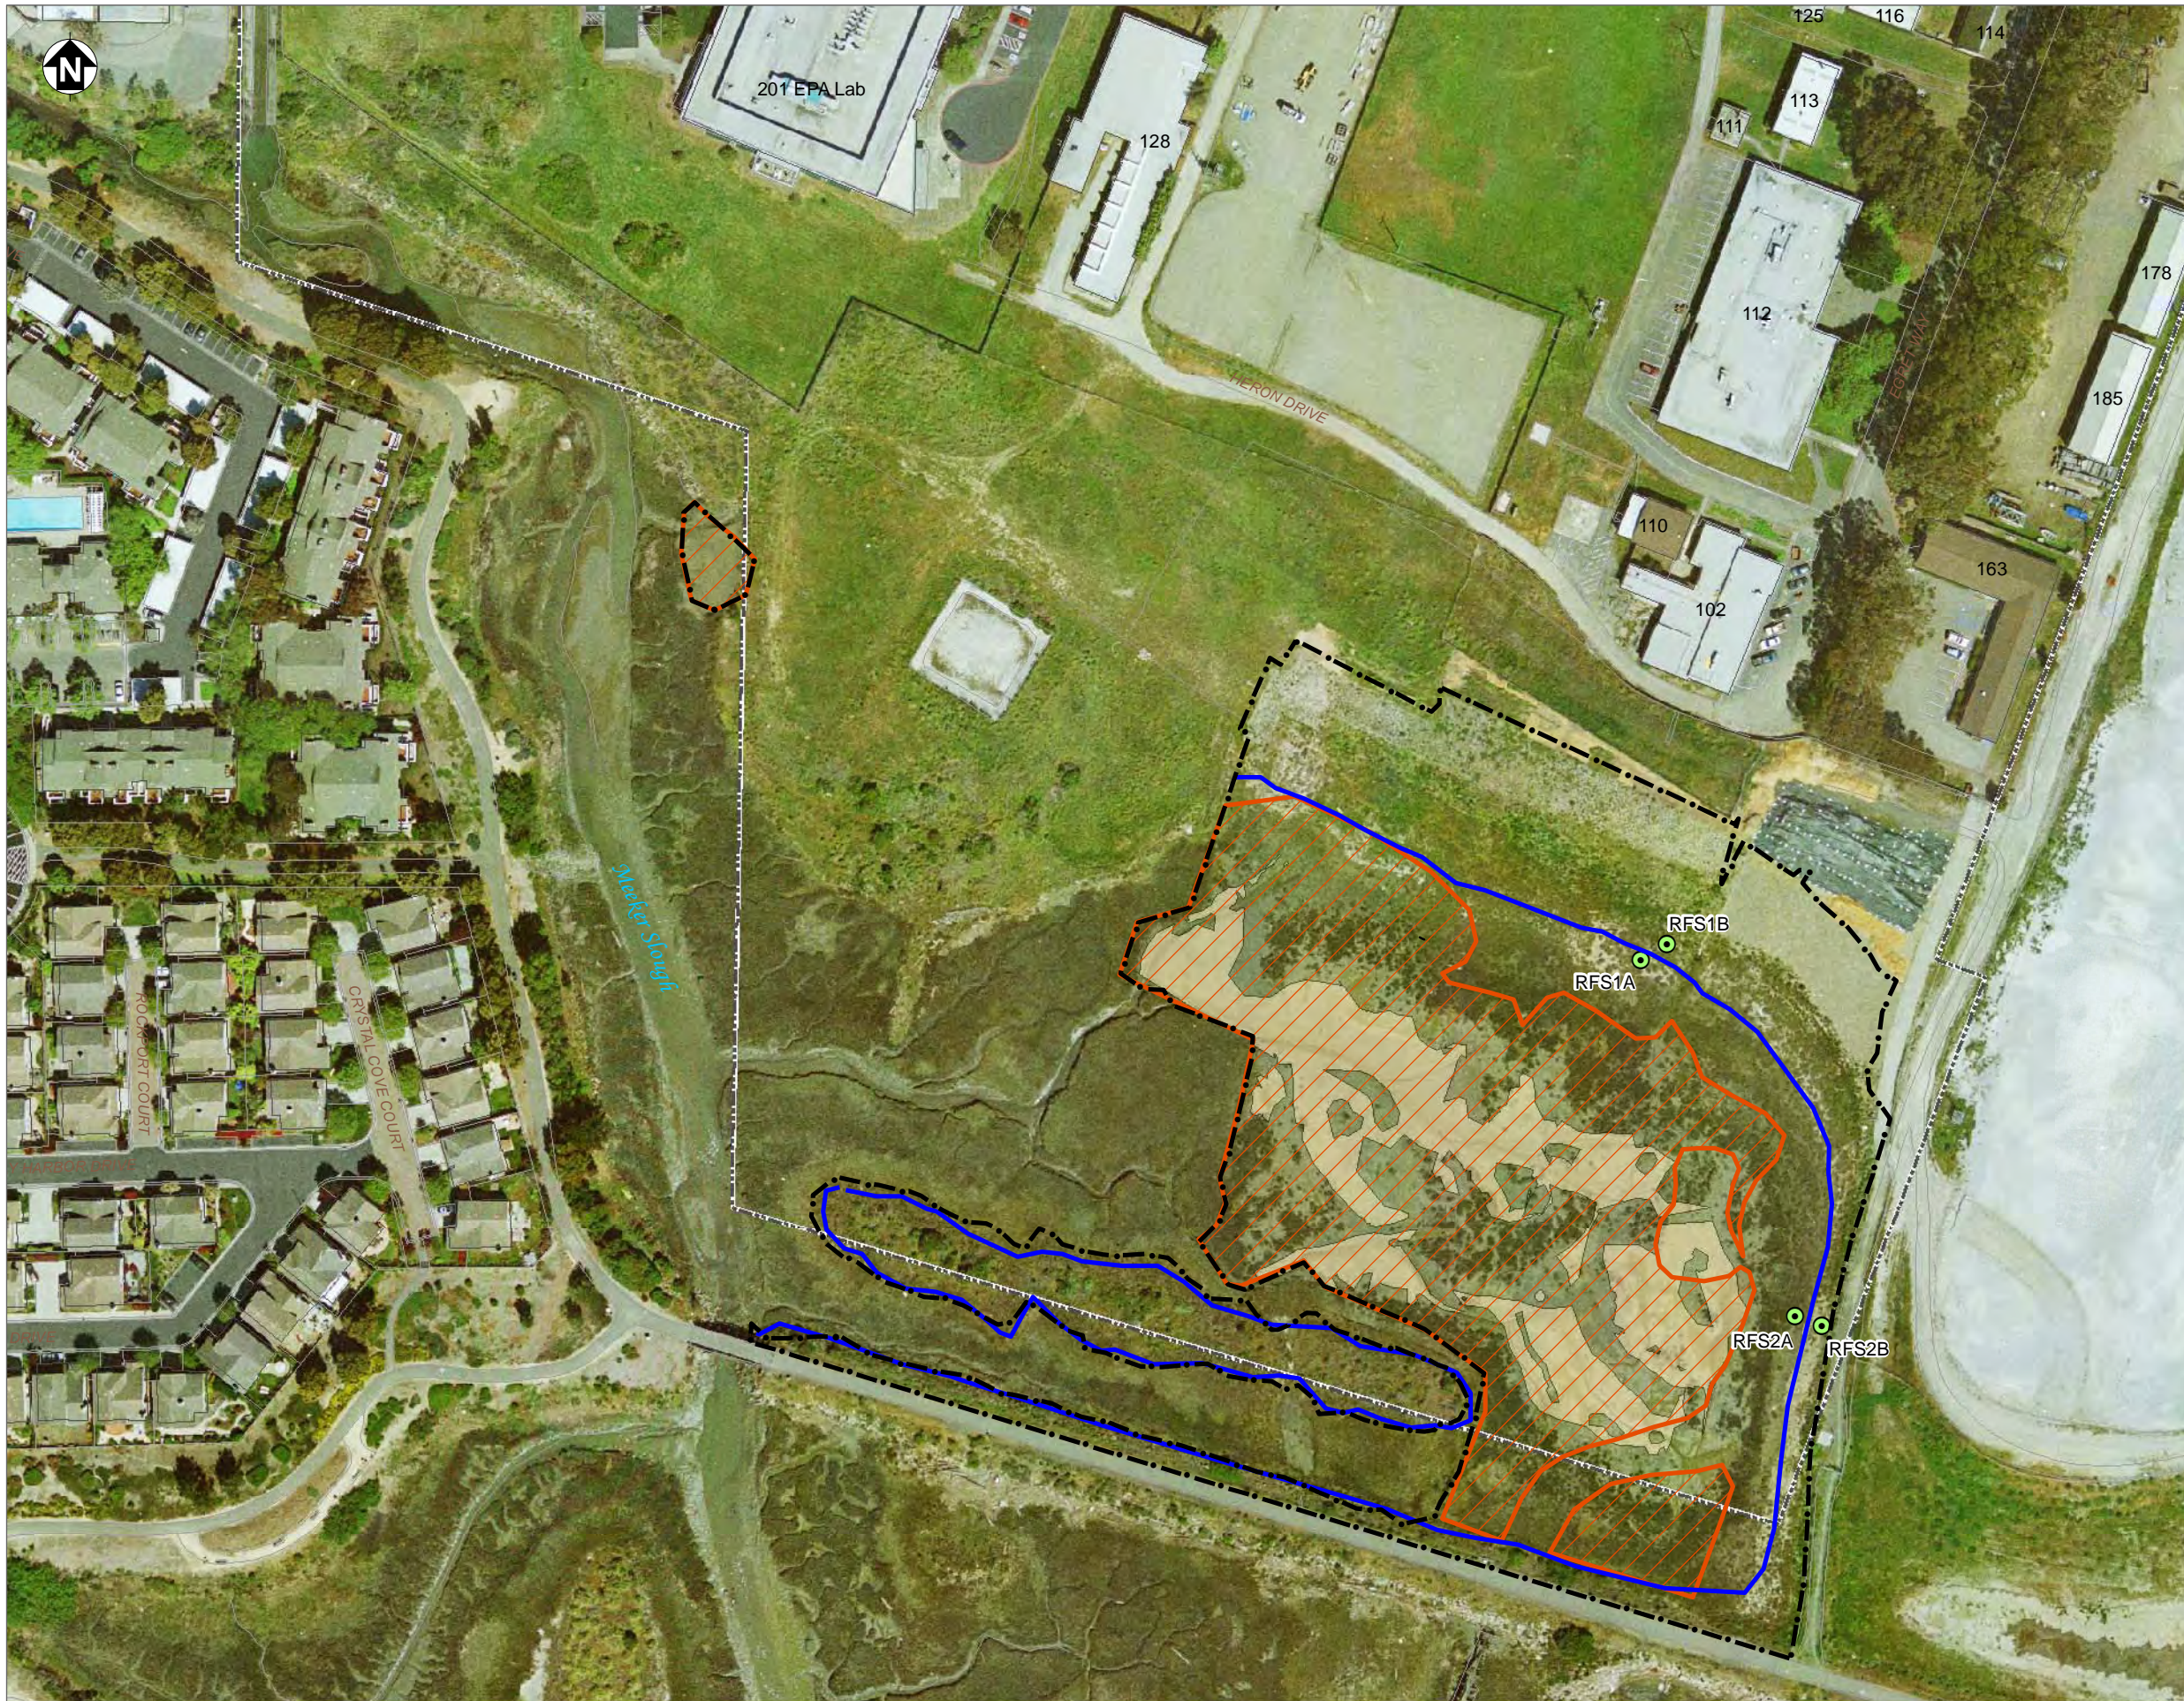
**FIGURE 1  
 WESTERN STEGE MARSH  
 WETLAND DELINEATION MAP**

Based on the presence of wetland vegetation, hydrology, and soils, 3.1 acres within the project boundary are considered USACE CWA Section 404 jurisdictional wetlands, as indicated on [Figures 1 and 2](#). In addition, 1.1 acres within the project boundary are mudflats, and are considered “other waters” under Section 10 of the Rivers and Harbors Act. The total created habitat within the Western Stege Marsh Restoration Project Area is 6.8 acres, as shown on [Figures 1 and 2](#).

Acreages within the Project Area:  
 6.7 acres of habitat restored by UC Berkeley (total Project Area acreage)  
 3.1 acres of wetland (area below HTL of 4.5 ft NGVD 29 - excludes mudflat area)  
 1.1 acres of mudflat or other tidal water

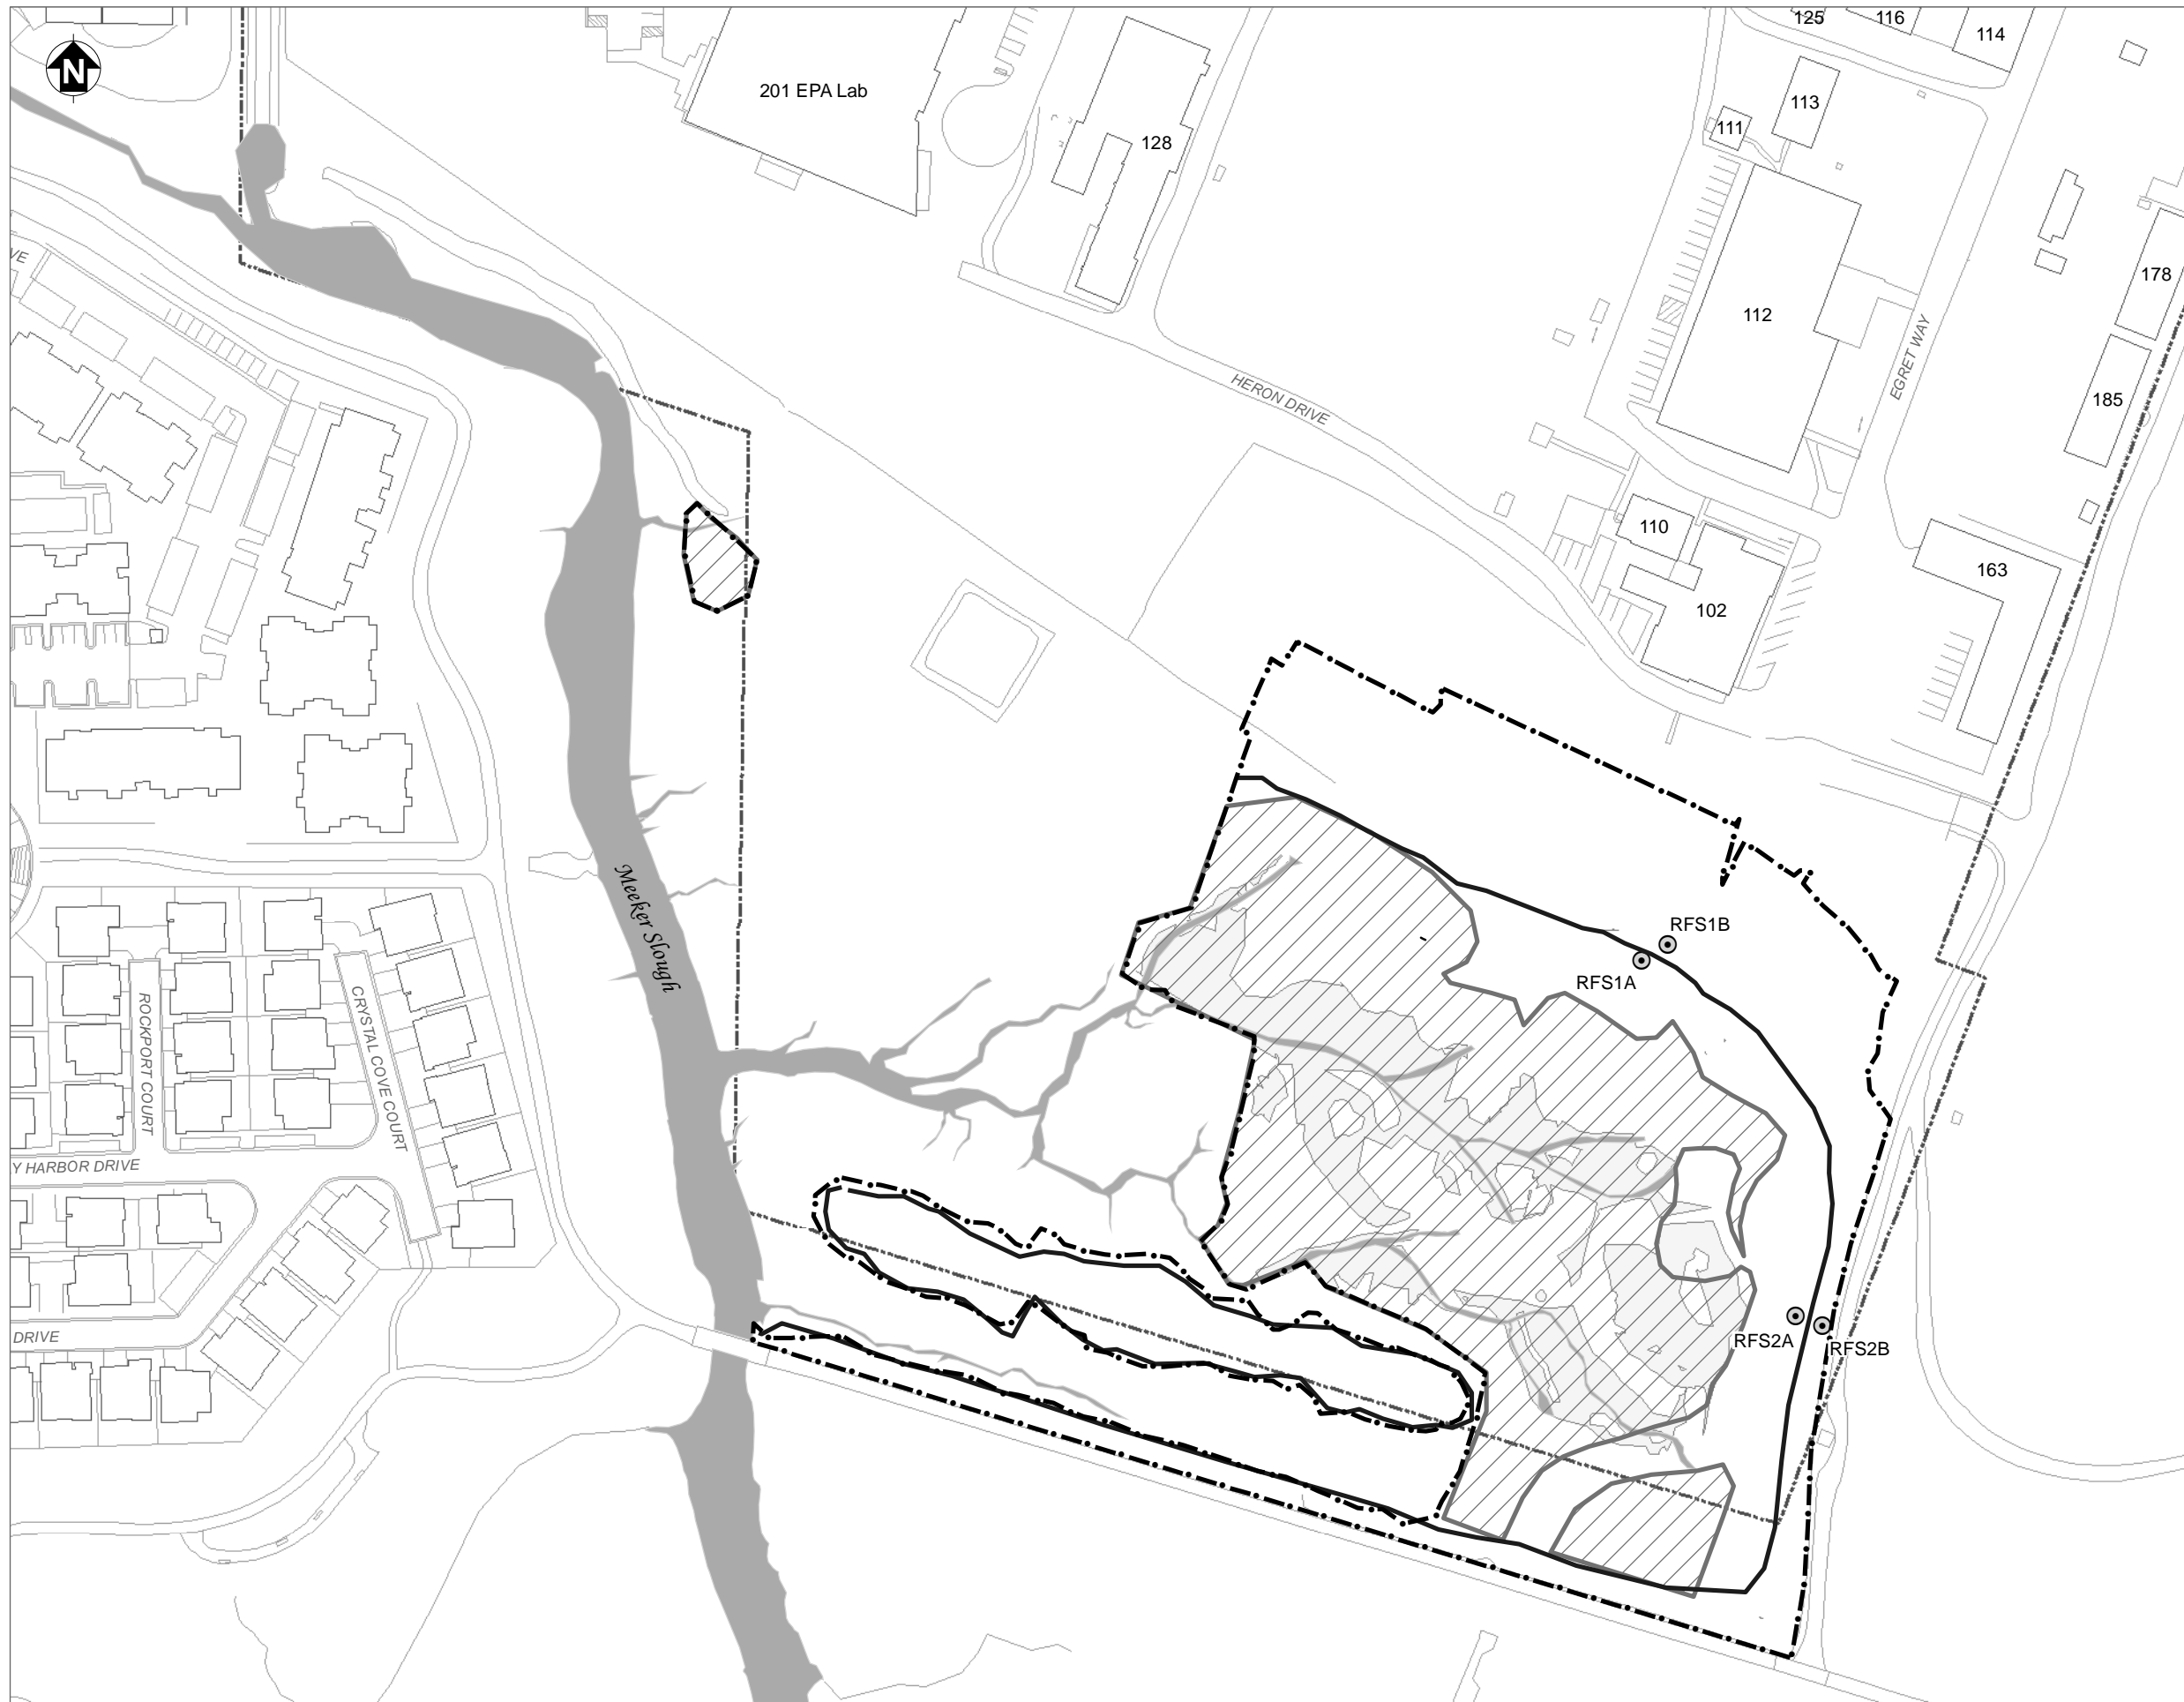
**FIGURE 2  
 WESTERN STEGE MARSH  
 WETLAND DELINEATION MAP**

Acreages within the Project Area:  
 6.8 acres of habitat restored by UC Berkeley (total Project Area acreage)  
 3.1 acres of wetland (area below HTL of 4.5 ft NGVD 29 - excludes mudflat area)  
 1.1 acres of mudflat or other tidal water

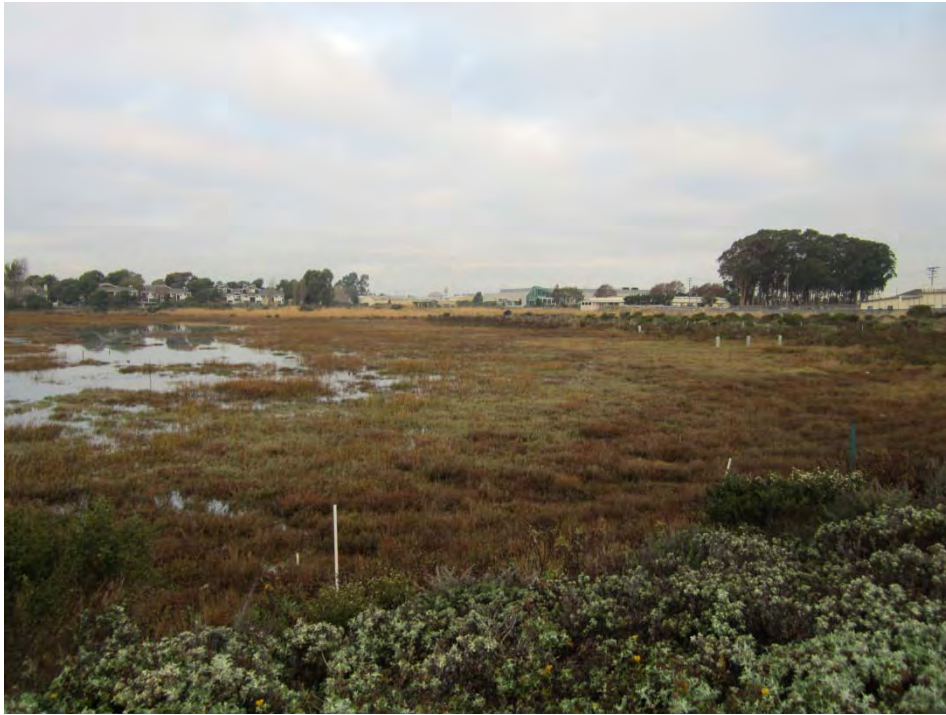
Western Stege Marsh is hydraulically connected to San Francisco Bay via Meeker Creek. The marsh is regularly inundated by tidal action. The outer jurisdictional boundary coincides with the HTL, which is at 4.5 feet NGVD 29, approximately 1 foot above the toe of the embankments on the south and east sides of the marsh. The marsh on the northern side of the tidal channels within the study area is sloped at an angle of approximately 1 percent, creating a gradual transition between low marsh and high marsh. The jurisdictional determination of the marsh coinciding with the HTL is consistent with the jurisdiction delineation conducted in January 2002, before the marsh remediation occurred ([Nichols and Carson 2002](#)). The jurisdictional boundary is shown on [Figure 1](#). This line was created by walking the marsh-edge in the field with a hand-held Global Positioning System (TopCon model GMS-2Pro). This information, along with a 2008 professional topographic survey, was used to approximate a 4.5-foot NGVD 29 contour. The MHTL is approximately 2.75 feet NGVD 29, calculated using data from the National Oceanic and Atmospheric Administration (NOAA) Richmond Inner Harbor tidal station (Station ID 9414849) ([Tetra Tech 2010](#)). This elevation is not shown on [Figure 1](#) because it has not been surveyed. The 2008 survey provides bracketing contours at 2 feet and 4 feet, but due to the irregularity of the marsh topography a 2.75-foot contour cannot be reliably estimated.

Photograph 2-2: Inundation of Lower Marsh during High Tide, November 21, 2011

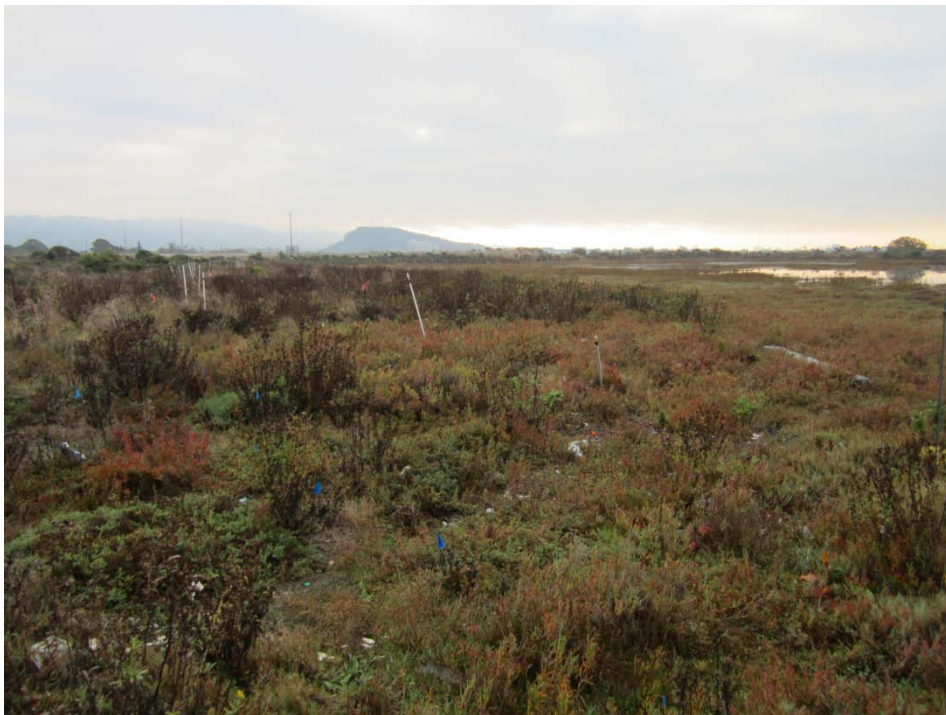
Hydrology was assessed by a visual observation of primary wetland hydrology indicators. Primary hydrologic indicators observed during the field investigation included drift deposits (plastic, trash, and wood), crustacean deposits (crabs), oxidized rhizospheres along living roots, and observations of tidal

Photograph 2-3: Drift Deposits of Plastic at High Tide Line

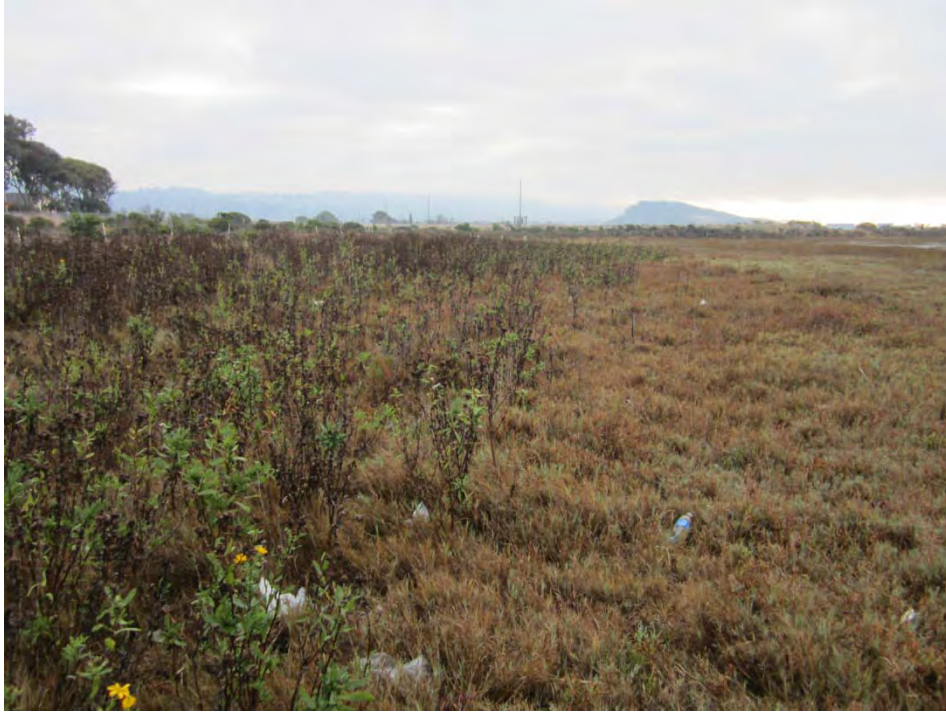
Photograph 2-4: Drift Deposits of Plastic and other Trash below High Tide Line

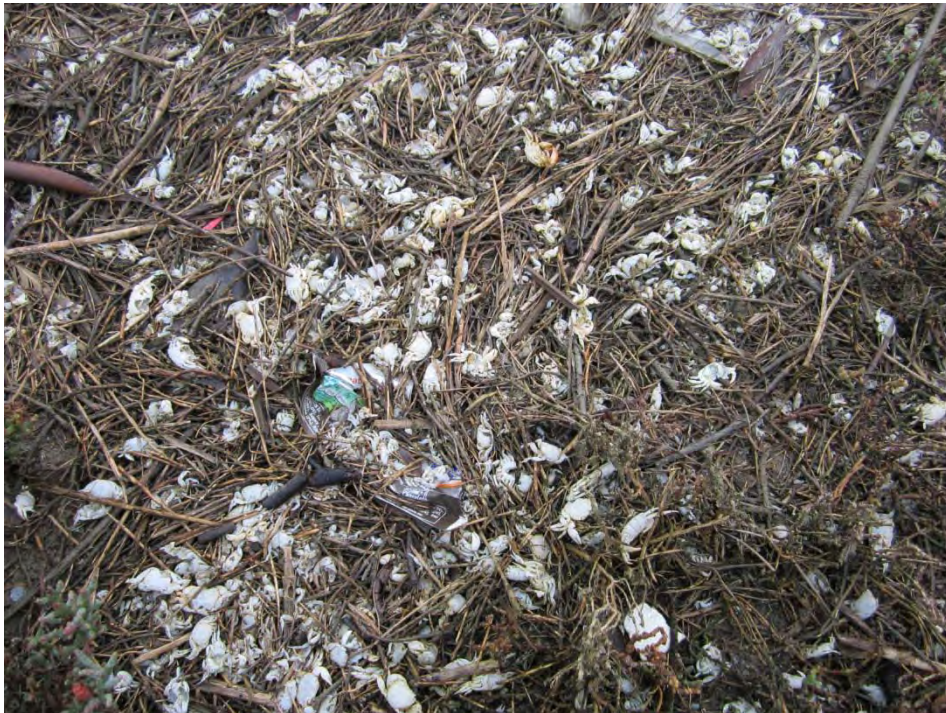
Photograph 2-5: Aquatic Invertebrates below High Tide Line

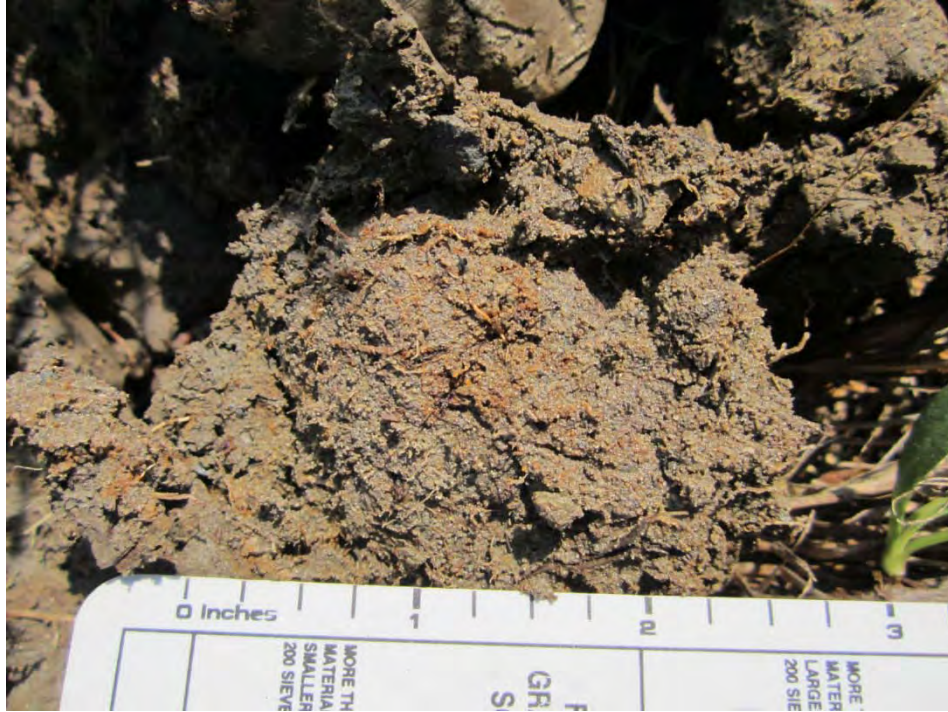
Hydric soil indicators, such as low chroma soil and mottles were observed in soil pits RFS1A and RFS2A. Sandy redox conditions were observed at soil pit RFS1A. The soil layer between 4 to 8 inches had a matrix with 97 percent of the soil having a chroma of 2, with 3 percent distinct redox concentrations occurring as soft masses and pore linings.

Photograph 2-6: Sample Location RFS1A – Sandy Redox Conditions

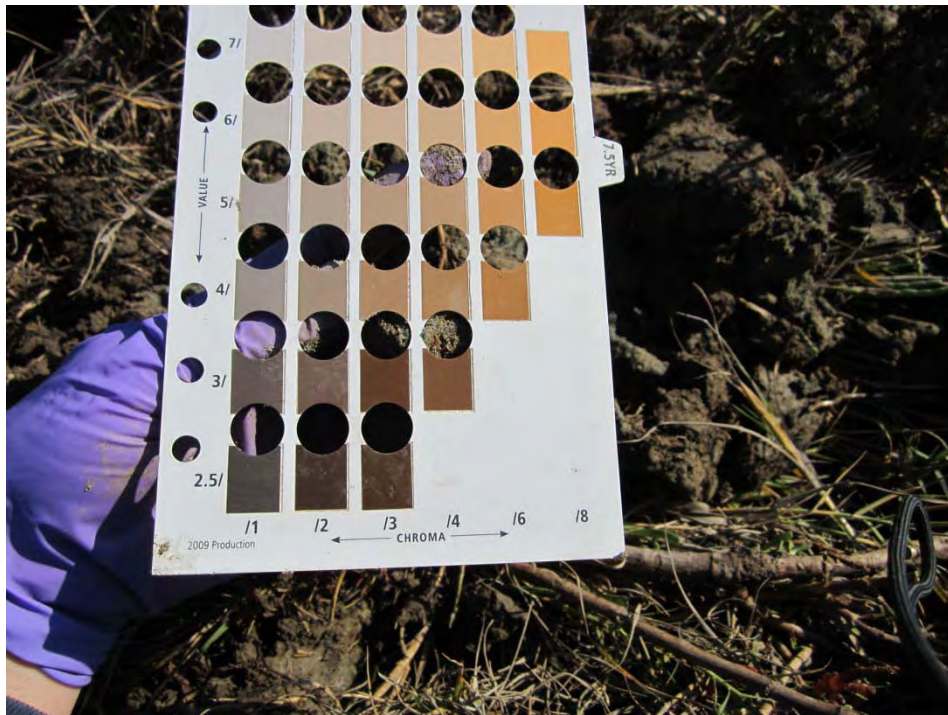
Photograph 2-7: Sample Location RFS1A – Classifying Soil Color of Redox Concentrations

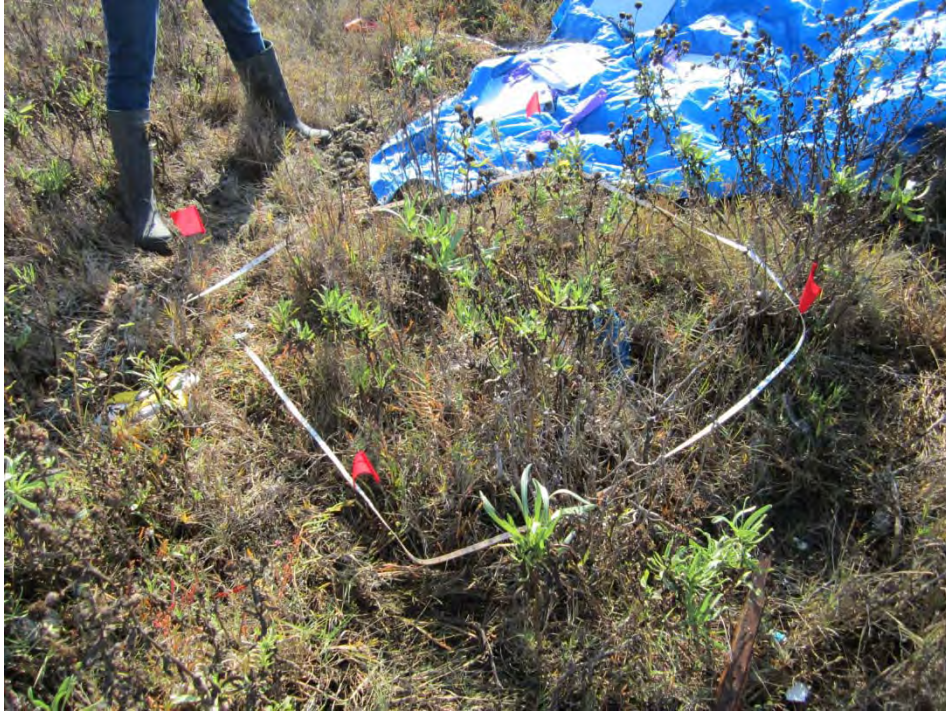
Vegetation within sampling plot RFS1A included marsh gum plant, salt grass, pickleweed, and jaumea, while vegetation within sampling plot RFS2A included salt grass and pickleweed only.

Photograph 2-8: Sample Location RFS1A – Vegetation Plot

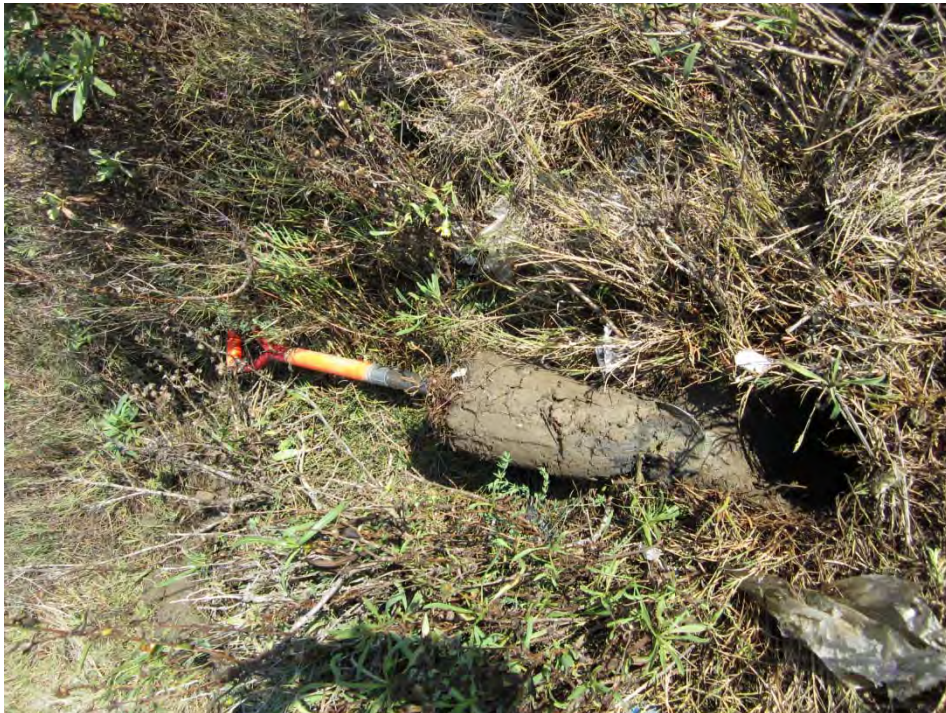
Soil pits RFS1B and RFS2B, upslope of RFS1A and RFS2A, were primarily made up of sandy clays and clay, and did not show any hydric soil indicators.

Photograph 2-9: Sample Location RFS1B – Soil Core

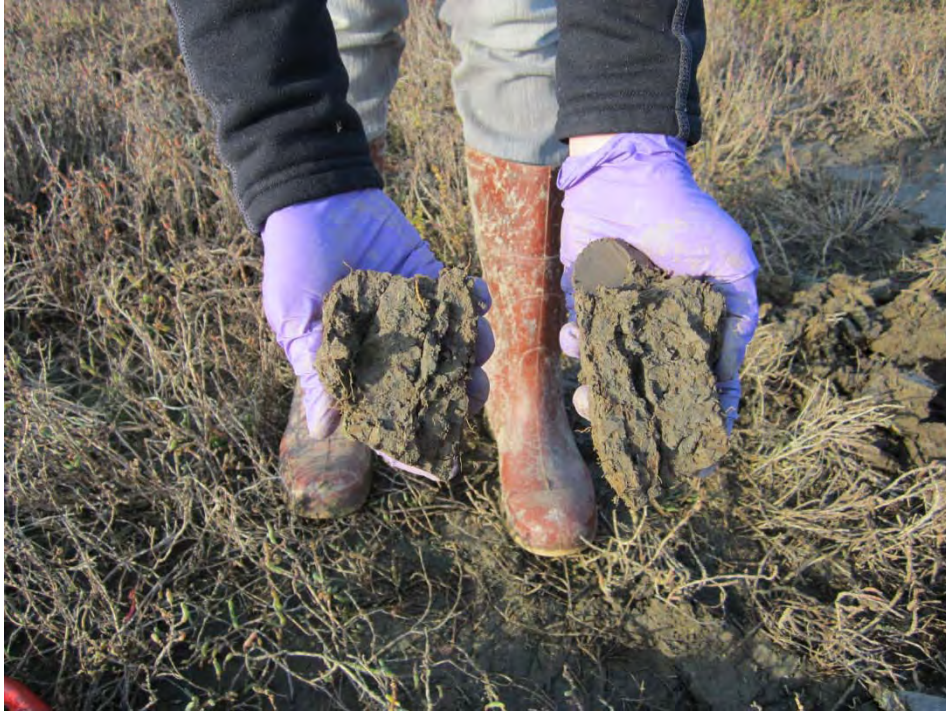
Soil pit RFS2A comprises clay (0 to 4 inches) and loam (4 to 10 inches) matrices, with approximately 1 percent dark-colored redox depletions within the 4 to 10 inch depth interval. None of the hydric soil indicators were formally met; however, the soils at Western Stege Marsh are primarily fill materials transported to the site in 2005, and therefore it is not expected that field indicators of hydric soils would be clearly observed in the fill soils. Tidal inundation occurs during high tide at this sampling plot, therefore it is inferred that hydric soils will more fully develop over time.

Photograph 2-12: Sample Location RFS2A – Mottling in Soil Core

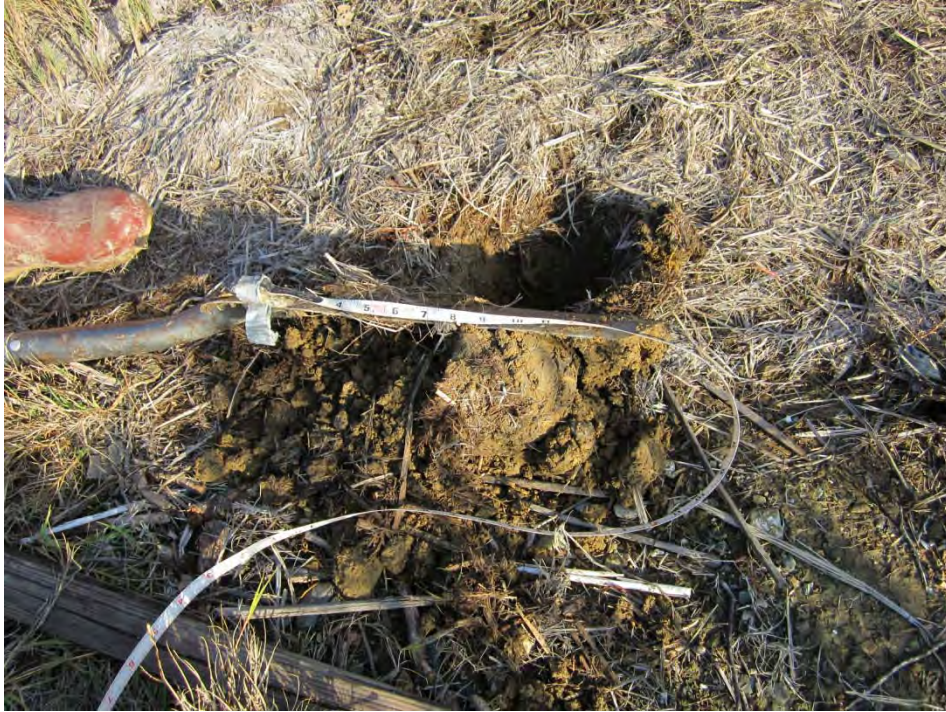
Photograph 2-14: Sample Location RFS2B –Soil Core

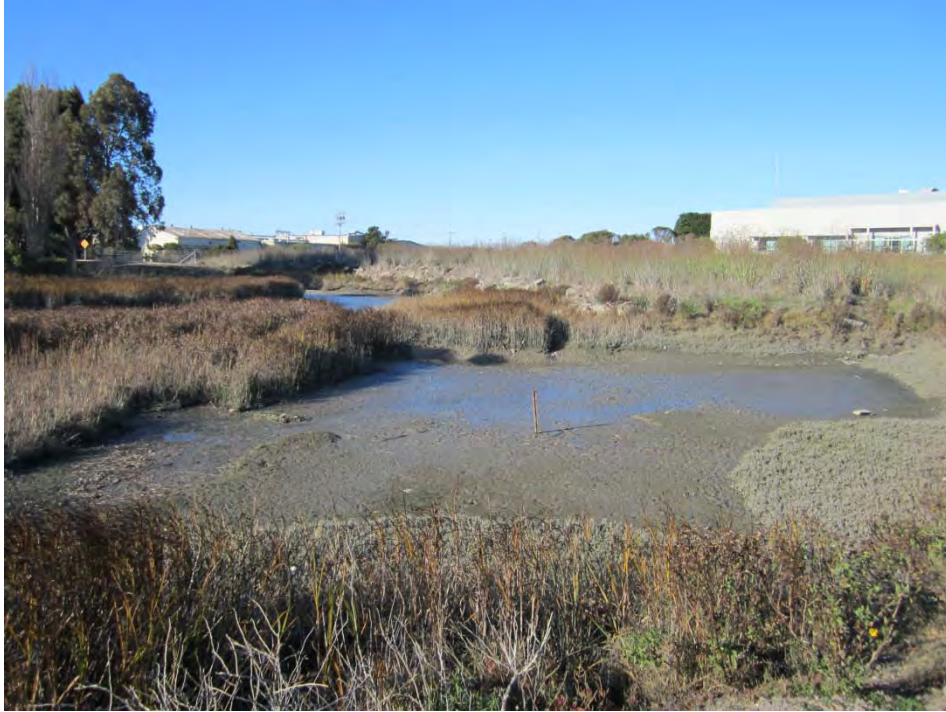
Photograph 2-16: Mudflat in the Northeast Project Area Site – from Southeast
