WETLAND DELINEATION REPORT FOR PORTIONS OF THE RICHMOND FIELD STATION RICHMOND, CALIFORNIA

July 2013

Tetra Tech, Inc.

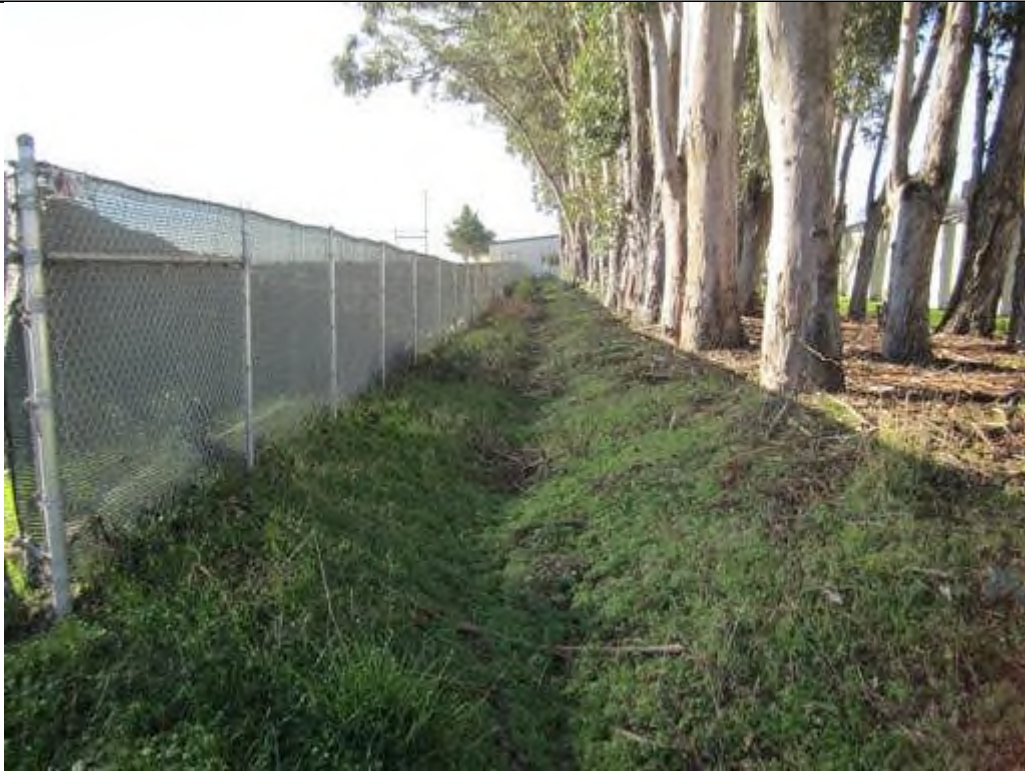
A vegetated channel is north of Building 128, between Building 275 and a fence line (Figure 3-2 and Photo 1, Appendix A). The channel appears to drain water from around Building 275 and carries water south for approximately 230 feet, turns west and drains to a box culvert at the northwest corner of Building 128 (Photo 2, Appendix A). From there, water flows due south (Photo 3, Appendix A) for approximately 180 feet to a 300-square-foot herbaceous wetland swale. The channel is periodically maintained to convey water. Sample points W-4, W-5, and W-6 were along this channel (Figure 3-1). Again, wetland determination data forms are in Appendix B.

Photo 1. Drainage channel that flows south parallel to Building 275 (facing south).

The channel conveys water that drains from adjacent buildings. Water is conveyed along an open swale (Photo 1, Appendix A), to an underground culvert (Photo 2, Appendix A), then daylighted again and joins another underground culvert (Photo 3, Appendix A). Despite this, there were no indicators of wetland hydrology at sample point W-4. Wetland hydrology indicators were observed at sample points W-5 (water marks and sediment deposits) and W-6 (water-stained leaves). Standing water was observed during the January 2013 site visit, but no standing water was observed during the February 2013 wetland delineation.

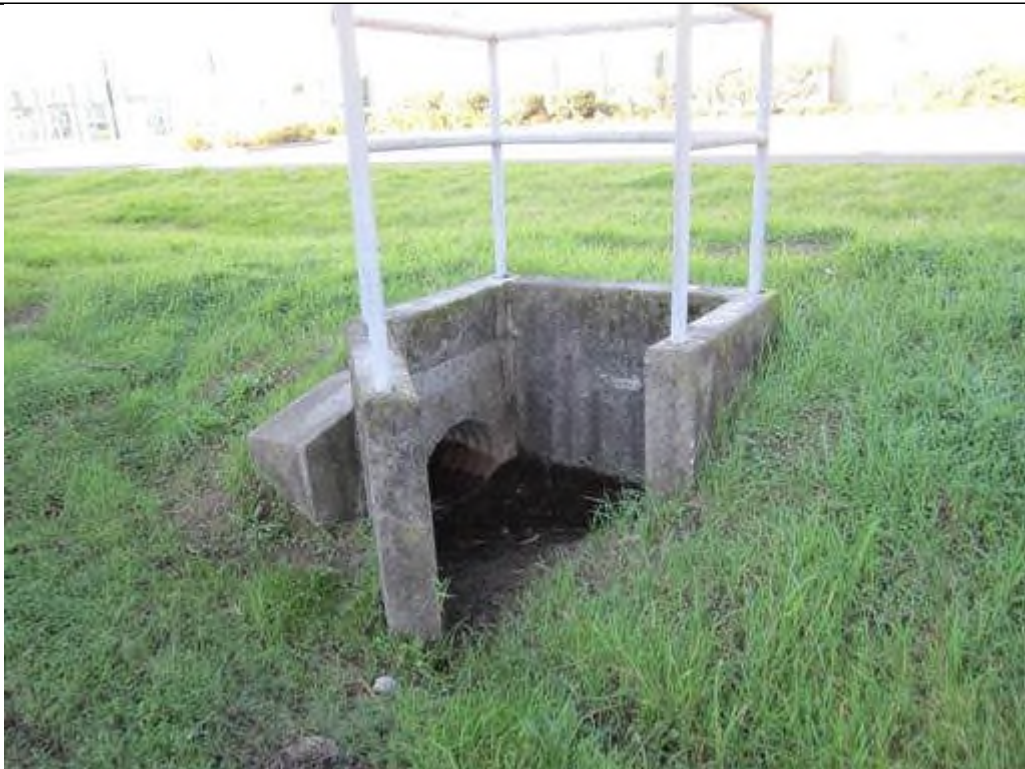
Photo 2. Drainage shown in Photo 1, as it turns west at Building 128 and flows into a box culvert (facing west).

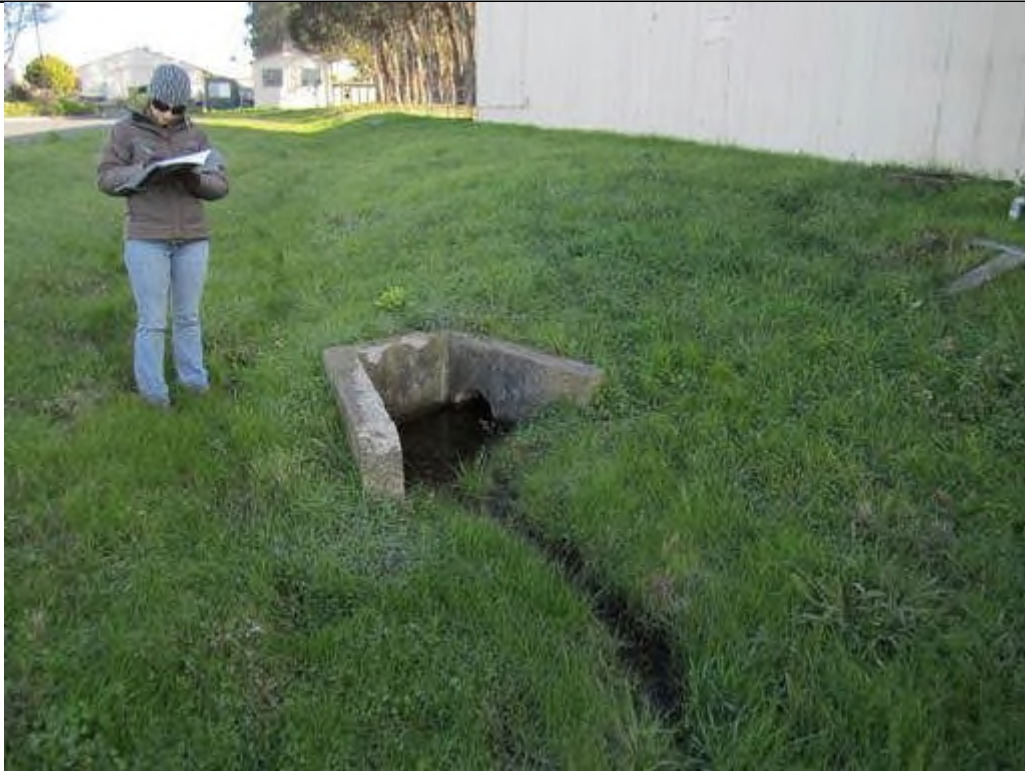
The source of water to the wetland swale is largely from the drainage channel from the north. The second culvert (Photo 3, Appendix A) appears to also convey water from the east, as indicated by the location of known underground water conveyances (Figure 3-2). Water is conveyed from the wetland swale, to the south, through a third culvert (Photo 5, Appendix A) where it flows to another open swale for approximately 20 feet. Beyond this point, there is very little evidence of an open swale. Another underground culvert carries water off the project study area to Western Stege Marsh (Figure 3-2). There were no indicators of wetland hydrology below the wetland swale.

Photo 3. Box culvert west of Building 128. Channel flows underground from previous culvert and exits here where it combines with wetland swale (facing north).

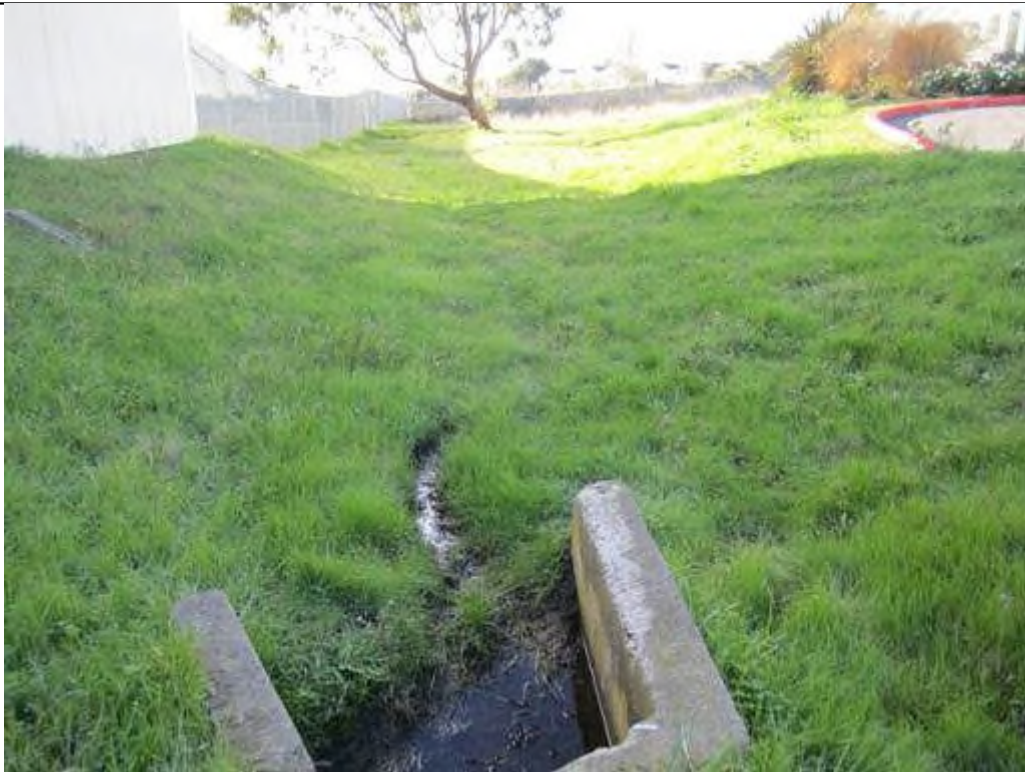
A 300-square-foot herbaceous wetland swale was observed in the southwest corner of the project study area (Photos 4 and 5, Appendix A) (Figure 3-1). The area is periodically maintained to convey water. No standing water was observed during the February wetland delineation.

Photo 4. Wetland swale from Photo 3 continues to flow as a channel to the fence line (facing south).

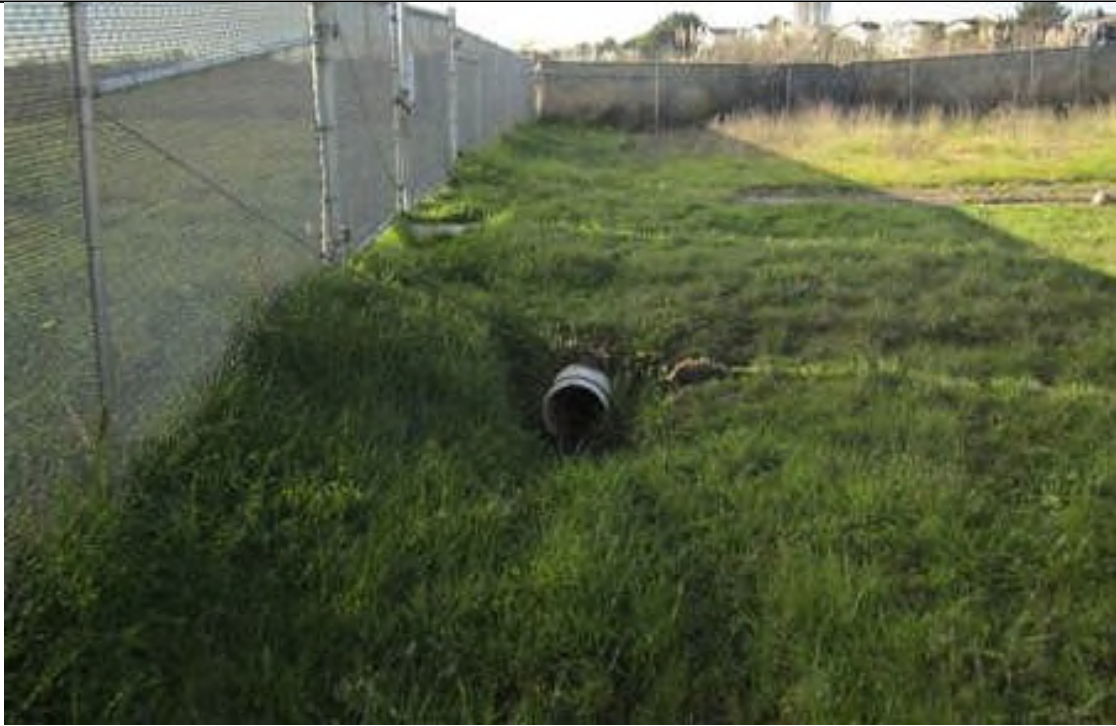
Photo 5. Wetland swale from previous photo flows into a culvert to pass under Heron Drive and continues as a narrow channel (facing south).

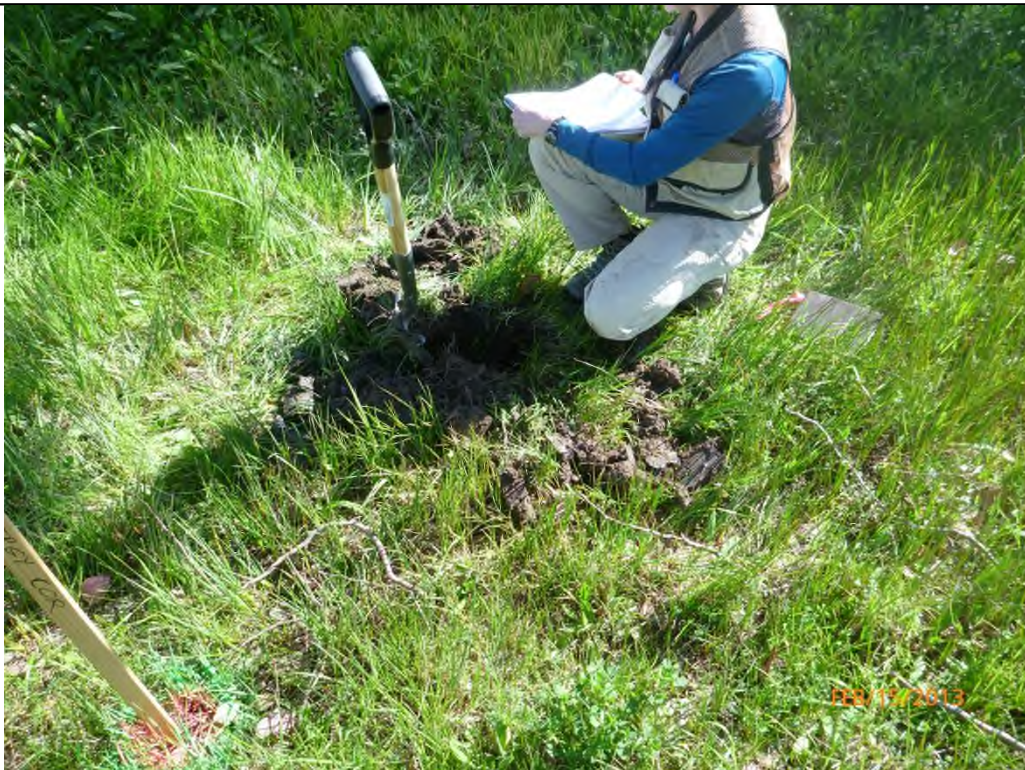
Photo 6. Wetland swale (300 square feet).

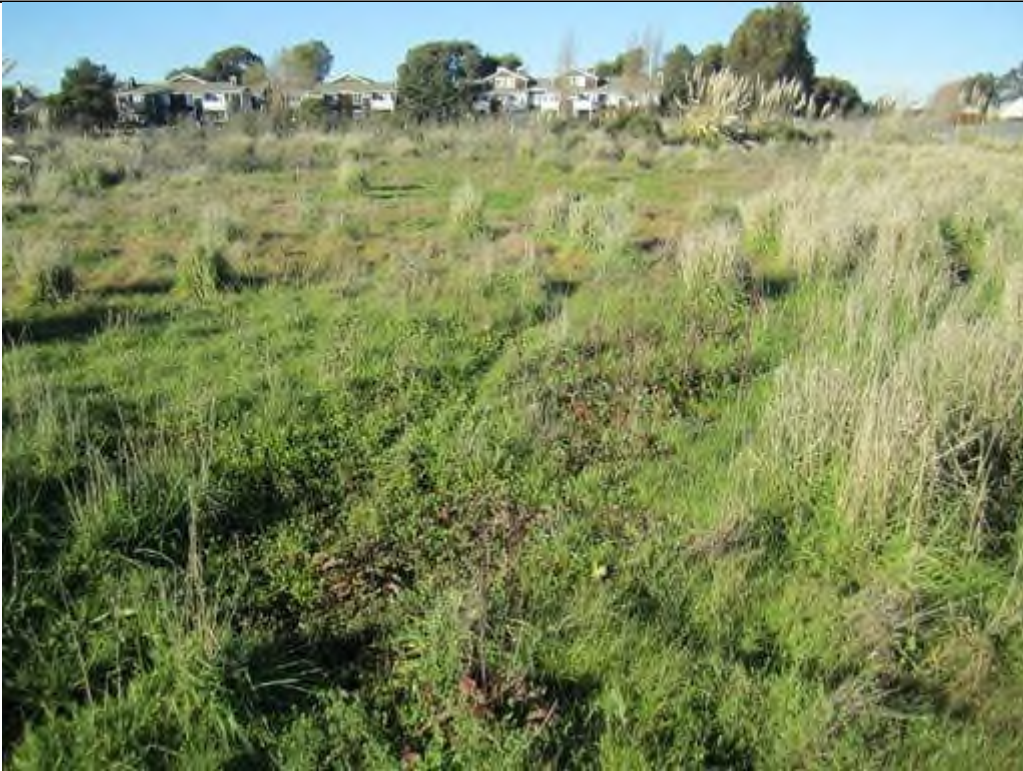
Photo 7. Sample point S-1 located south of Building 128 and Heron Drive, in a nonnative grassland habitat (facing west). During the January 2013 site visit, hydric vegetation in the area suggested a potential depressional wetland; however, no hydric soils or wetland hydrology indicators were recorded during the February 2013 delineation.
