TETRA TECH, INC.

October 6, 2020

**Subject: University of California, Berkeley, Richmond Field Station Site  
2020 Groundwater Sampling Results Technical Memorandum  
Site Investigation and Remediation Order I/SE-RAO 07/07-004, Section 5.16**

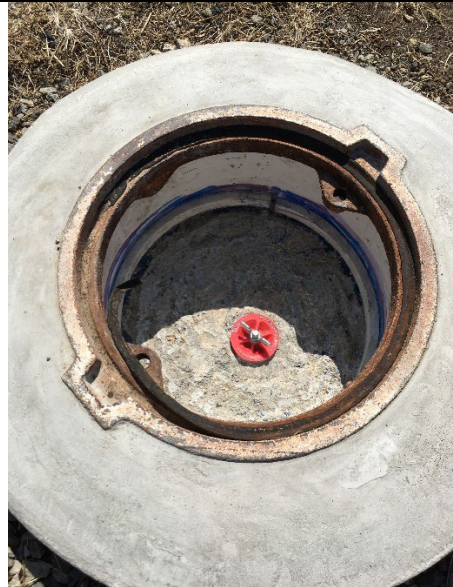
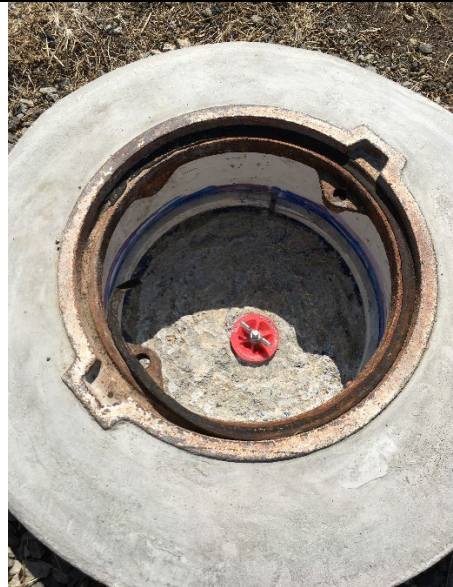
**Photograph 1**

Piezometer PZ-8

During this period, repairs were completed at B280A and PZ-8, which had damaged upper casings as a result of local traffic. Photographs of the repaired piezometers are included as Attachment 2.

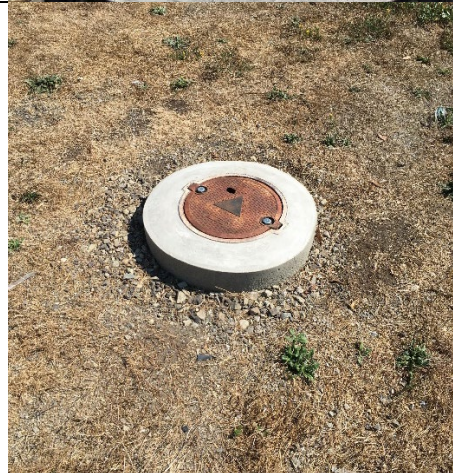
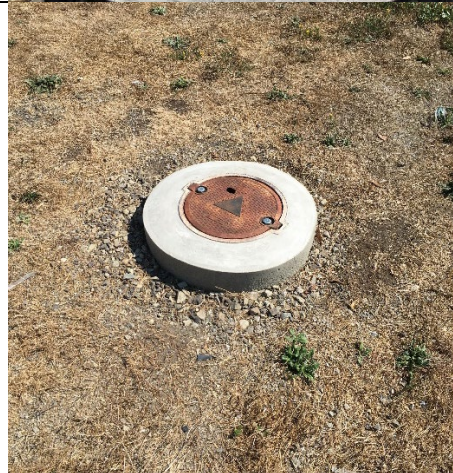
**Photograph 2**

Piezometer PZ-8

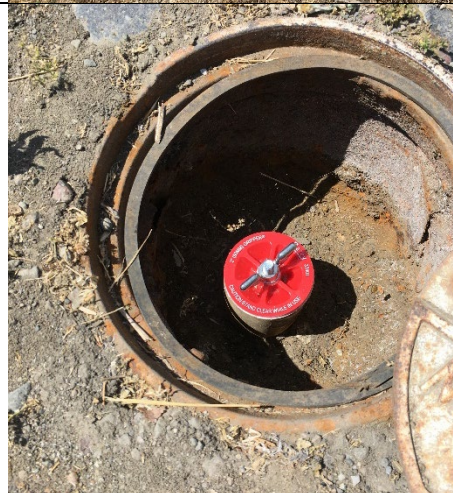
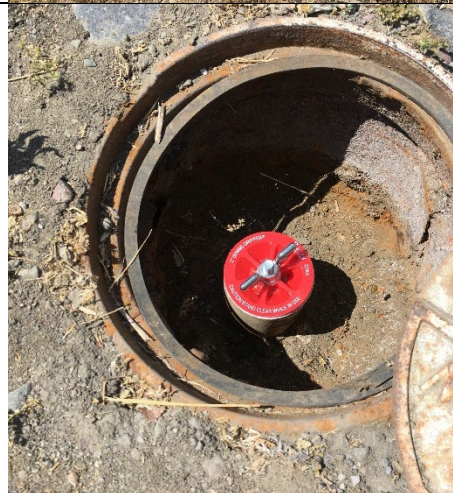
**Photograph 3**

Piezometer B280A
