ANNUAL MONITORING REPORT

NORTHERN REGIONAL LIBRARY FACILITY, PHASE IV MITIGATION
UNIVERSITY OF CALIFORNIA, BERKELEY (RICHMOND BAY CAMPUS)
RICHMOND FIELD STATION
RICHMOND, CA

December 28, 2021

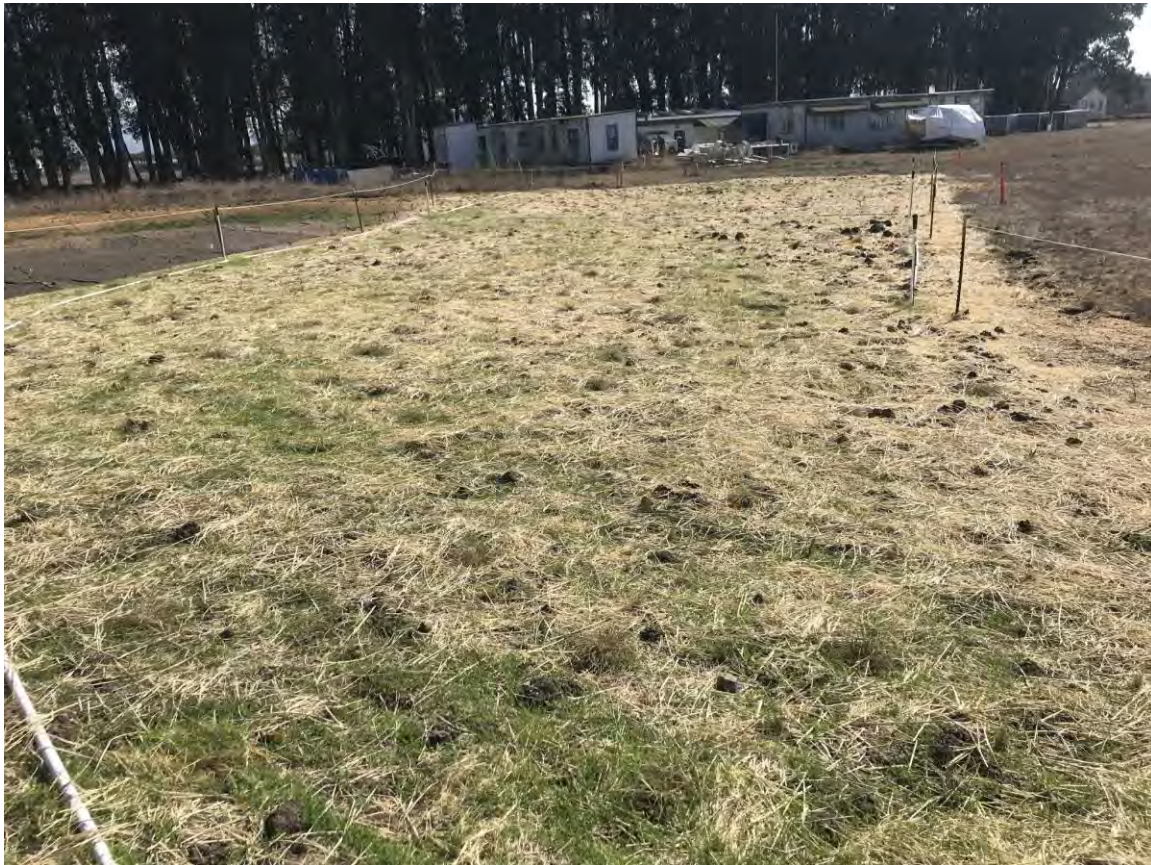
Initial restoration activities included the spreading of excavated soil and ripping the restoration area performed by others in fall 2020, and the installation of a temporary irrigation system, seeding, planting and mulching performed by RANA between October 2020 and December 2020 (fig 1) (table 1 and 2).

Figure 1. Seeded, strawed, and mulched mitigation site (December 2020).

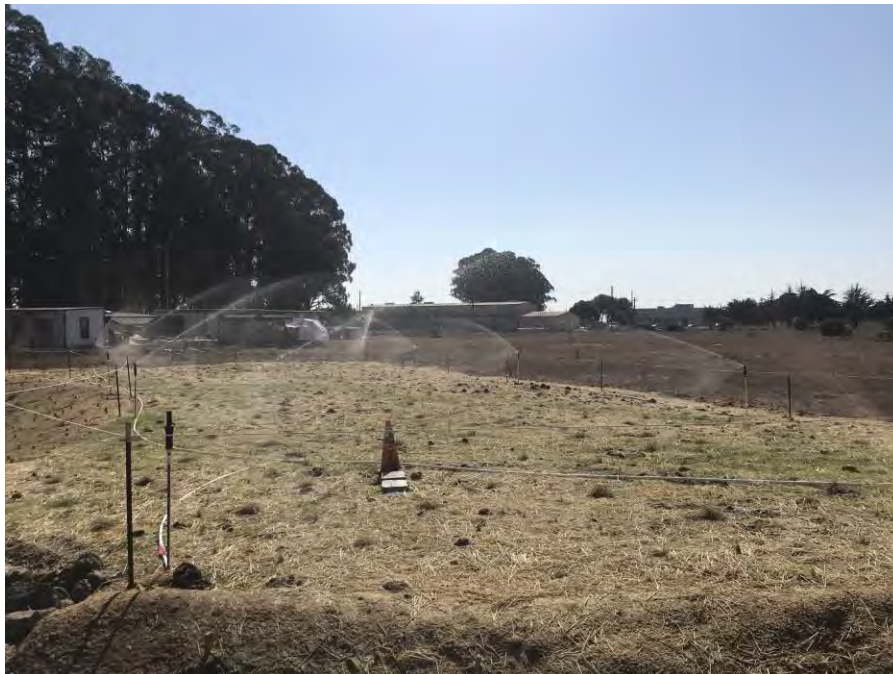
The restoration area is irrigated by a temporary irrigation system. Soils at the site drain poorly and weather conditions during most of the year tend to be cool and dry. The irrigation system was used during the dry months of Year 1 (three times per week). The irrigation system was turned off in October and will remain off until seasonal rains stop and the soil begins to dry (**fig 2**).

Figure 2. Temporary irrigation at mitigation site

- Plant additional coastal terrace prairie plants throughout restoration site (see section 4.1).
- Continue with quarterly maintenance activities, with potential additional maintenance visit scheduled for late spring in order to ensure non-native plants remain under control.
- Focus maintenance visits on weed removal on southern portion of the site.
- Discontinue use of the temporary irrigation system in late summer to demonstrate that vegetation is self-sustaining.
- Remove temporary irrigation during the final maintenance visit.

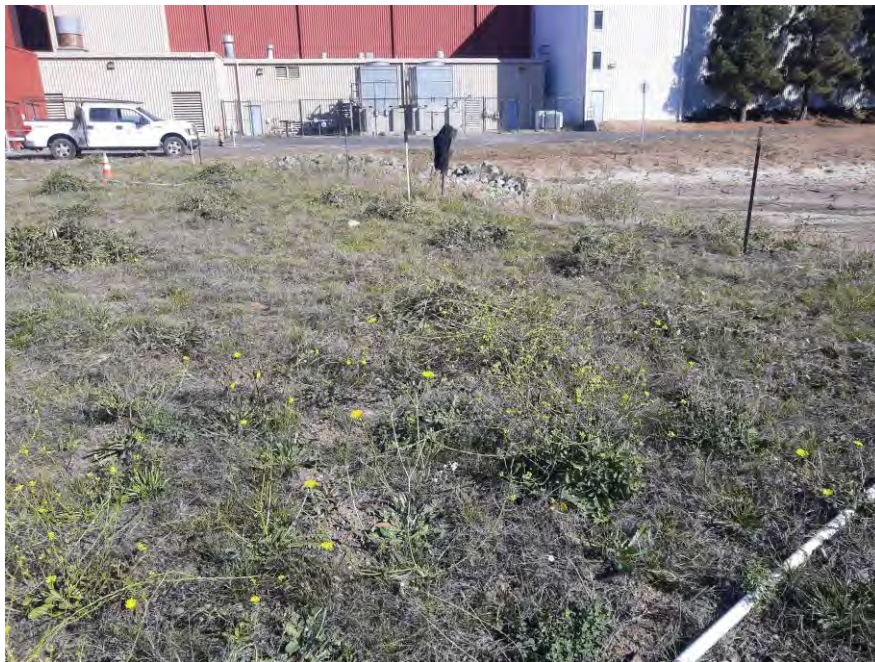
Weed control is the most critical aspect of revegetation at the project site. At each site visit and maintenance event, non-native weeds are identified and removed prior to seed production. The focus of weed removal centers on species that are listed by the Cal-IPC as 'medium' or 'high' invasiveness. Target Invasive Weeds removed include black mustard (*Brassica nigra*), stinkwort (*Dittrichia graveolens*), fennel (*Foeniculum vulgare*), cat's ear species (*Hypochaeris* spp.), and Harding grass (*Phalaris aquatica*). Cal-IPC 'limited' species bur clover (*Medicago polymorpha*), English plantain (*Plantago lanceolata*), prickly ox-tongue (*Picris echinoides*), *Rumex* spp., and sow thistle (*Sochus* spp.) were also removed during maintenance visits (**fig 3**).

Figure 3. Removal of black mustard and cat's ear species at the mitigation site.

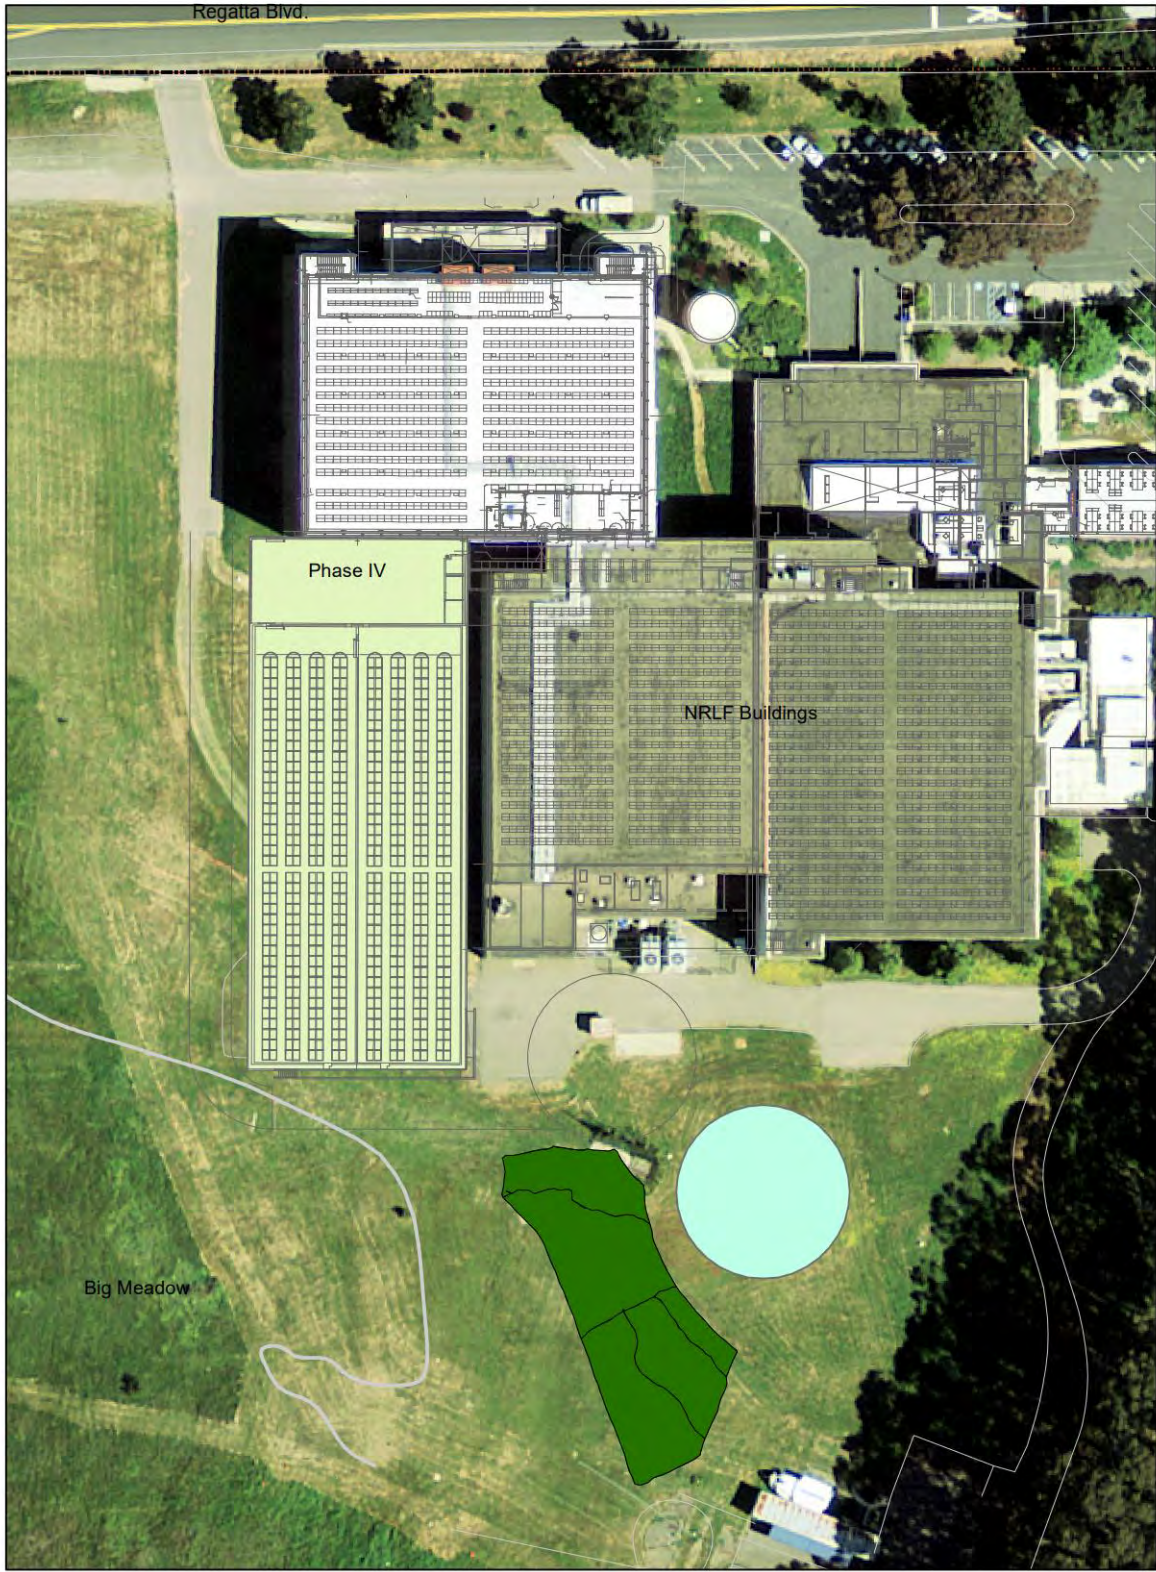
Map 2. Restoration Area

Bioswale Mitigation Area Phase IV

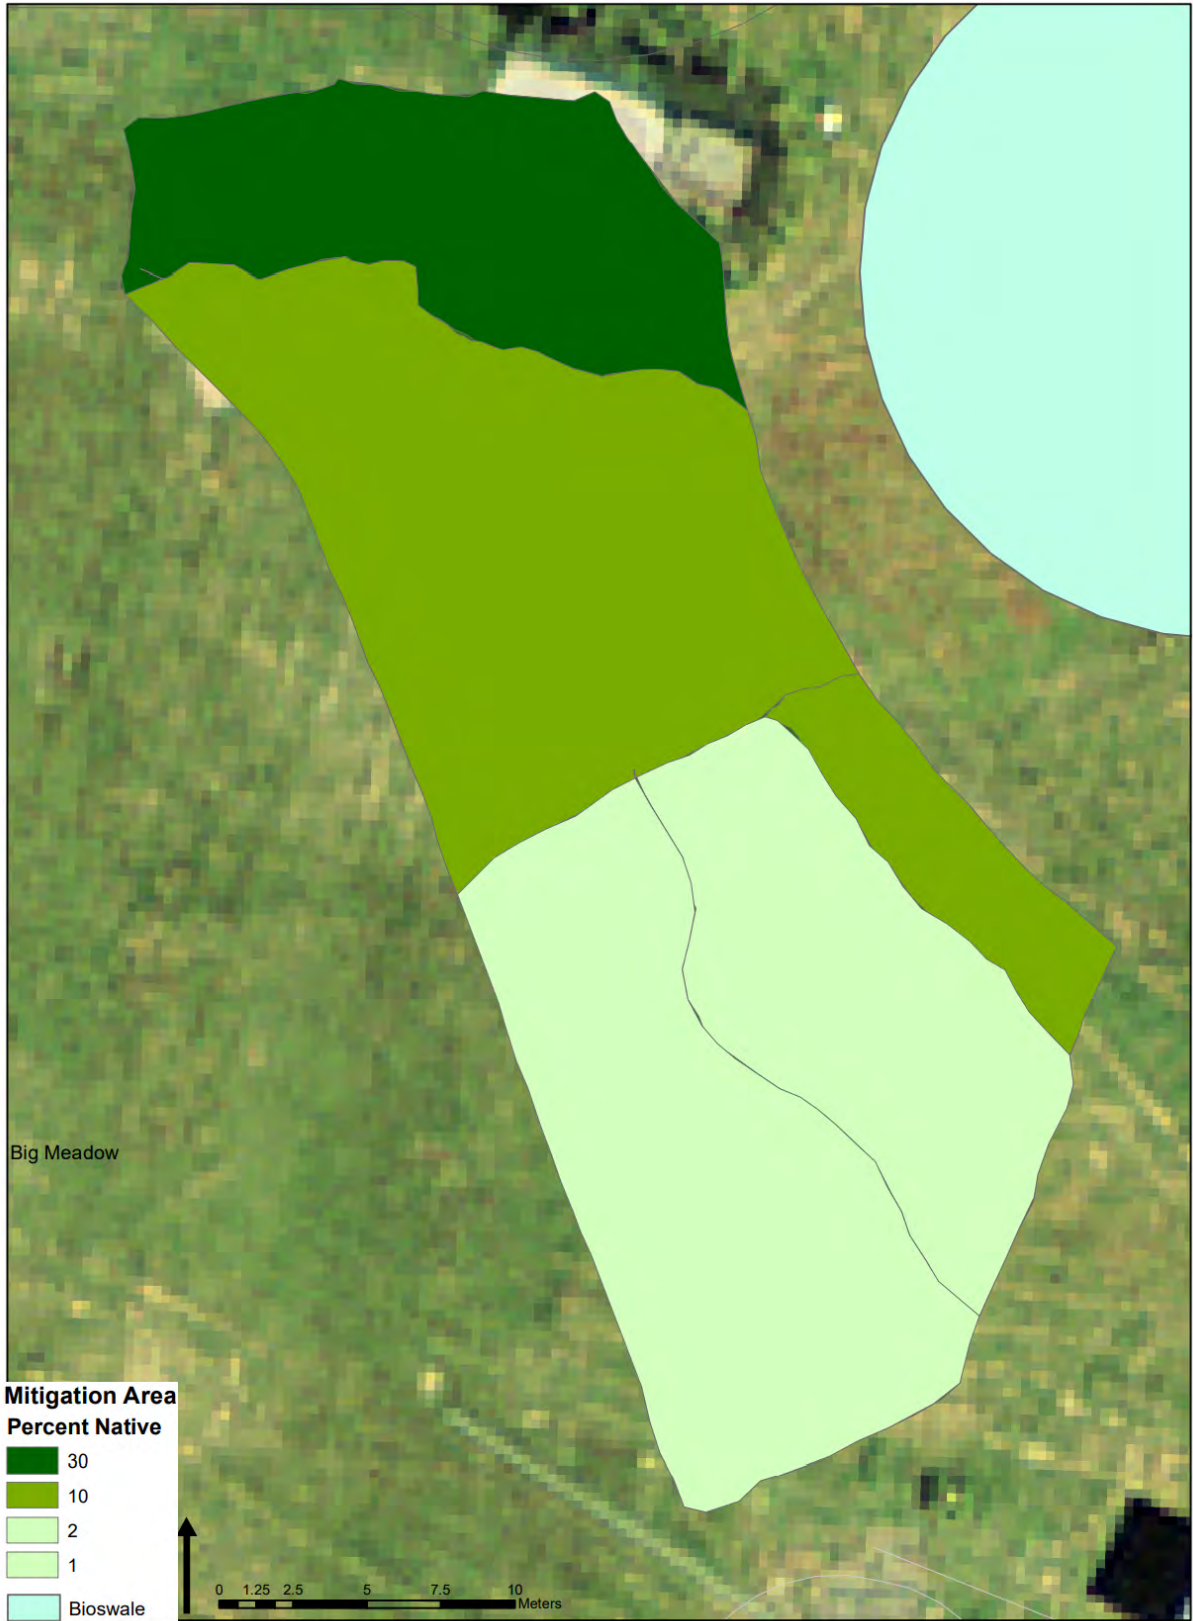
Map 3. Percent Native Cover of Restoration Area

There are no performance criteria associated with the coastal prairie mitigation for the Phase IV development. However, we would like to see native coastal prairie species throughout the restoration area with greater than 20% cover. Qualitative observation during maintenance visits found that coverage of native vegetation in a quarter of the restoration site have greater than 30% cover. Around half of the site has native vegetation at approximately 10% and a quarter of the site has around 1% native vegetation (**Map 3**). Areas with high native cover are at the north of the site while areas with reduced cover are to the south.

We recommend planting additional coastal terrace prairie species throughout the restoration area with a majority of the plants designated to the southern portion of the site. A supplemental planting pallet can be found in **Table 3**. All container stock will be propagated from site-specific seed.

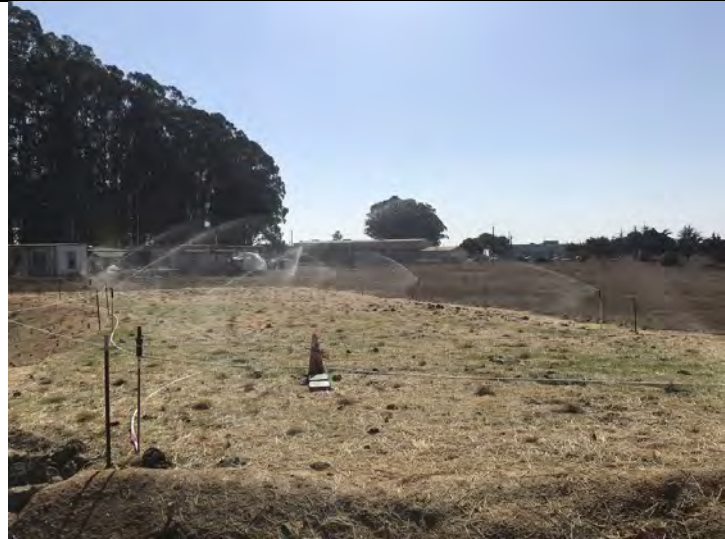
Irrigation test. December 3, 2020

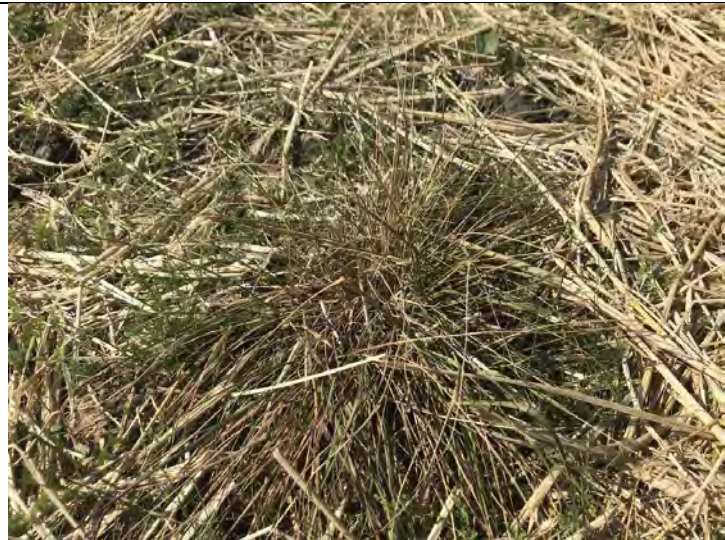
Date	Activity	Notes
10/15/2020	Completion of Initial Installation	Initial installation of temporary spray irrigation system, seeding, rice straw mulching, container stock planting, and temporary rope fence completed. Irrigation system operating due to dry weather conditions. (Initial installation contract)
12/3/2020	Inspection	Inspection of mitigation area to review irrigation system function, germination and establishment. Irrigation system turned on due to dry weather. Container stock appears healthy and seed germination as well as weed seed germination from the seed bank is evident. (Initial installation contract)
2/5/2021	Weed control	Turned off irrigation system due to recent heavy rainfall. Manual weeding of emerging annual weeds from around planted container stock. (Maintenance visit performed under initial installation contract)
3/25/2021	Weed control	Irrigation system turned off. Manual weeding of yellow sour clover and other annual weeds around planted container stock. Manual removal of several Harding grass plants along perimeter of mitigation area. Container stock is currently in good condition, although California oatgrass is showing some stress.

California oatgrass. December 3, 2020

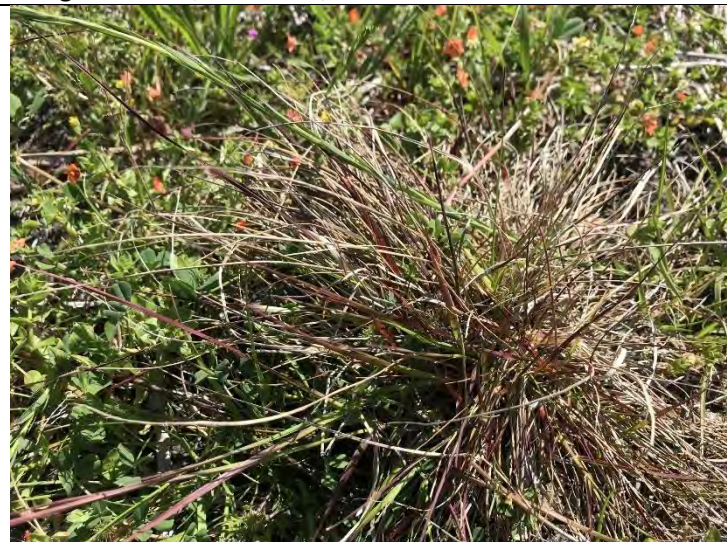
Planted purple needle grass (*Stipa pulchra*) plants have become established throughout the restoration area. While many of the gallon sized California oat grass (*Danthonia californica*) plants did not survive. We recommend planting additional grass plugs (*S. pulchra* and *D. californica*) as well as additional coastal terrace prairie forbs throughout the mitigation site in order to increase native cover.

California oatgrass, March 25, 2021

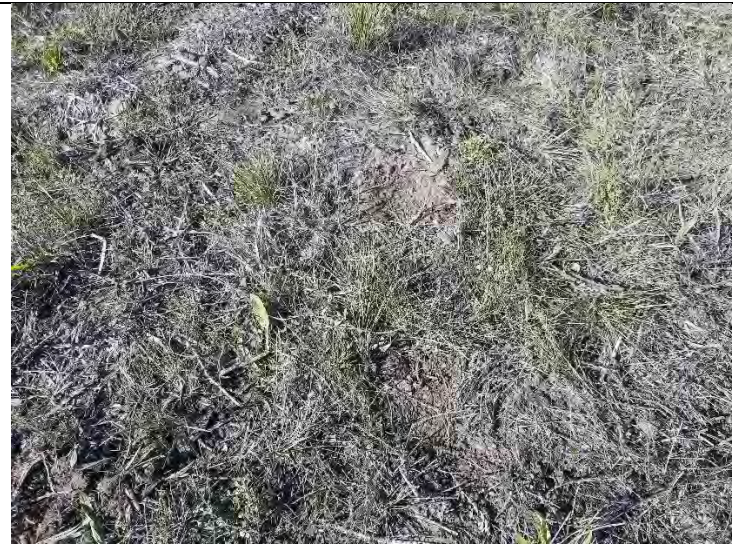
Purple needle grass, October 14, 2021

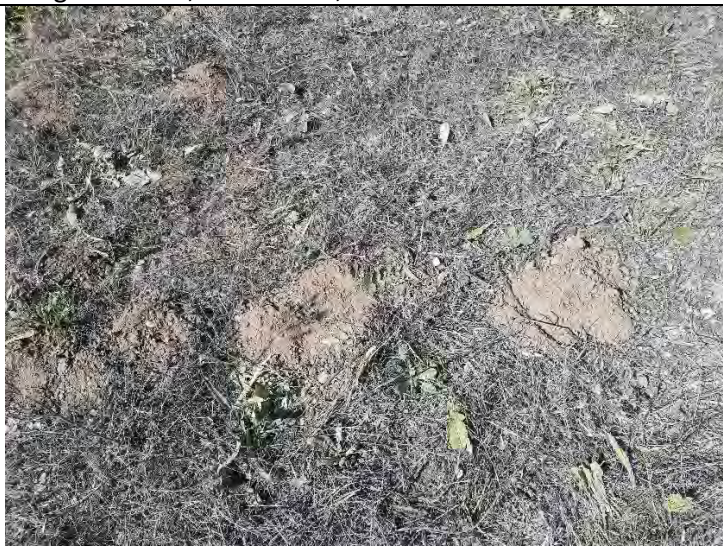
4/16/2021	Weed control	Irrigation system turned on. Manual weeding of yellow sour clover and other annual weeds around planted container stock. Cut other annual weeds to a height of 4-inches using string trimmers. Survival rate of California oatgrass appears poor. Stipa pulchra planted from leach cones are small but surviving.
5/15/2021	Weed Control	Manual weeding of yellow sour clover and other annual weeds around planted container stock. Cut other annual weeds to a height of 4-inches using string trimmers.
8/10/2021	Weed Control	Manual weeding of yellow sour clover, black mustard, raphnus and other weeds. Removed other weeds using string trimmers.
10/14/2021	Weed Control	Octobers visit focused on manual removal of weeds, including: dittrichia (stinkwort), black mustard, small melilot, white stemmed filaree, bur clover, bristly oxtongue and Harding grass. Irrigation was adjusted to two days per week. Areas of dense needle grass establishment. Gopher activity observed.

Gopher activity, October 14, 2021

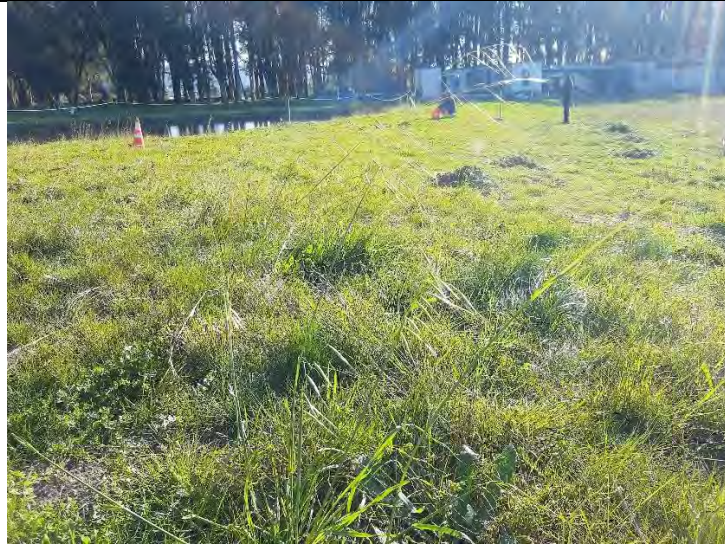
10/20/2021	Irrigation Adjustment	Irrigation was turned off due to forcasted rain events.
12/13/2021	Weed Control	This visit focused on manual removal of weeds including: black mustard, small melilot, white stemmed filaree, bristly oxtongue, ribwart plantain, etc. The northern portion of the site has dence native cover. The southern portion of the site have very little native cover.

Stipa pulchra in northern side of mitigation area, December 9, 2021

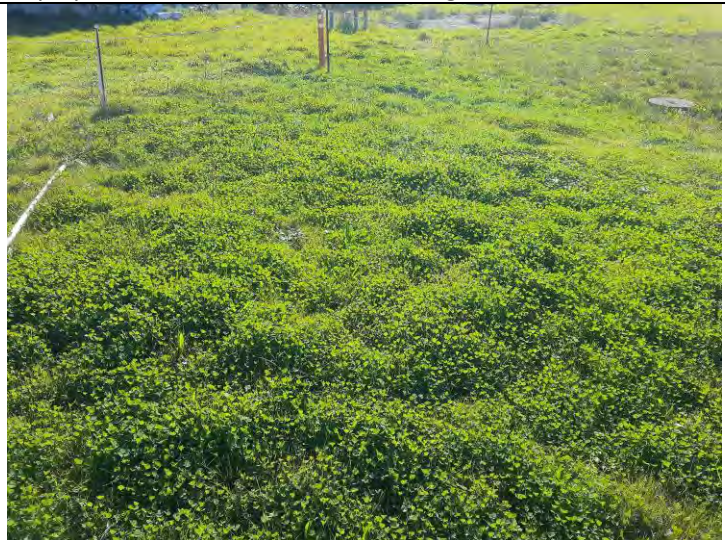
Weeds in southern portion of mitigation area, December 9, 2021
