# Year 2 Monitoring Report for the Western Stege Marsh Restoration Project

DTSC Order I/SE- RAO 06/07-004 Section 5.16

**University of California, Berkeley**  
**Richmond Field Station, Richmond, California**

**November 15, 2007**

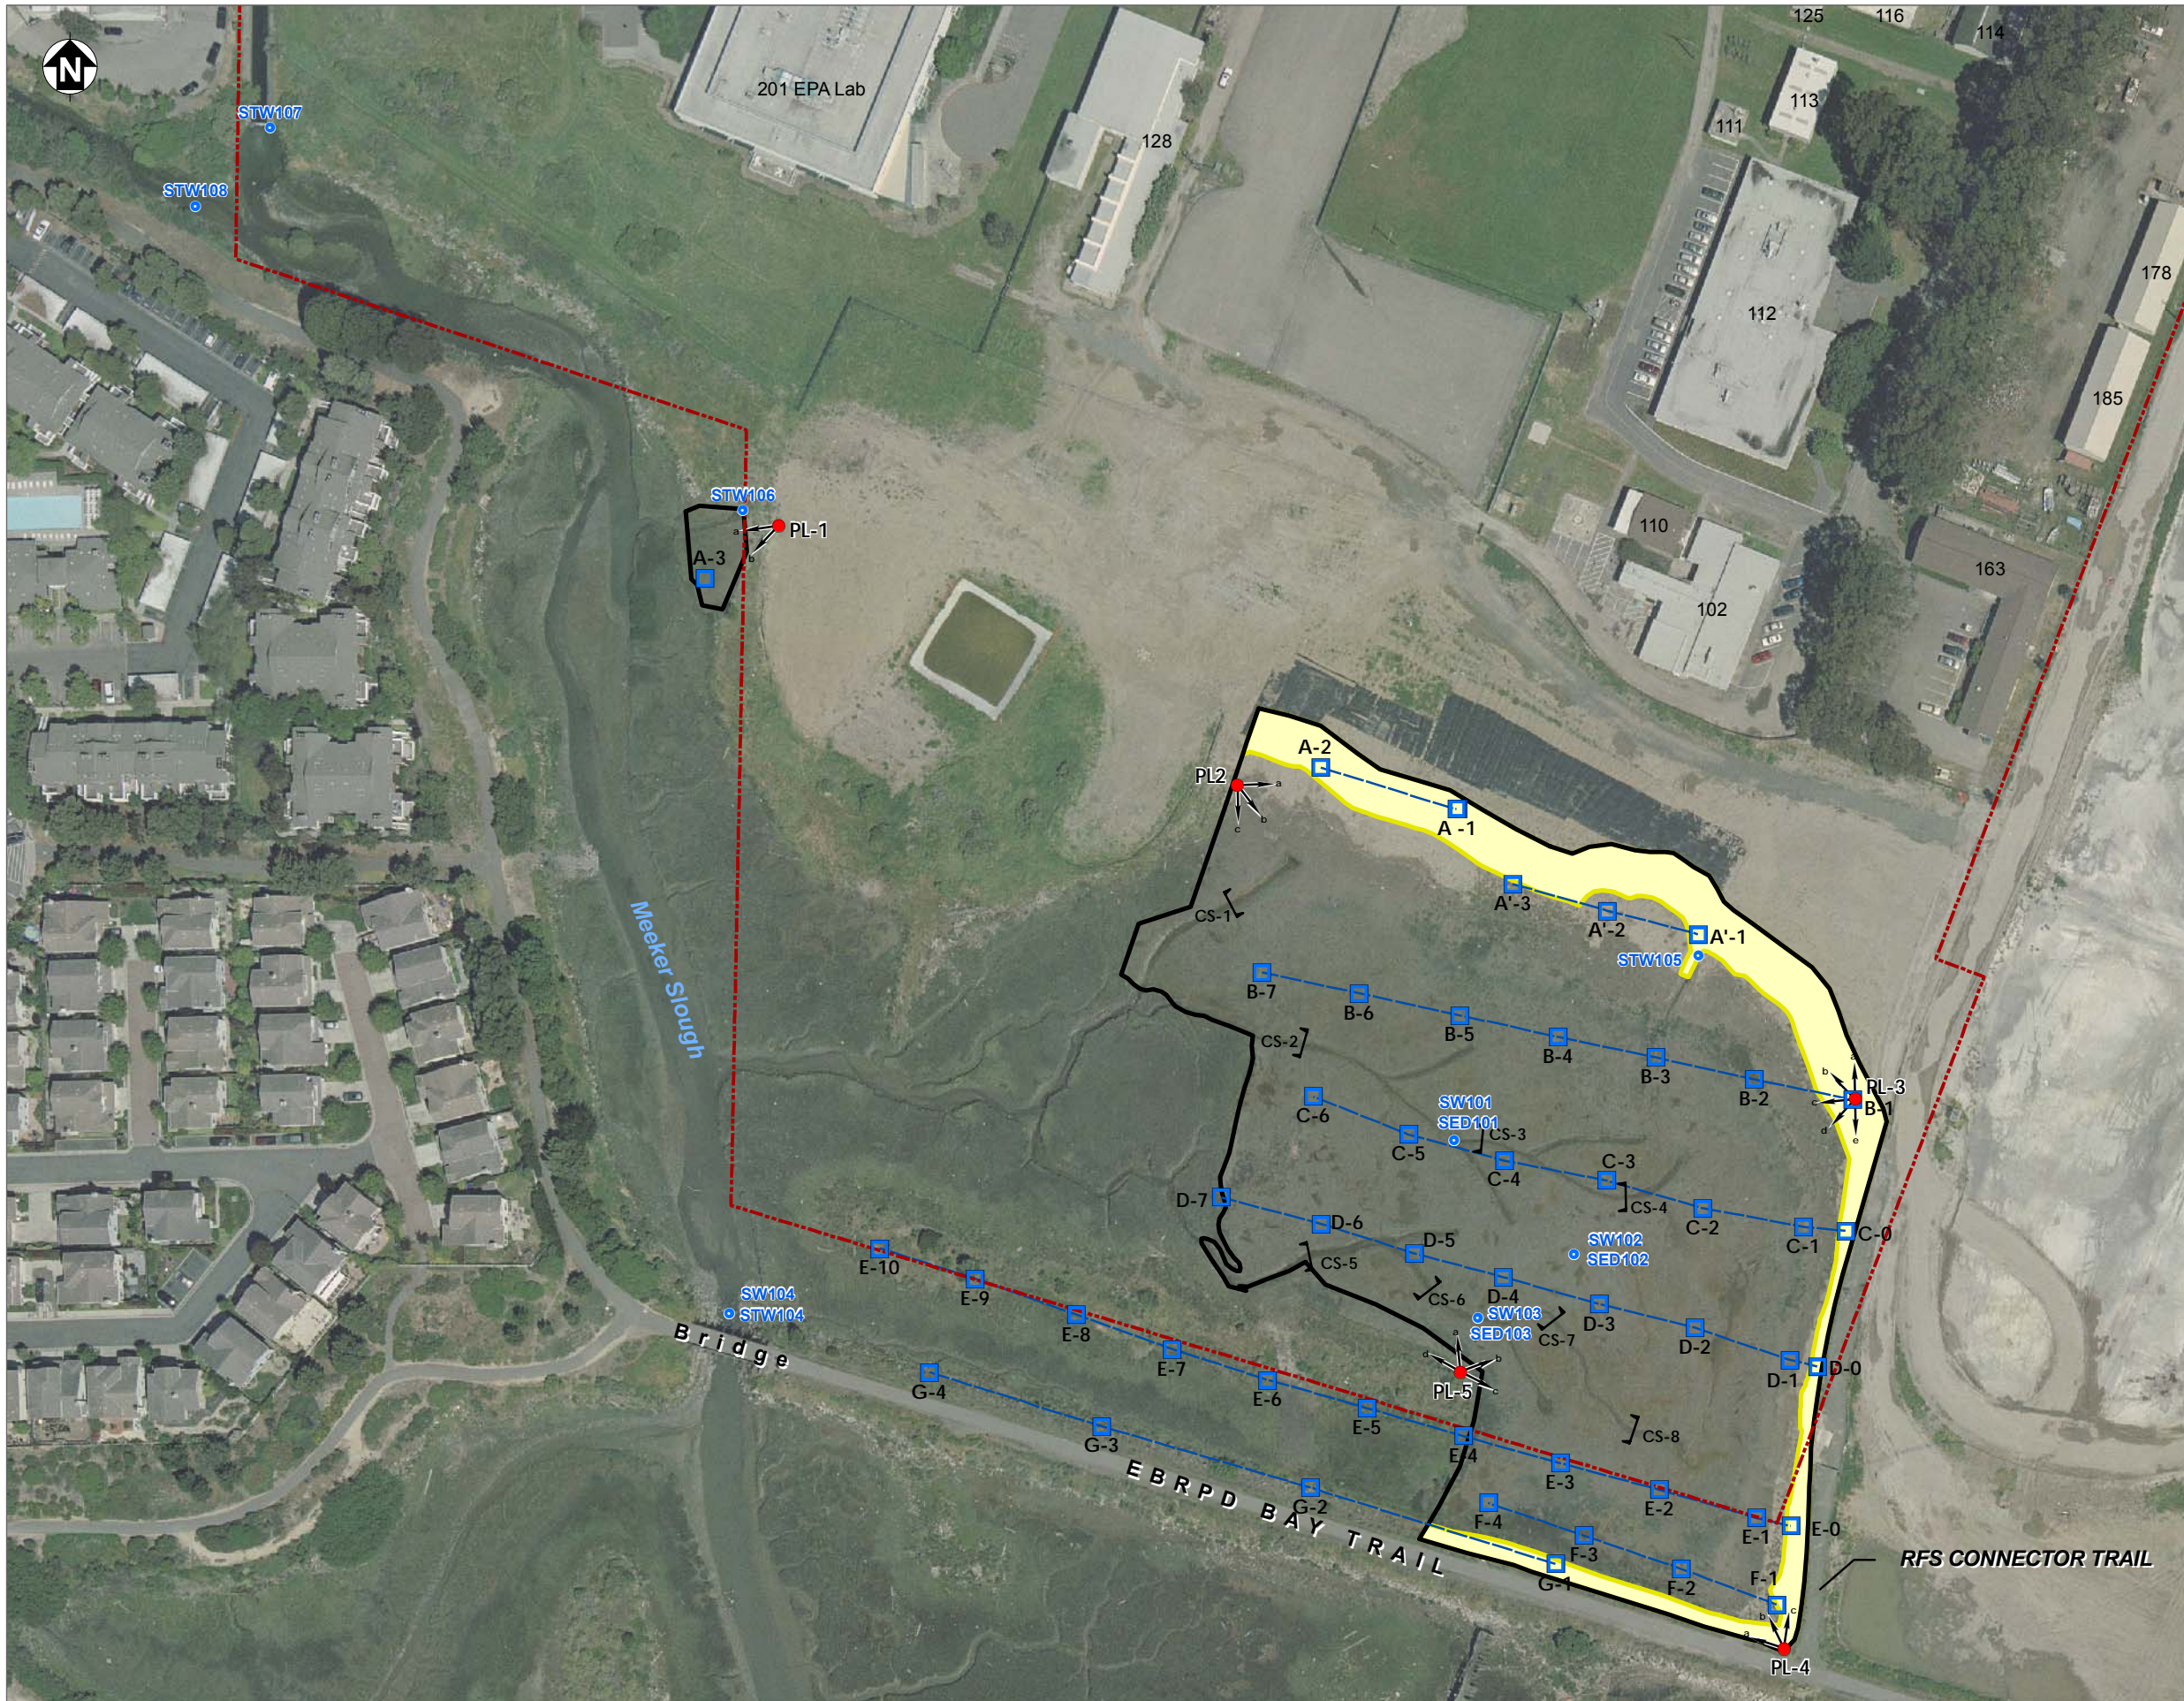
**FIGURE 4**  
**MONITORING LOCATIONS**

- Photo Stations
- Channel Crossing
- Sampling Location
- Vegetation Survey Quadrats
- Transects
- Richmond Field Station Property Boundary
- Marsh Monitoring Area
- Ecotone Area (as Designed in BBL's August 2004 Marsh Monitoring Plan)

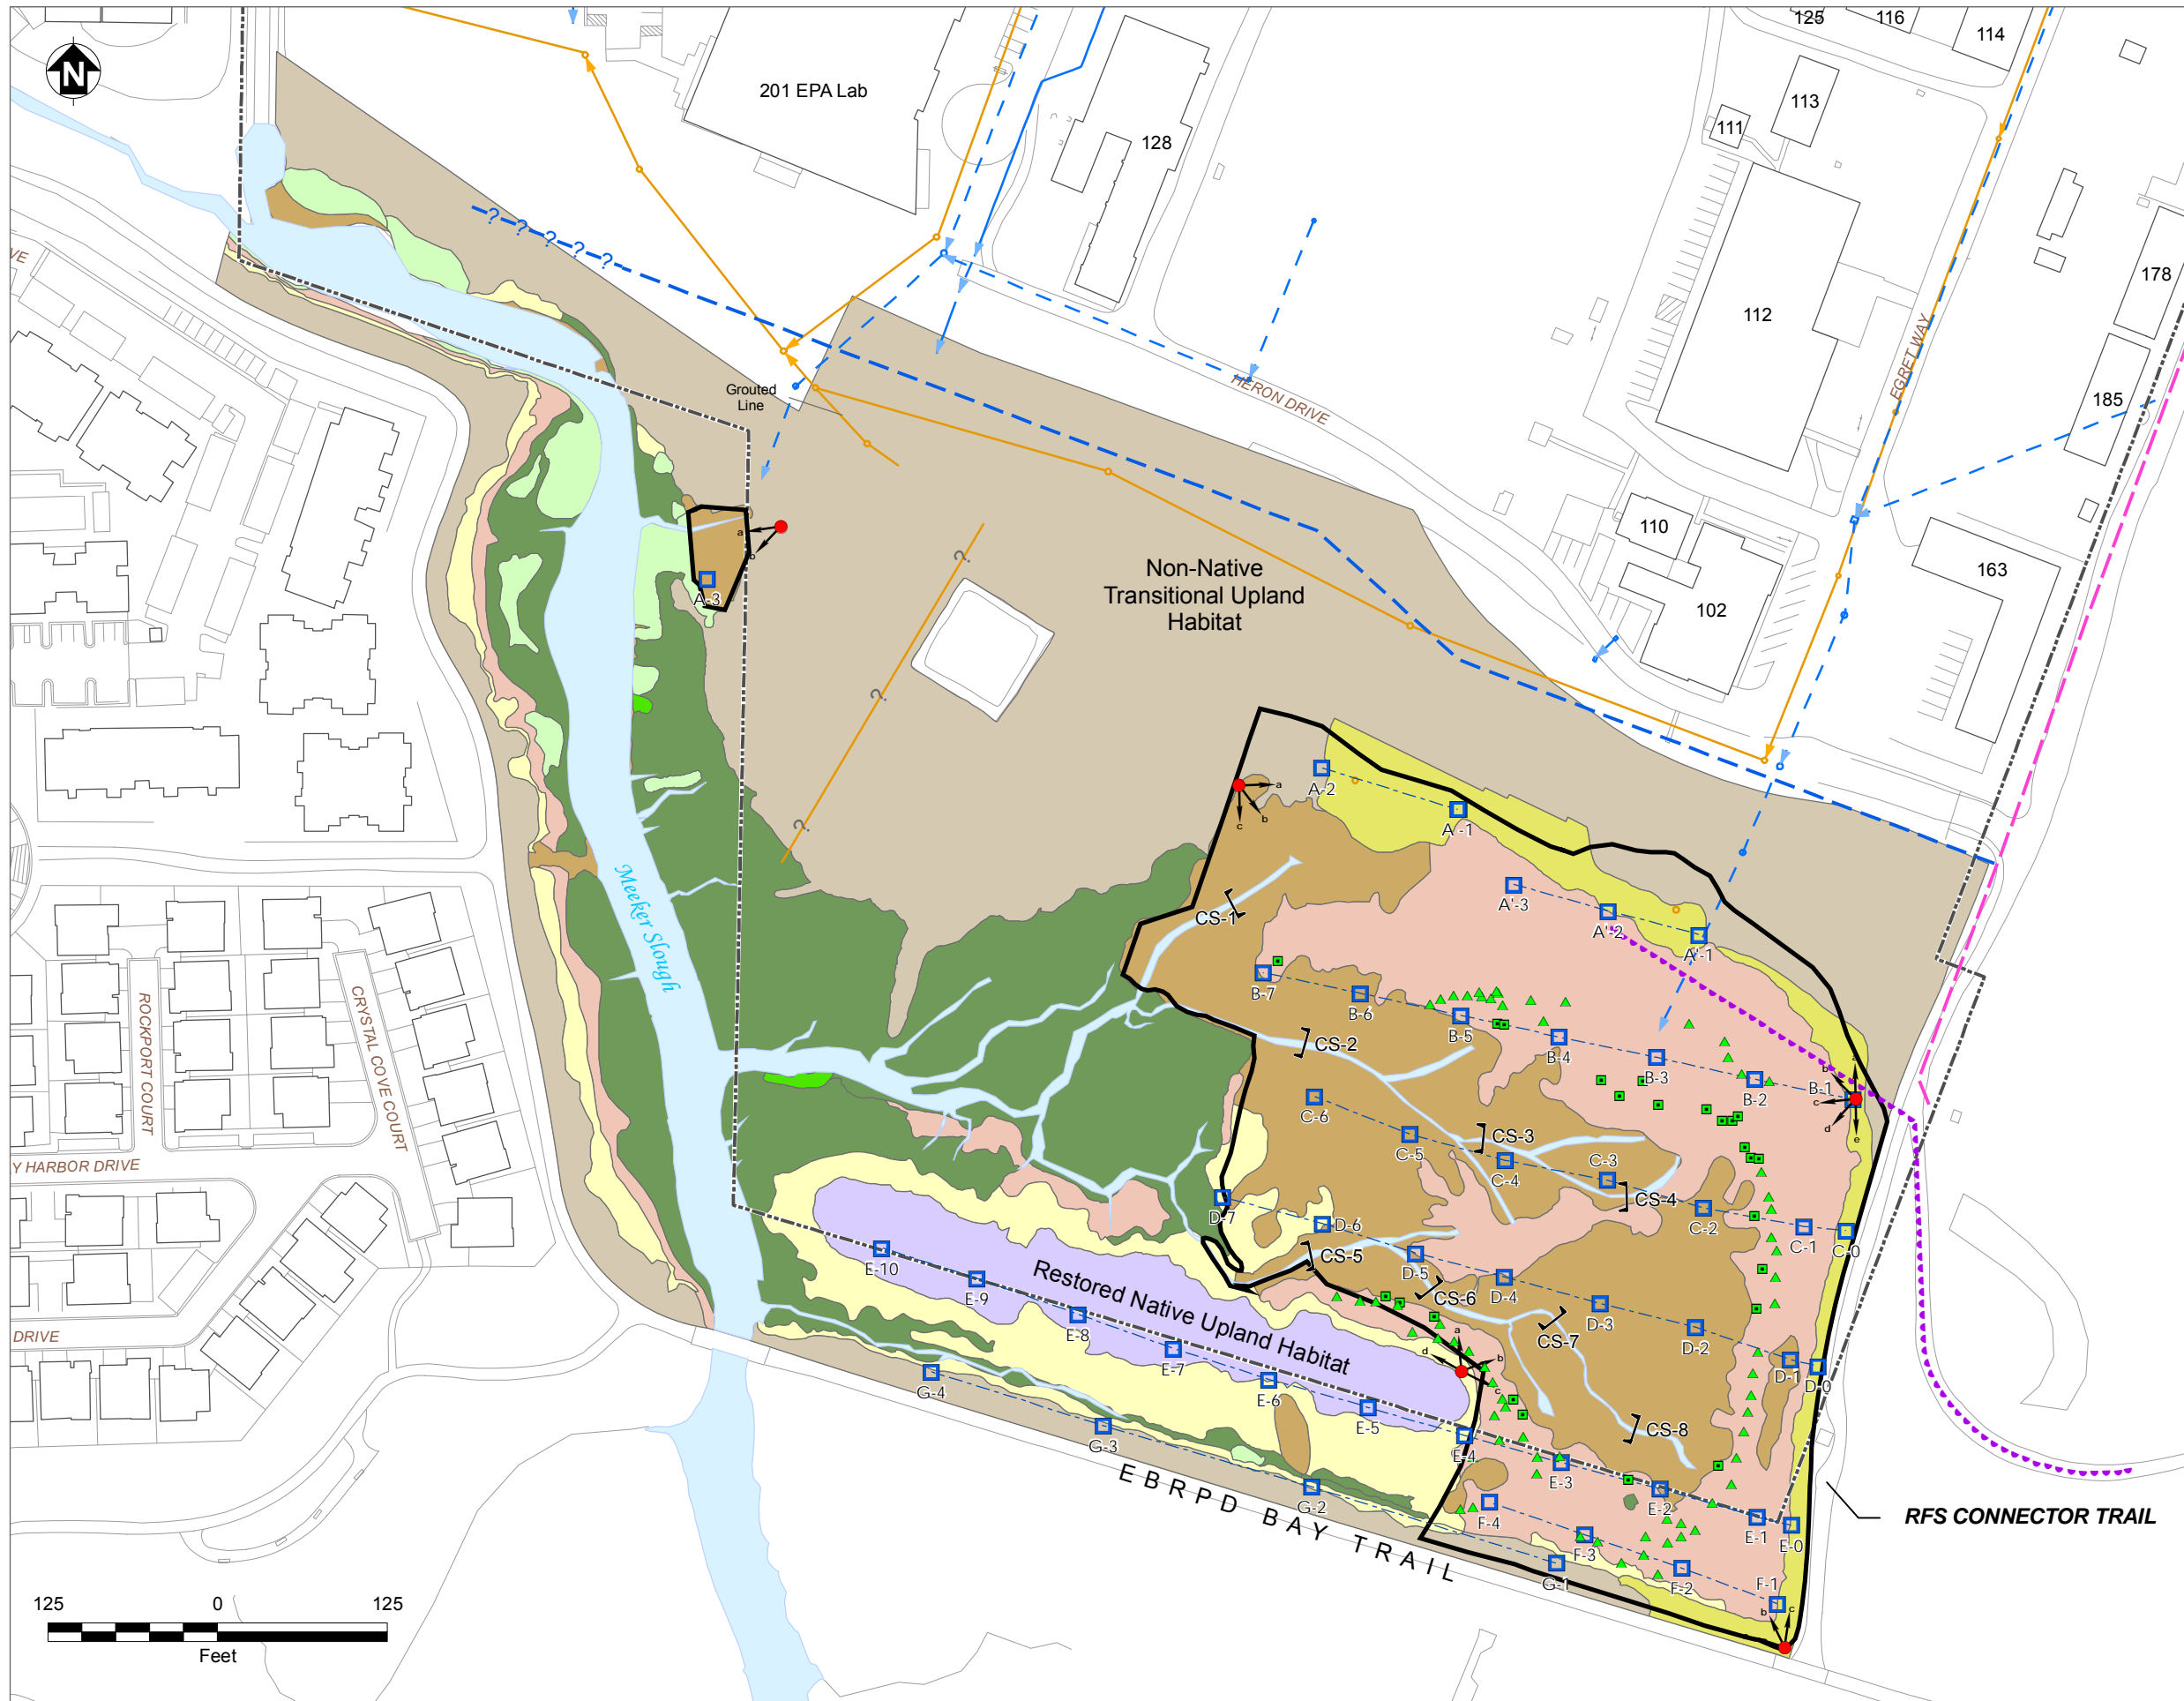
**FIGURE 5**  
**MAJOR PLANT COMMUNITIES**  
**PRESENT AT WESTERN STEGE MARSH,**  
**SEPTEMBER 2006**

- Photo Stations
  - Channel Crossing
  - Vegetation Survey Quadrats
  - Individual *Spartina* Planting Locations (Information Provided by The Watershed Project)

- ▲ 2003 Plantings
  - 2006 Plantings
  - Transects
  - Marsh Monitoring Area
  - Habitat Areas Delineated by Field Observation (Tetra Tech September, 2006; acreages listed in parentheses pertain to marsh monitoring area only)

Native vegetation covered approximately 44 percent of the ground (excluding tidal mudflats) within the 47 monitoring quadrats. Thus, percent cover by native vegetation was double the project standard of at least 20 percent native plant cover (see [Table 1](#) and the table below). Pickleweed was the dominant species (see [Figure 5](#)); Pacific cordgrass and marsh gumplant were other desirable species noted. The California state grass, purple needlegrass (*Nassella pulchra*) appeared in quadrat E-10. Purple needlegrass is a medium to large, long-lived bunchgrass that thrives in deep clayey soil; its 20-foot-long root makes it tolerant of summer drought. Expansion of purple needlegrass would provide desirable cover in the upland habitat represented by transect E.

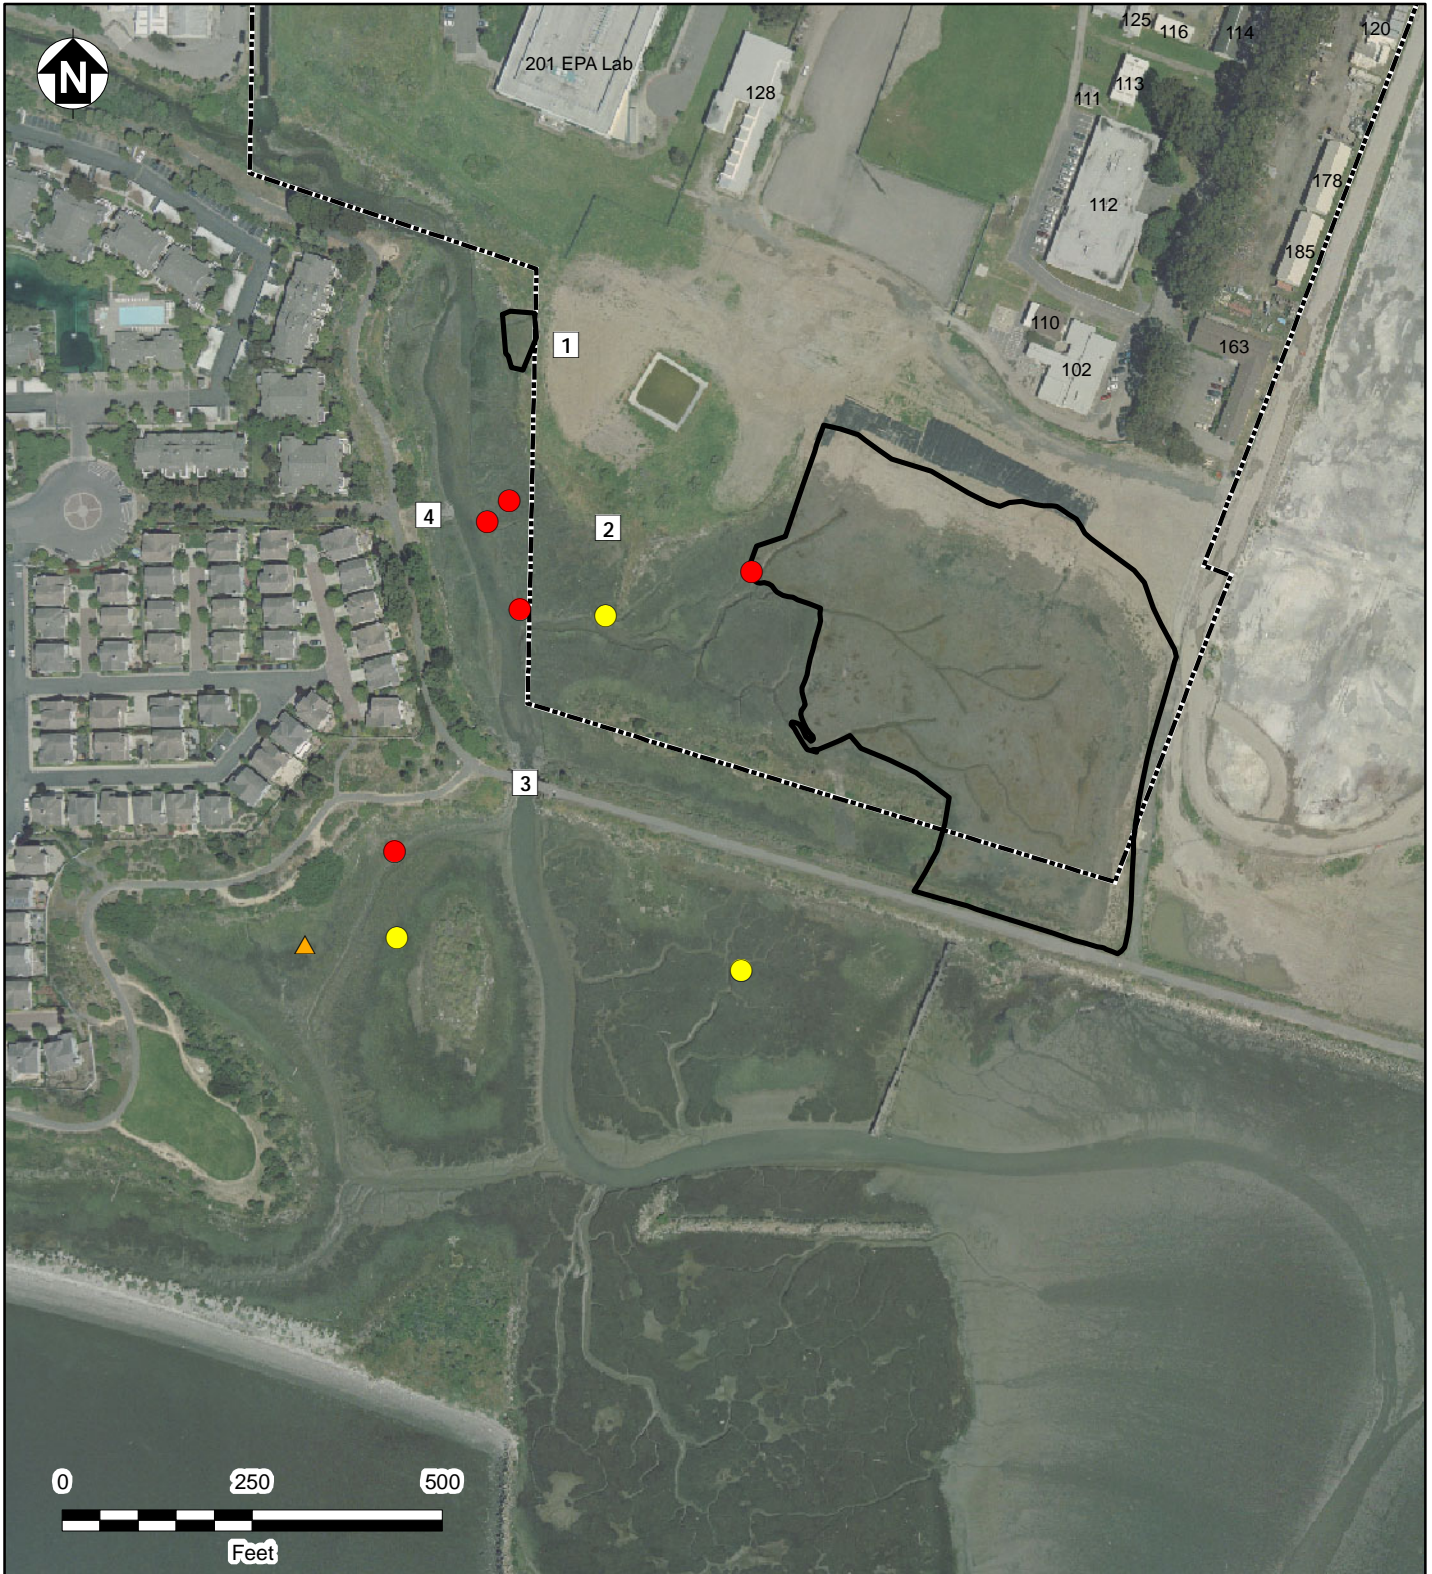
● Estimated Location of Clapper Rail, December 3, 2006 (15:00 - 17:10 hours)

● Estimated Location of Clapper Rail, December 12, 2006 (16:00 - 17:20 hours)

The distribution of California clapper rail detections, shown on [Figure 6](#), suggests that the birds are using all emergent tidal marsh habitat associated with the undisturbed marsh adjacent to the WSMRP site, regardless of the plant community present. This finding is consistent with the San Francisco Bay Area Wetlands Ecosystem Goals Project ([Anderson and Evens 2000](#)) recommendation of a predominant pickleweed marsh with cordgrass, gumplant, and other high marsh plants as ideal habitat for the California clapper rail. The California clapper rail is associated with the major and tributary slough systems that wind through the vegetated portion of the marsh. Given the tendency of the California clapper rail to be sedentary during the winter and spring, it is expected that the birds detected during the December 2006 surveys will remain at the site through the nesting season. [Attachment 2](#) provides a detailed summary of the December 2006 and January 2007 surveys of the California clapper rail.

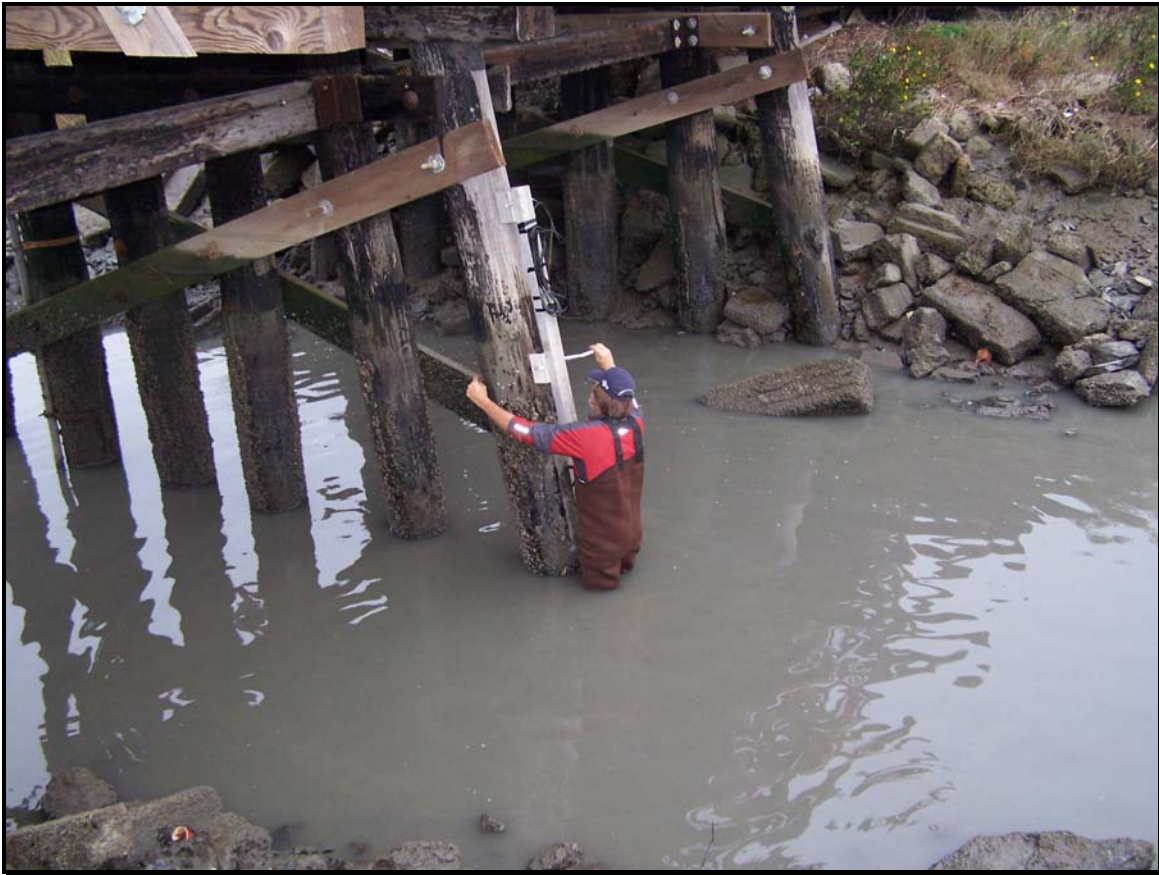
Water level fluctuation was monitored with a self recording tide gauge installed beneath the East Bay Regional Park District (EBRPD) Bay Trail bridge over Meeker Slough Channel. On field day 1, a Coastal Leasing Inc. Macro Tide recording pressure sensor was attached to a down stream piling at mid channel (Figure 1). The sensor was fitted to an aluminum staff which was attached to the piling with stainless steel hose clamps. The tide gauge was positioned at the bottom of the staff at the sediment surface. A serial I/O cable was installed on the sensor and routed to an existing junction box below the bridge walkway, allowing periodic data retrieval. The elevation of the gauge was surveyed with RTK GPS positioning on day 3. The surveyed elevation of the sensor is -2.727 feet (NGVD 29).

**Figure 1. Macro Tide installation at Meeker Slough on 11/16/2006.**

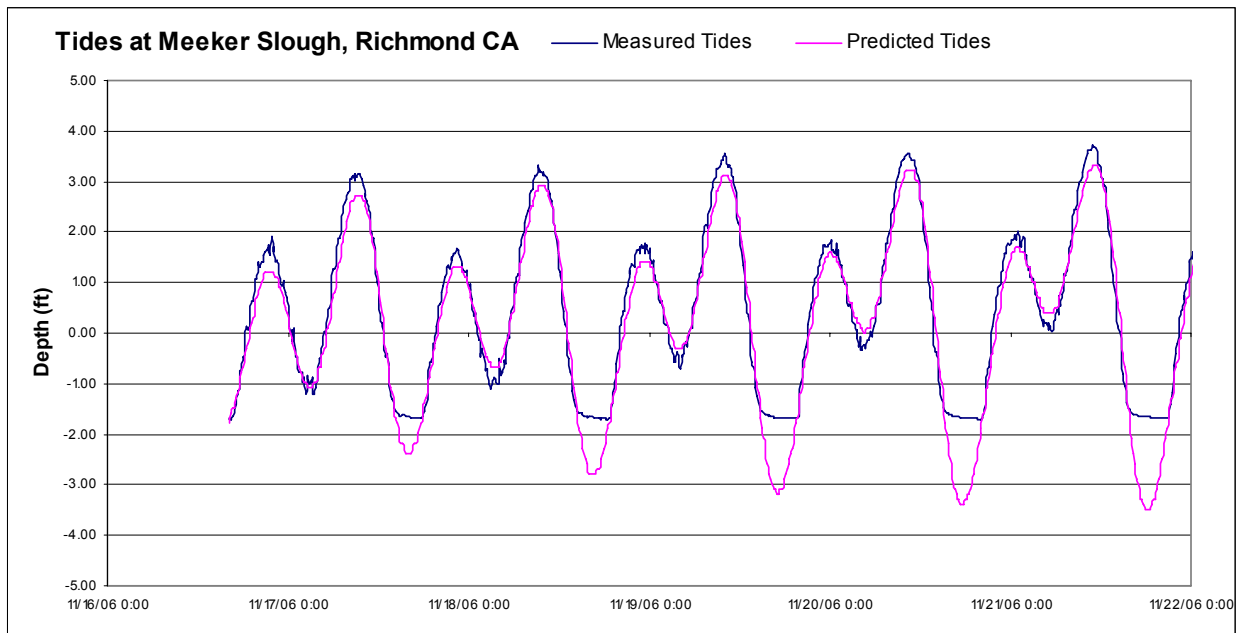
Water level data were downloaded upon completion of the bathymetric surveys on November 22, 2006, as well as on January 23, 2007. Ten minute averaged water levels were corrected for atmospheric pressure, and referenced to the National Geodetic Vertical Datum of 1929 (NGVD-29) for the final report. Time series tide elevation values were compared to NOAA predicted tide values at Richmond Inner Harbor and found to be in good agreement (Figure 2 and Appendix B).

**Figure 2. Measured and NOAA predicted tides at Meeker Slough from 11/16/2006 through 11/22/2006. (Depths ref: NGVD-29)**

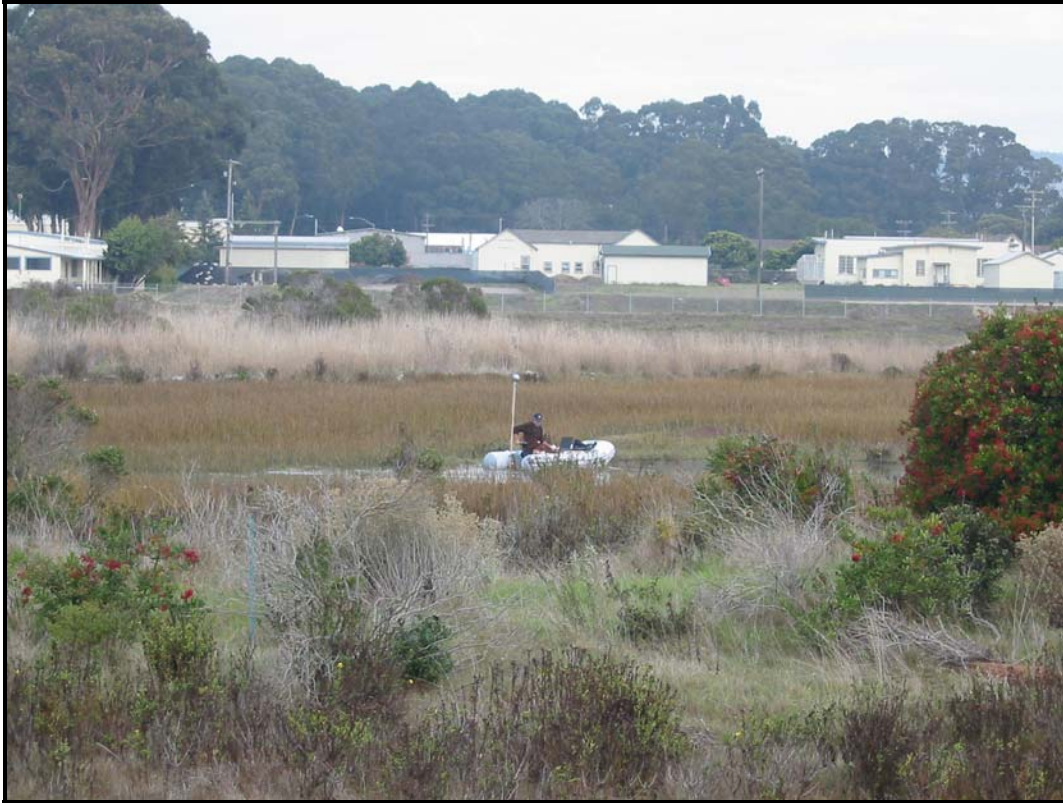
The bathymetric survey was completed from an inflatable, hard-bottomed Zodiac® vessel. The shallow-draft boat allowed for bathymetric data to be collected far into the shallow channels. A single-beam, 200 kHz sonar transducer was mounted on the stern of the boat and a GPS antenna was mounted vertically above the transducer. Figure 4 shows the system in operation at the project site.

**Figure 4. Bathymetric survey system in operation. Image taken facing northeast from the EBRP path. Survey vessel is in a smaller channel east of the main Meeker Slough channel. Photo dated 11/22/2006.**

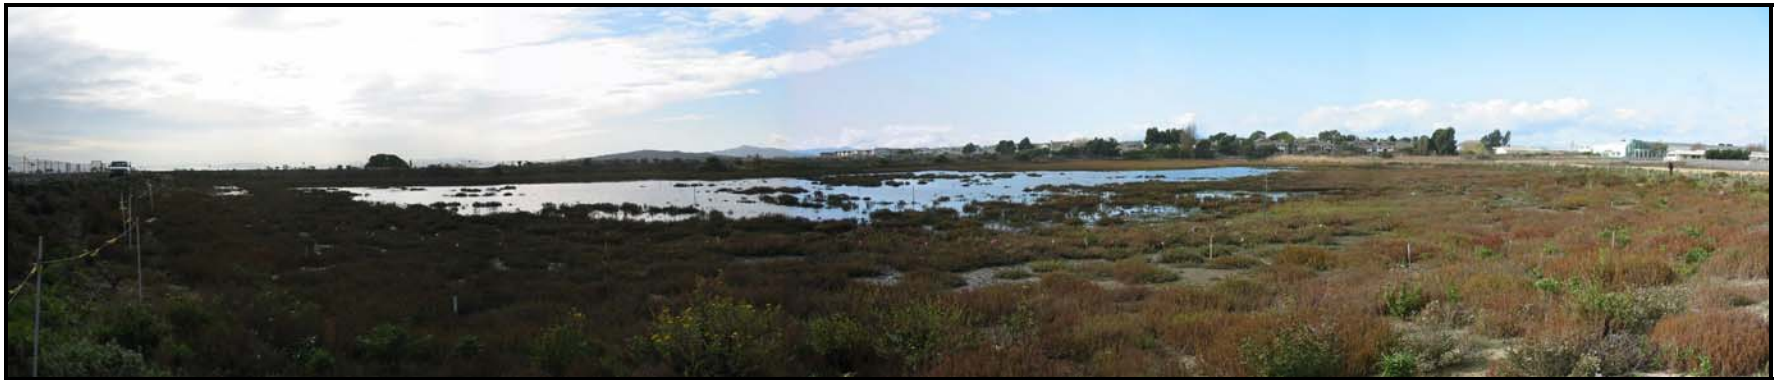
**Figure A.1. Panoramic view of the project area. View from left to right is from the south to the west. The RFS Connector Trail is at the left of the image. Photo dated 11/21/2006.**

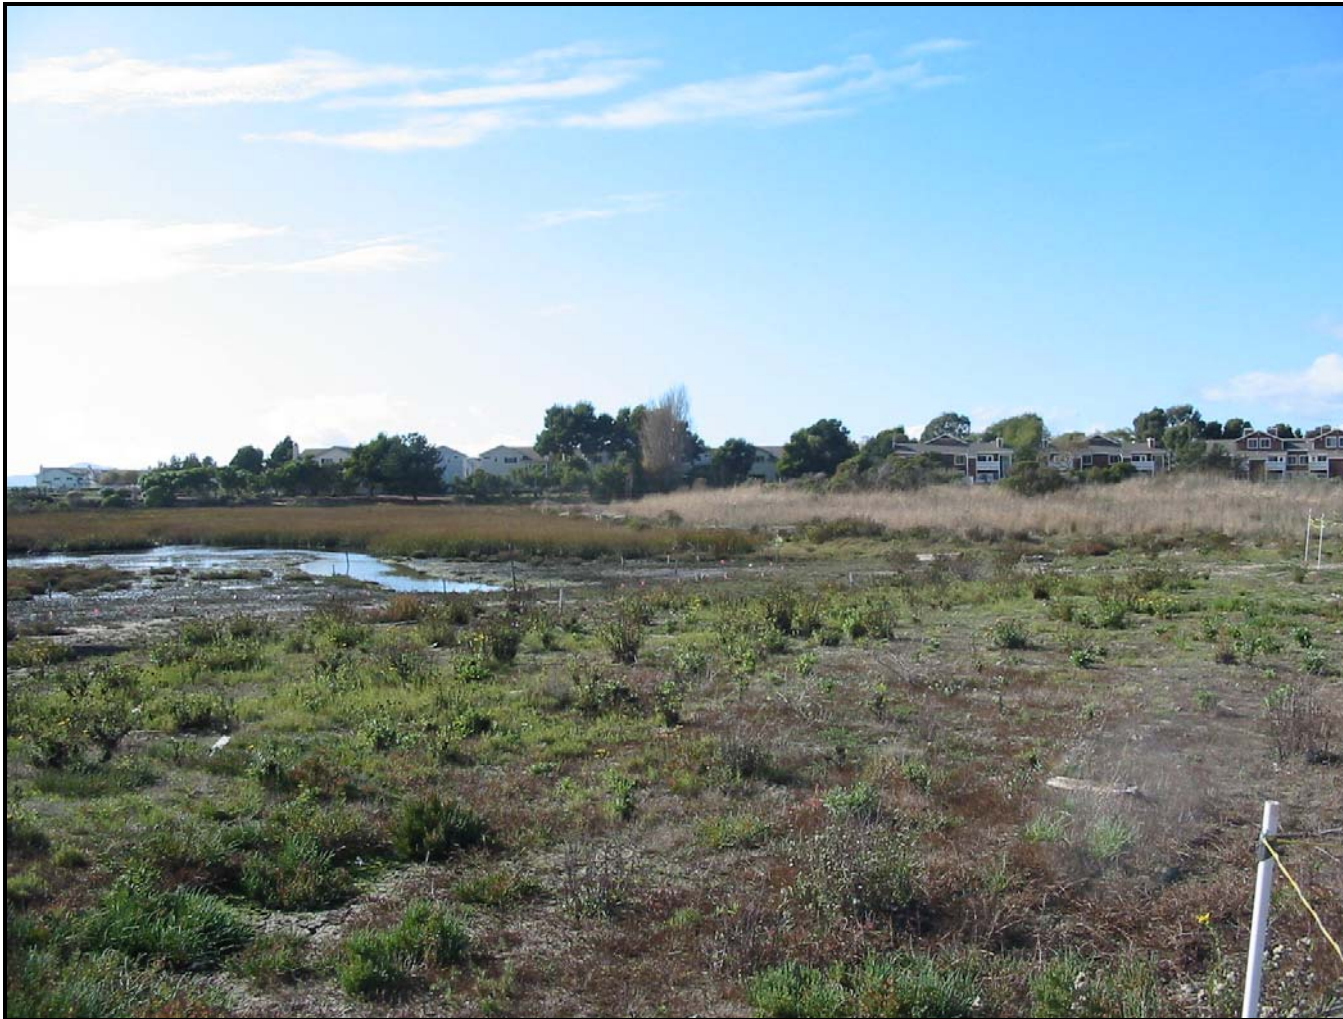
**Figure A.2. View from point A1 in transect A, facing west and looking down transect A. Stakes are not visible because stake A2 did not exist. Photo dated 11/21/2006.**

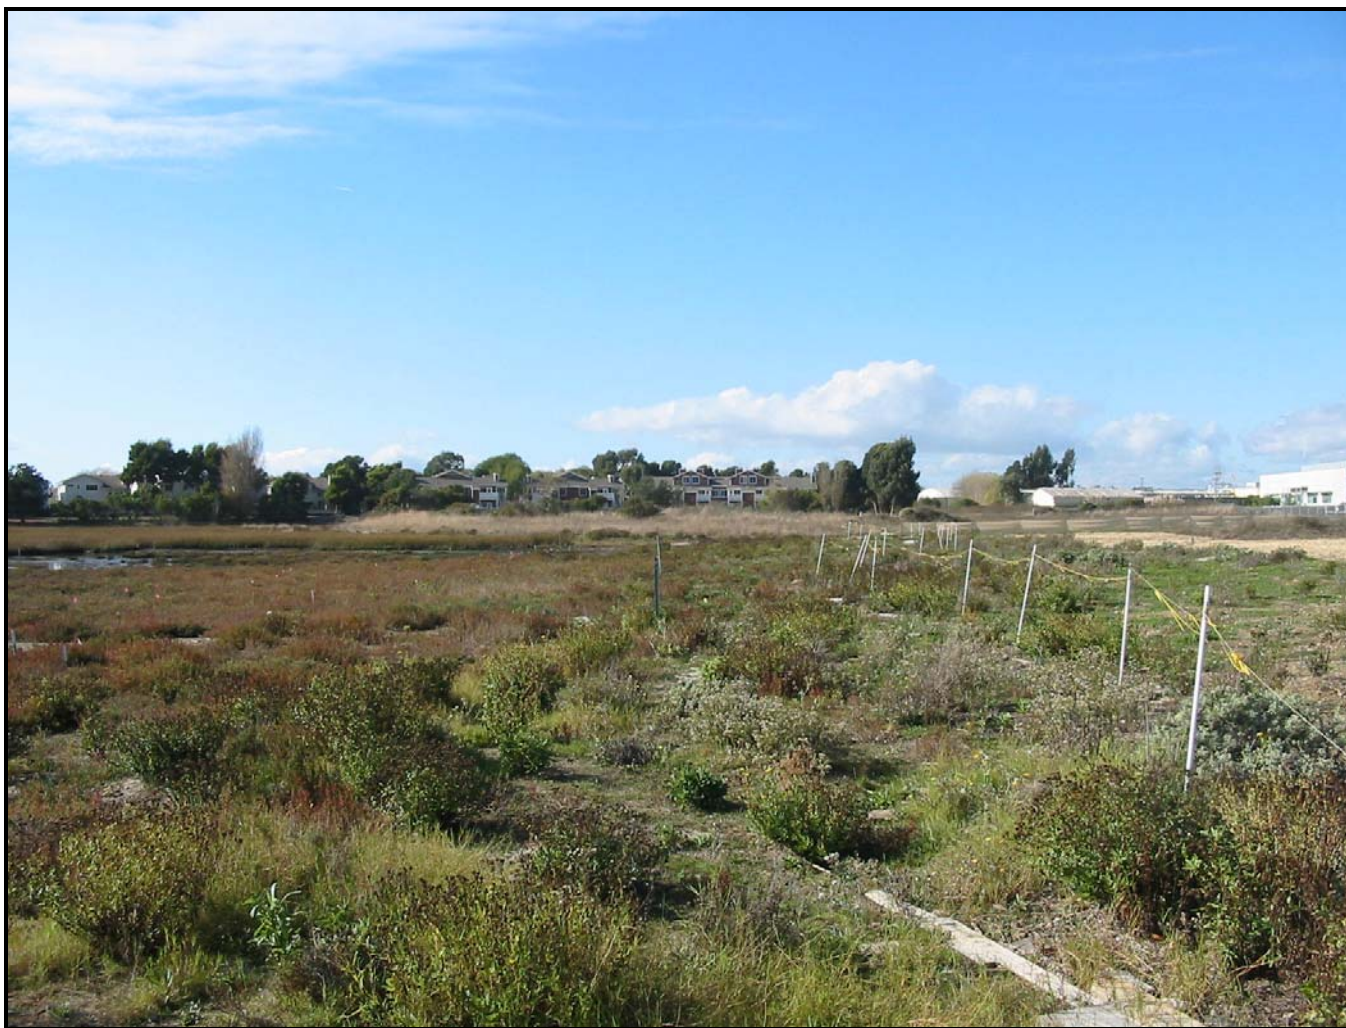
**Figure A.3. View from point A1' in transect A', facing west and looking down transect A'. Stake A2' is visible near the centerline of the image. Photo dated 11/21/2006.**

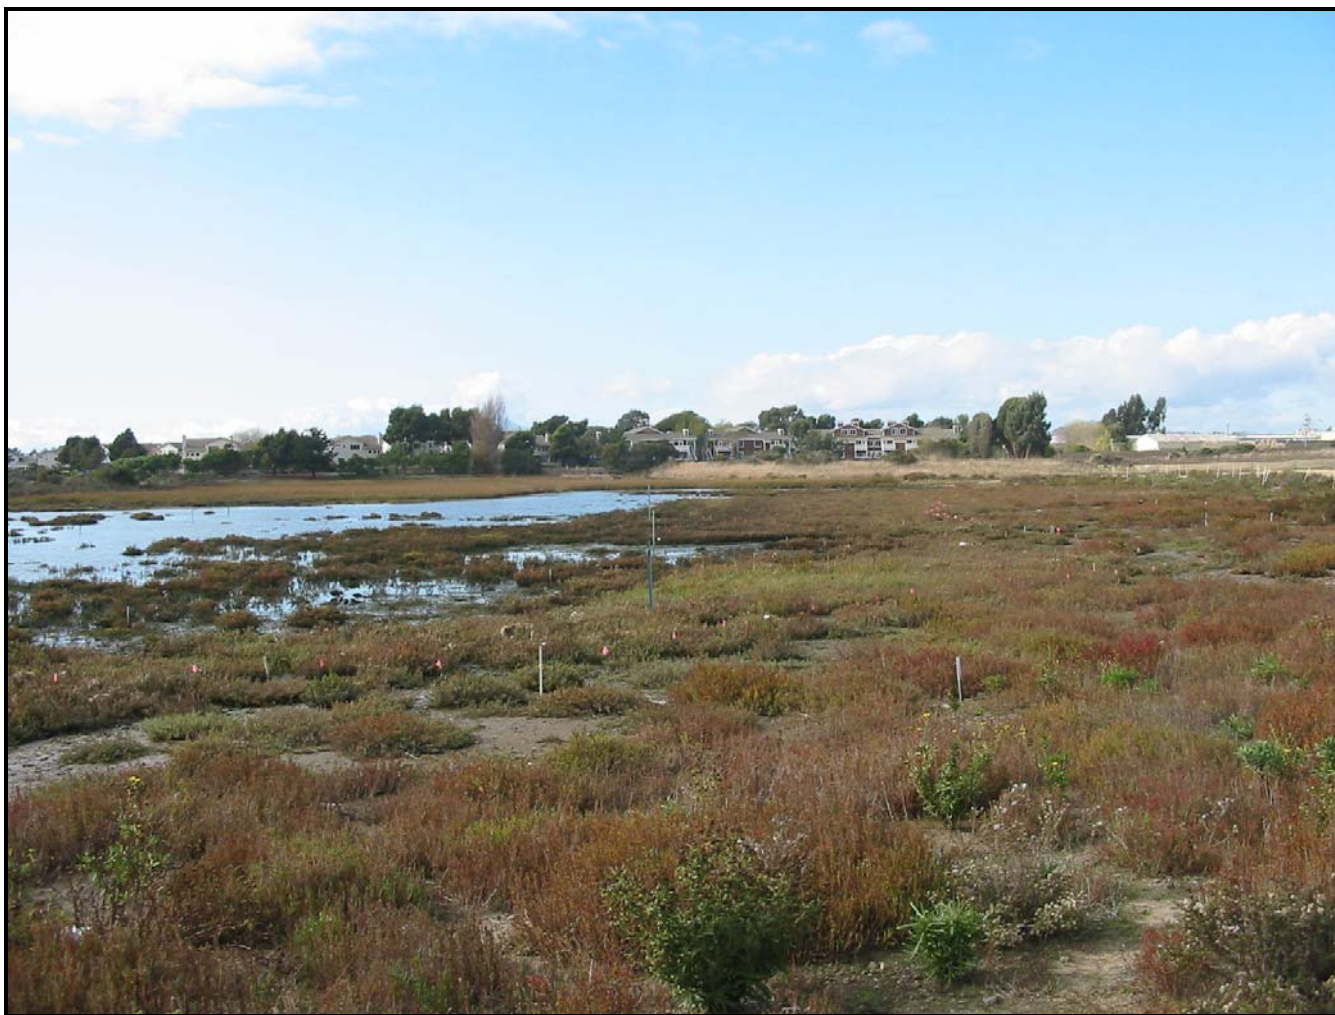
**Figure A.4. View from point B1 in transect B, facing west and looking down transect B. Stakes are visible near the centerline of the image. Photo dated 11/21/2006.**

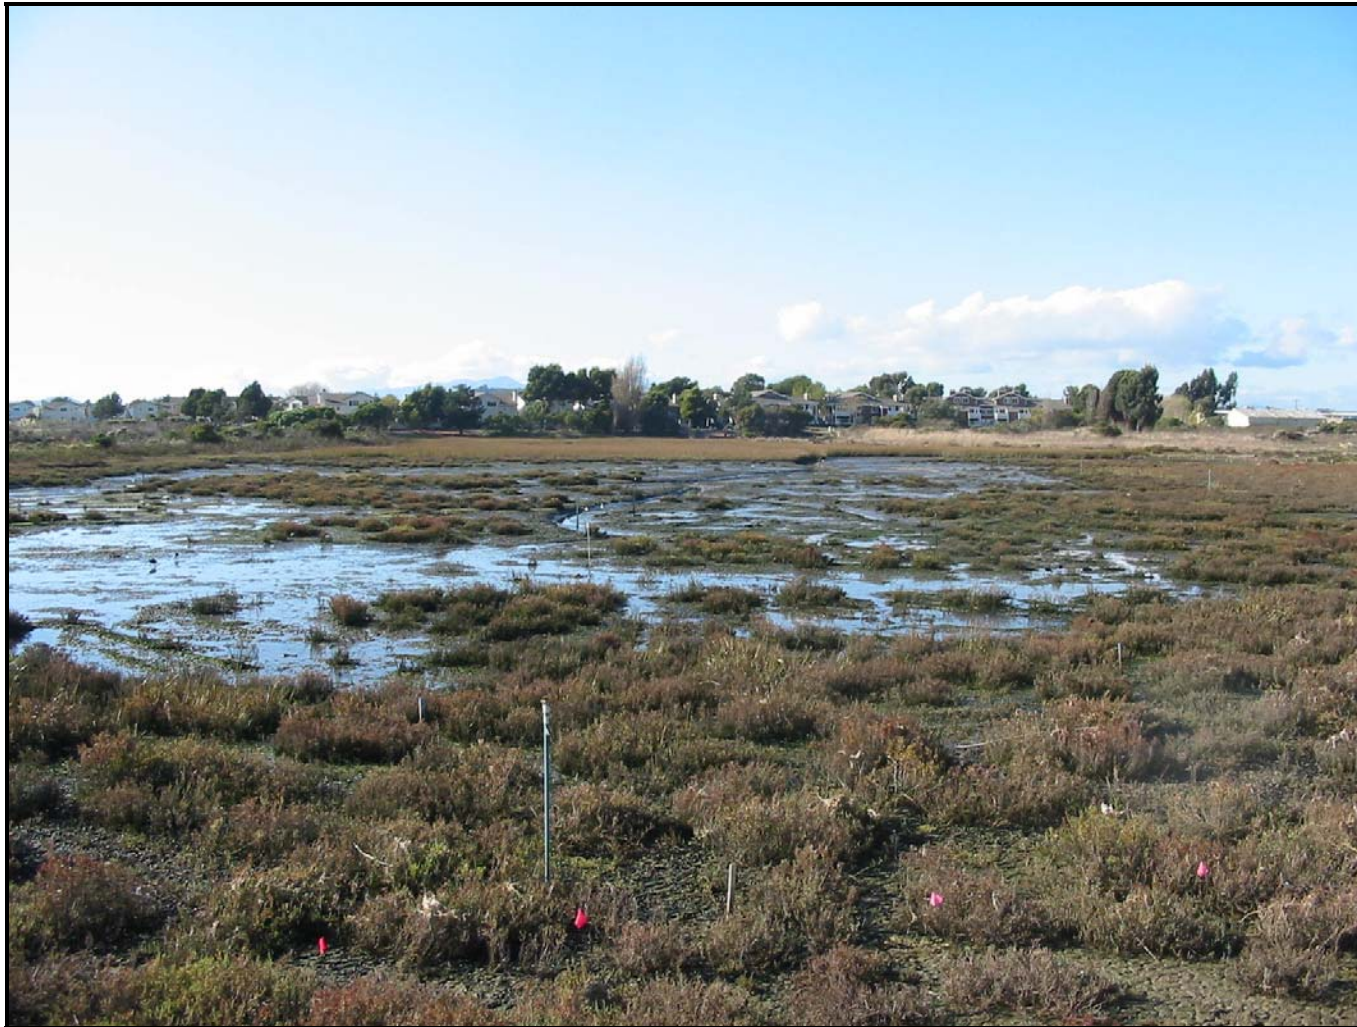
**Figure A.5. View from point C0 in transect C, facing west and looking down transect C. Stake C1 is visible in the foreground, near the bottom portion of the image. Transect C stakes are visible in the background, near the centerline of the image. Photo dated 11/21/2006.**

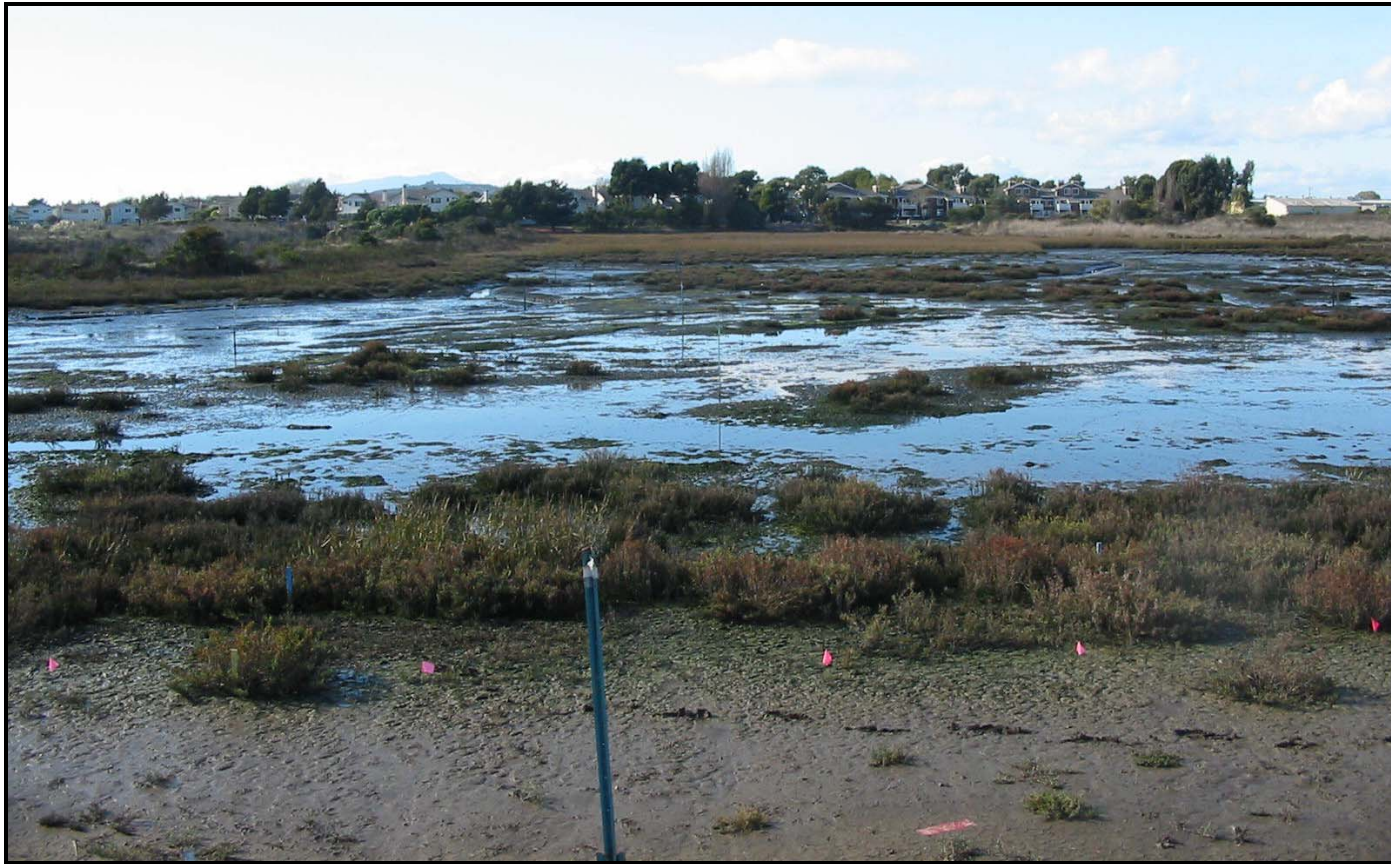
**Figure A.6. View from point D0 in transect D, facing west and looking down transect D. Stake D1 is visible in the foreground, near the bottom portion of the image. Transect D stakes are visible in the background, near the centerline of the image. Photo dated 11/21/2006.**

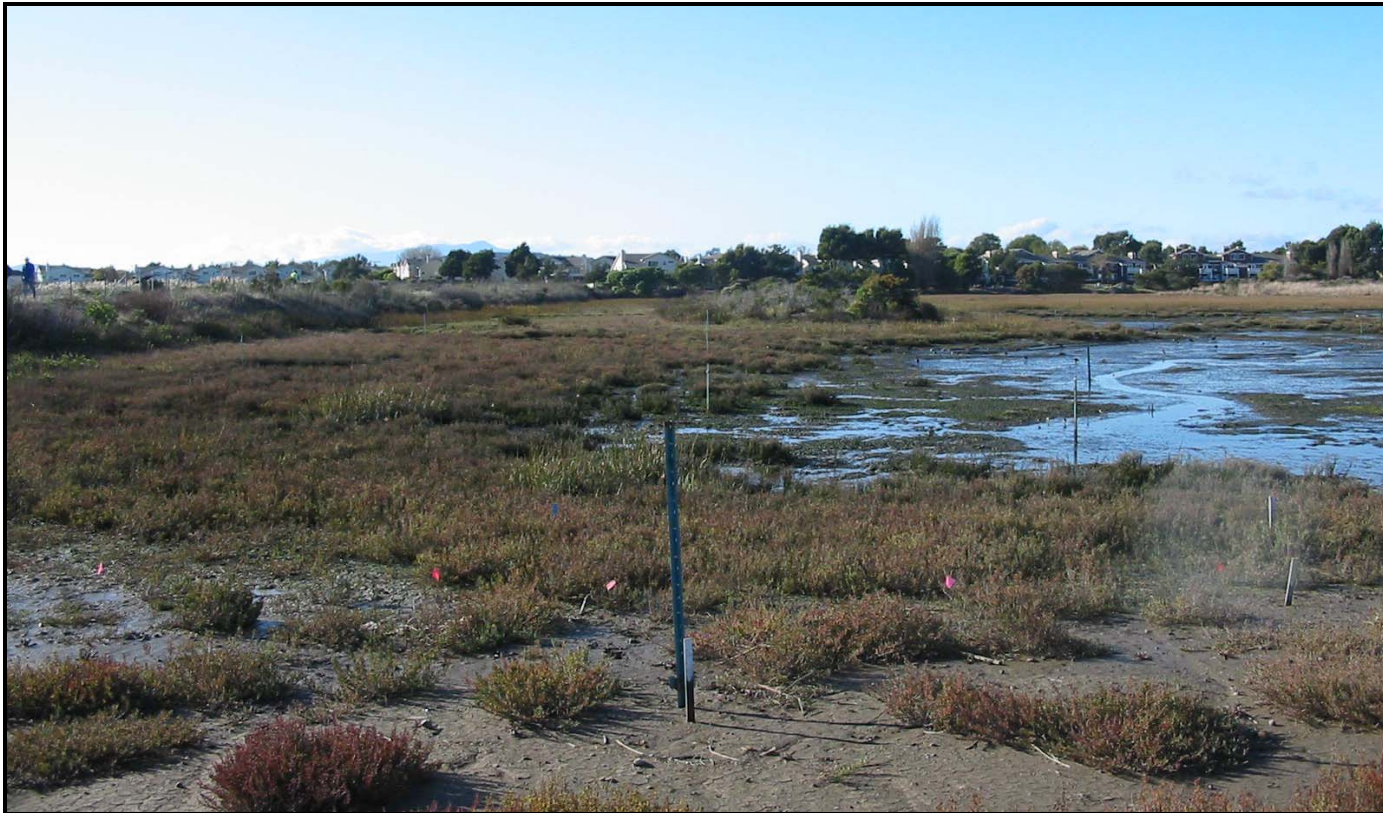
**Figure A.7. View from point E0 in transect E, facing west and looking down transect E.  
Stake E1 is visible in the foreground, near the bottom portion of the image.  
Transect DE stakes are visible in the background, near the centerline of the image.  
Channel crossing stakes are visible toward the right side of the image. Photo dated 11/21/2006.**
