# Year 2 Monitoring Report for the Western Stege Marsh Restoration Project

DTSC Order I/SE- RAO 06/07-004 Section 5.16

**University of California, Berkeley**  
**Richmond Field Station, Richmond, California**

**November 15, 2007**

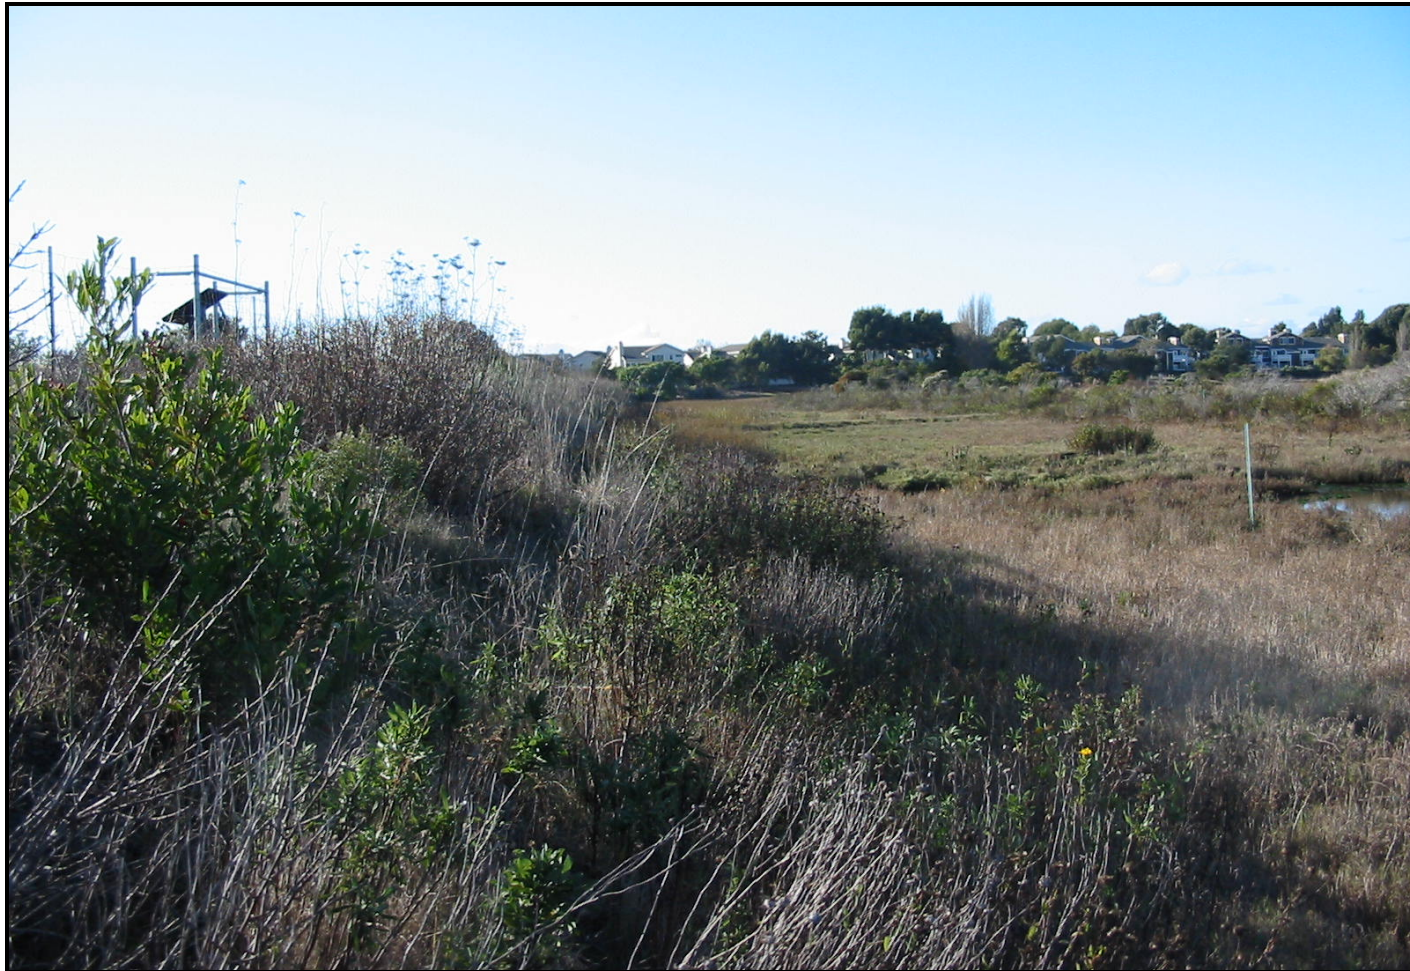
**Figure A.8. View from point G1 in transect G, facing west and looking down transect G. Transect G stakes are not visible along the slough bank. Stake F4 is visible at the right of the image. Photo dated 11/21/2006.**

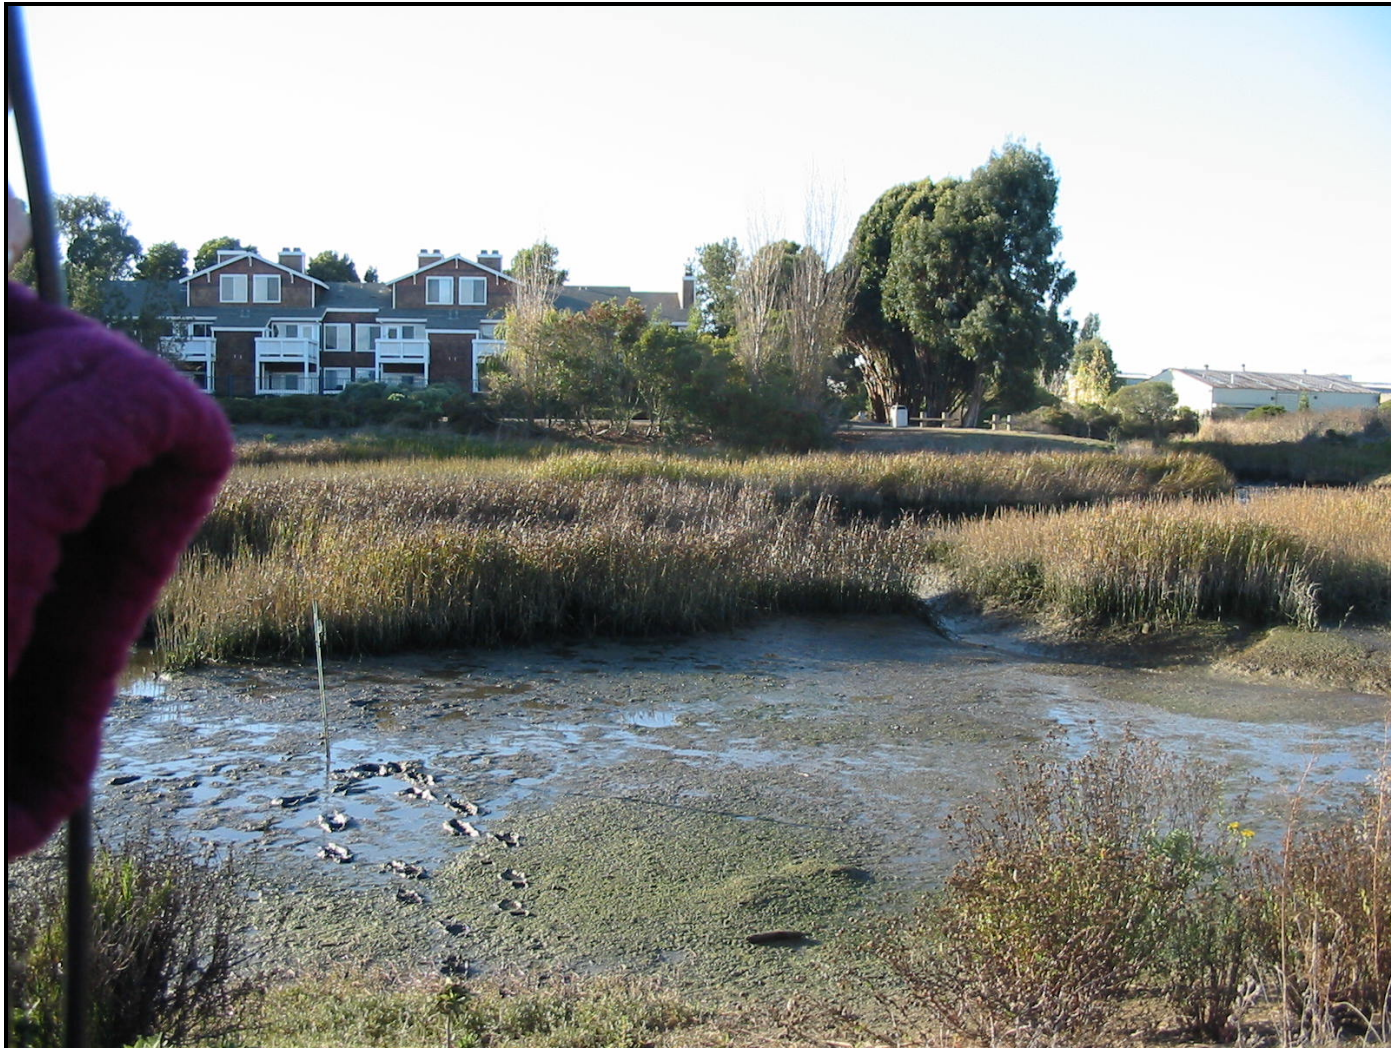
**Figure A.9. View of previously-surveyed point A3 (green stake) toward the west. Meeker Slough main channel is shown in the image background. Photo dated 11/21/2006.**

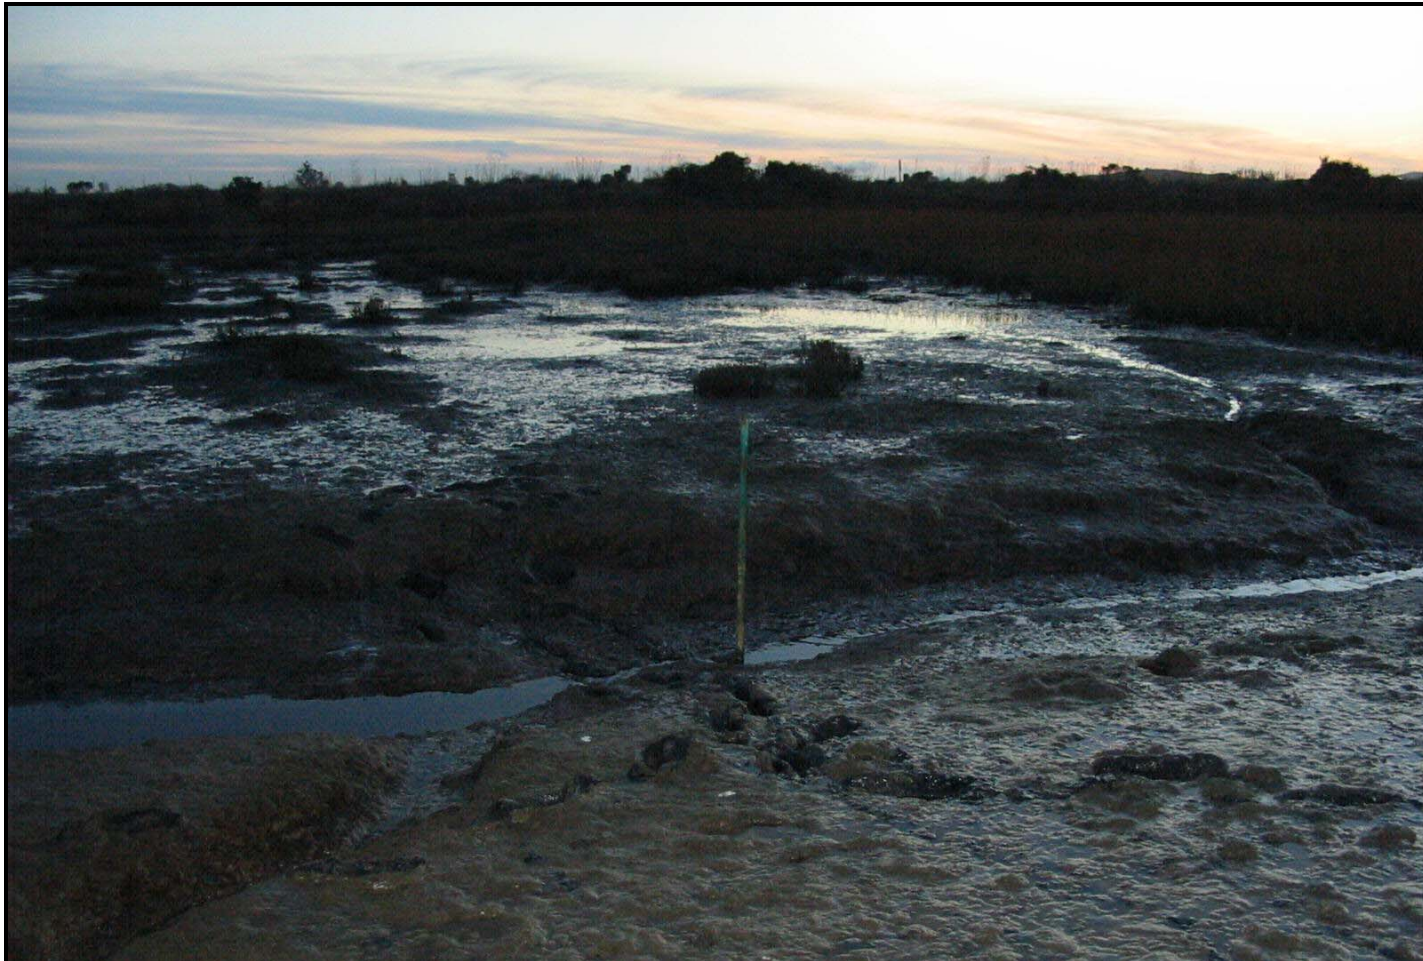
**Figure A.10. Example of a stake marking the centerline of a channel.  
Channel crossing surveys were conducted perpendicular to the channel thalweg and in line with the stake. Photo dated 11/21/2006.**

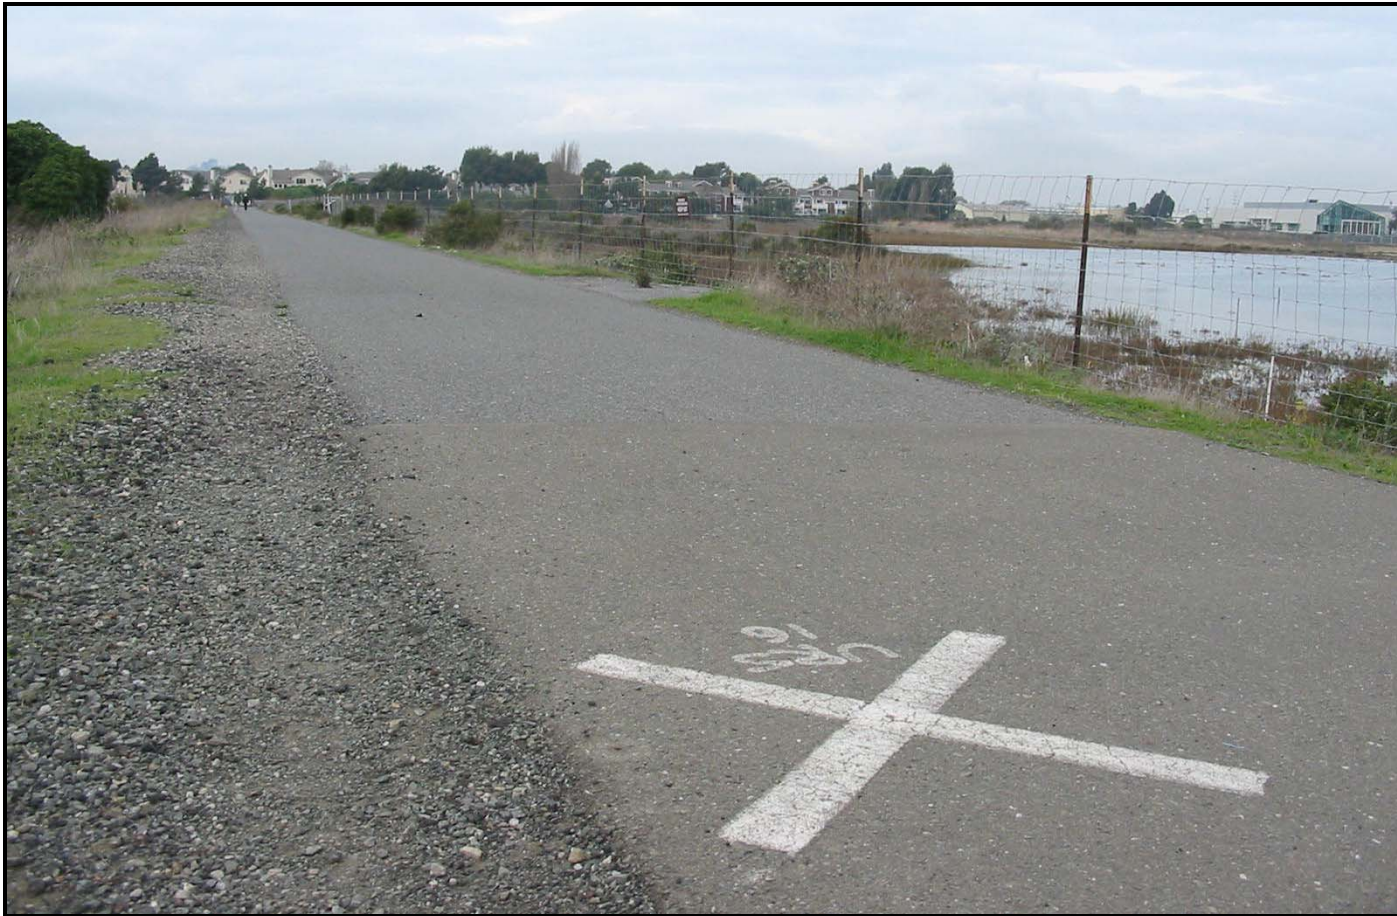
**Figure A.11. Existing survey control point located on the EBRPD Bay Trail at the southeastern corner of the project site. The coordinates of the control point were confirmed with 2004 surveyed coordinates. This location was used as a control point in the November, 2006, and August, 2007 surveys. Photo dated 11/21/2006.**

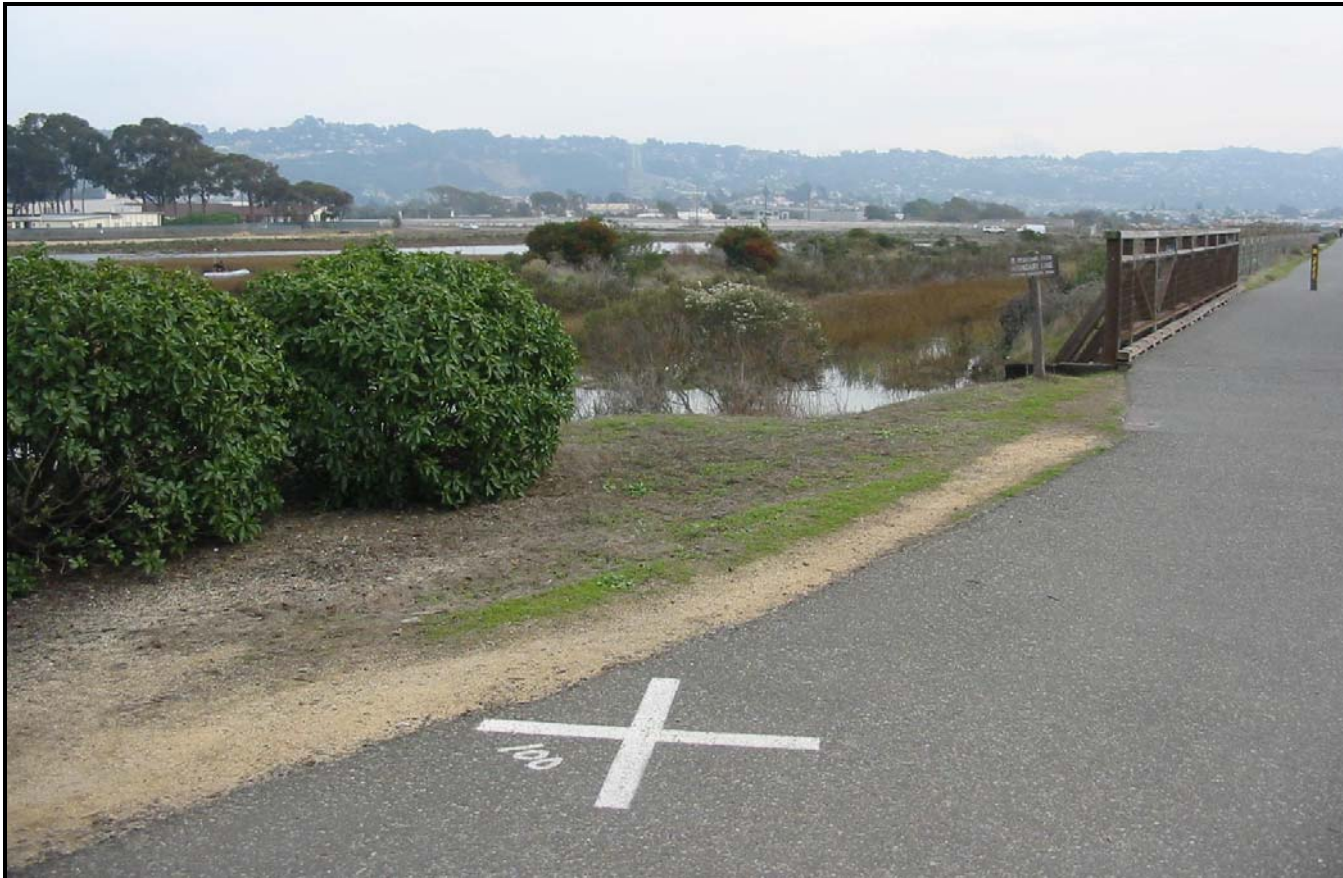
**Figure A.12. Existing mark located on the EBRPD Bay Trail. The location was surveyed during the November, 2006 and August, 2007 surveys. No documentation of a previous survey of this mark is available for comparison. The marker is located at the southwestern corner of the study area. Photo dated 11/21/2006.**

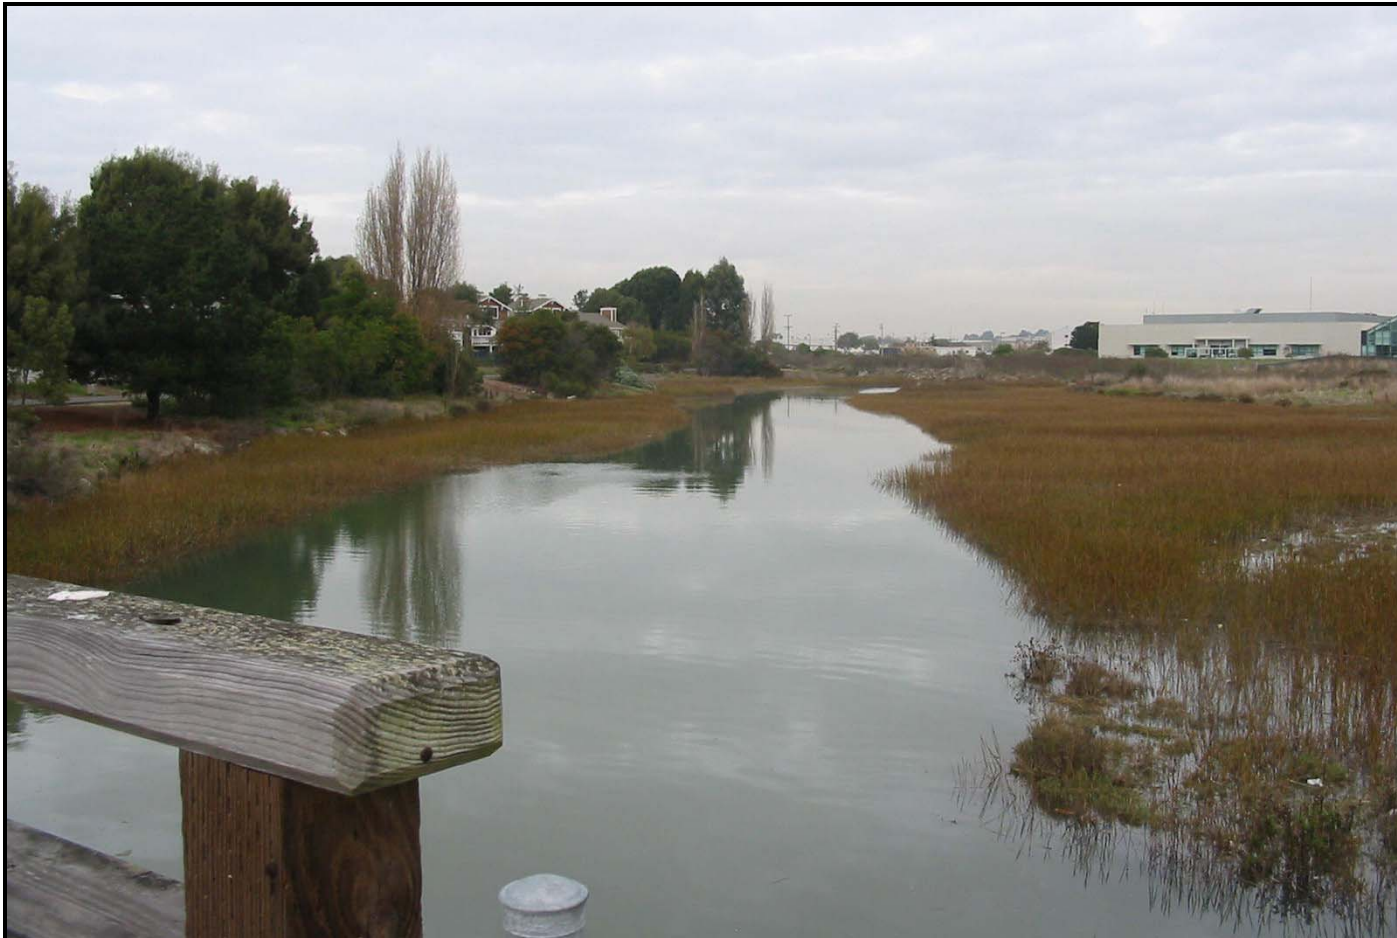
**Figure A.13. View facing north from the EBRP bridge showing the northern section of the Meeker Slough main channel. The image was taken at high tide. Photo dated 11/21/2006.**

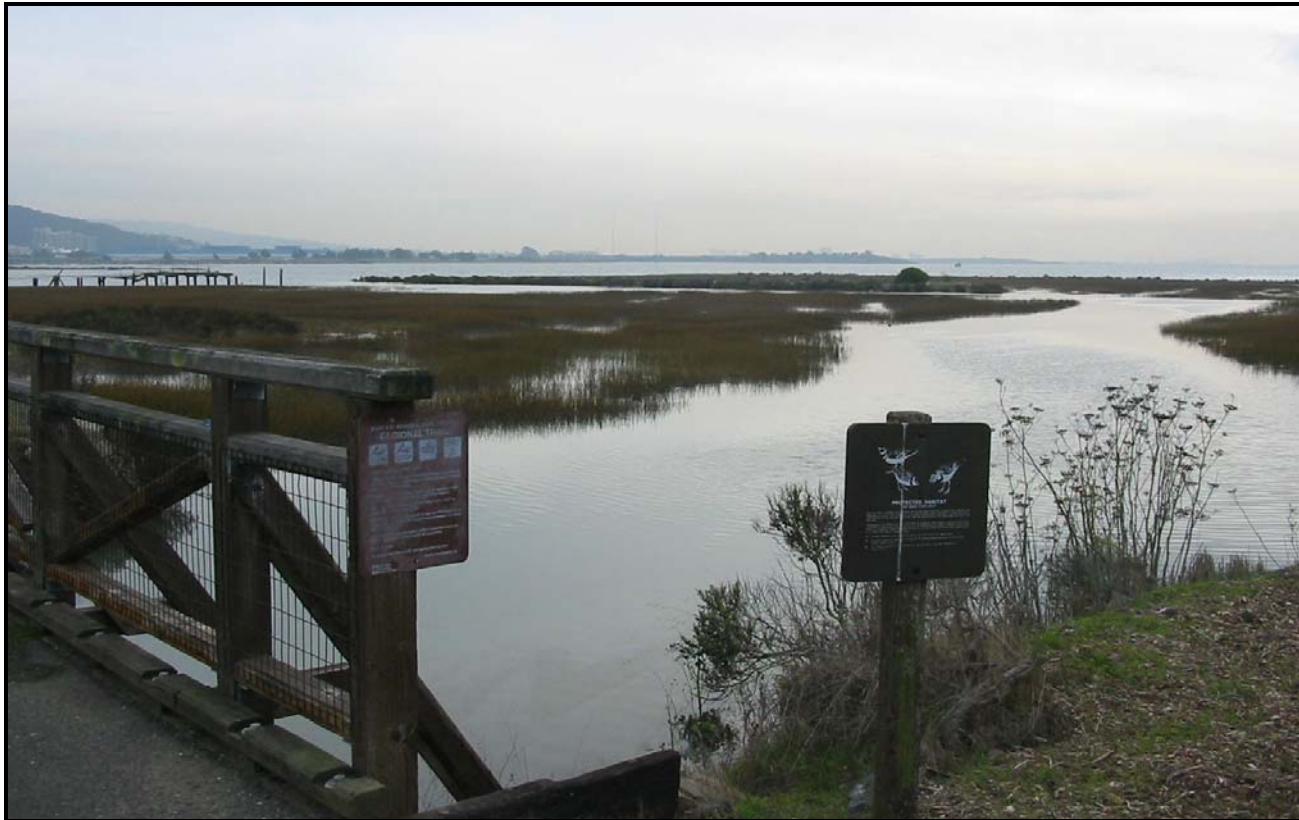
**Figure A.14. View facing south from the EBRP path bridge showing the southern section of the Meeker Slough main channel. The image was taken at high tide. San Francisco Bay is in the background. Photo dated 11/21/2006.**

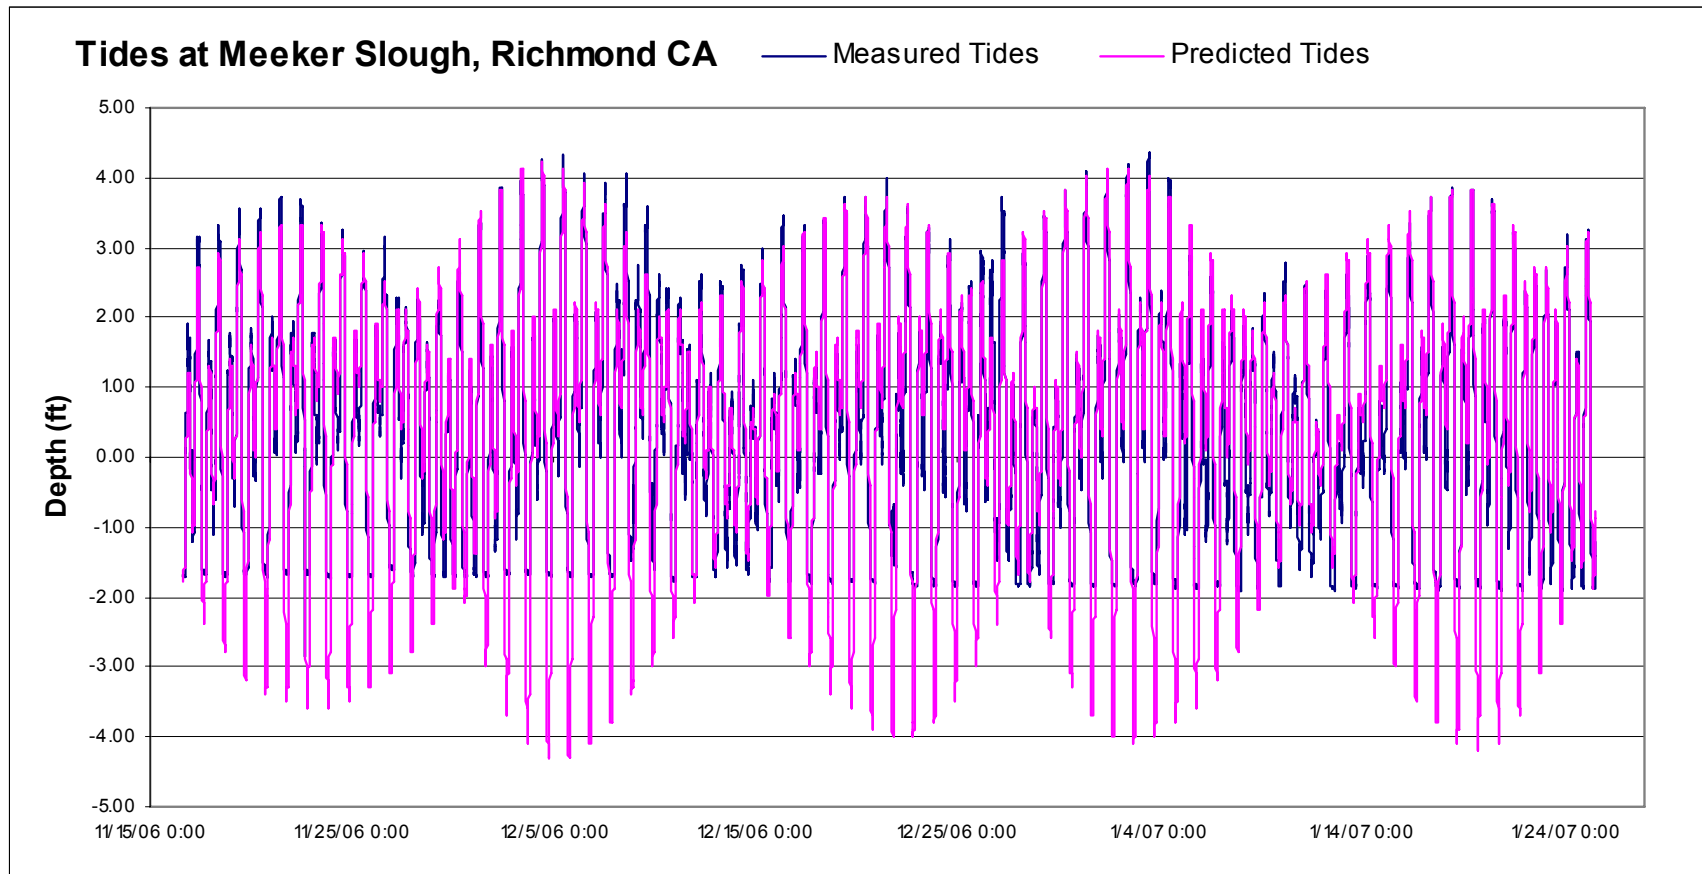
Figure B.1. Graphic representation of tide data (predicted and measured) from 11/2006 to 01/2007. Depths ref: NGVD-29.

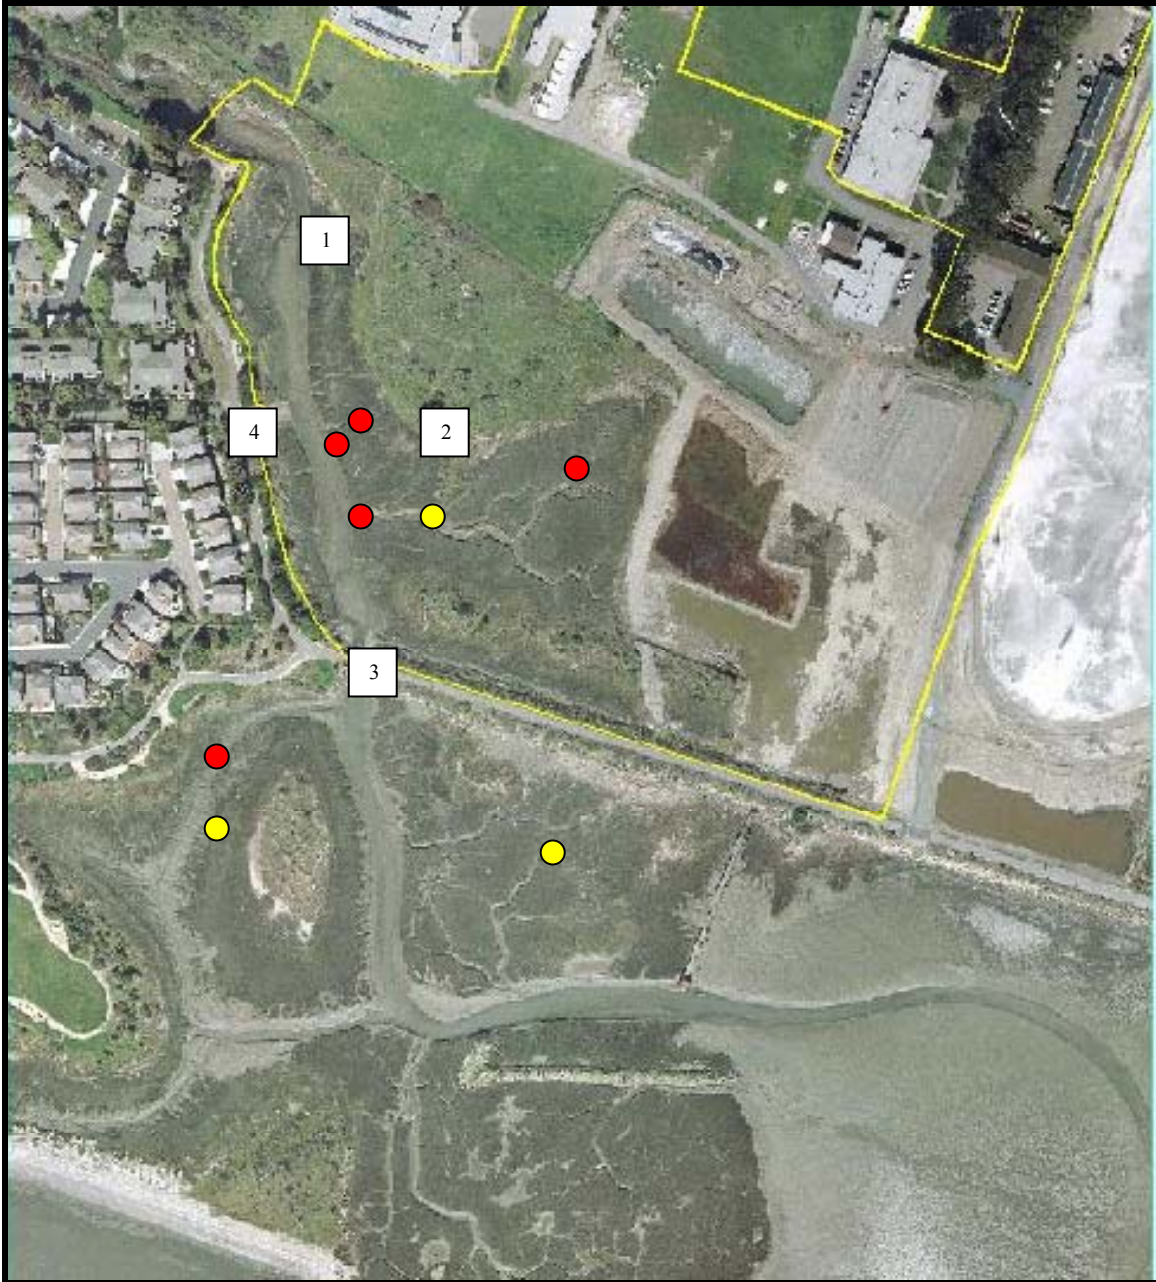
**Figure 1. Western Stege Marsh.**

White squares represents orange the locations of the listening stations.  
Red dots indicate estimated locations of clapper rails 12/03/06 (1500-1710 hrs).  
Yellow dots indicate locations of clapper rails 12/12/06 (1600-1720 hrs)

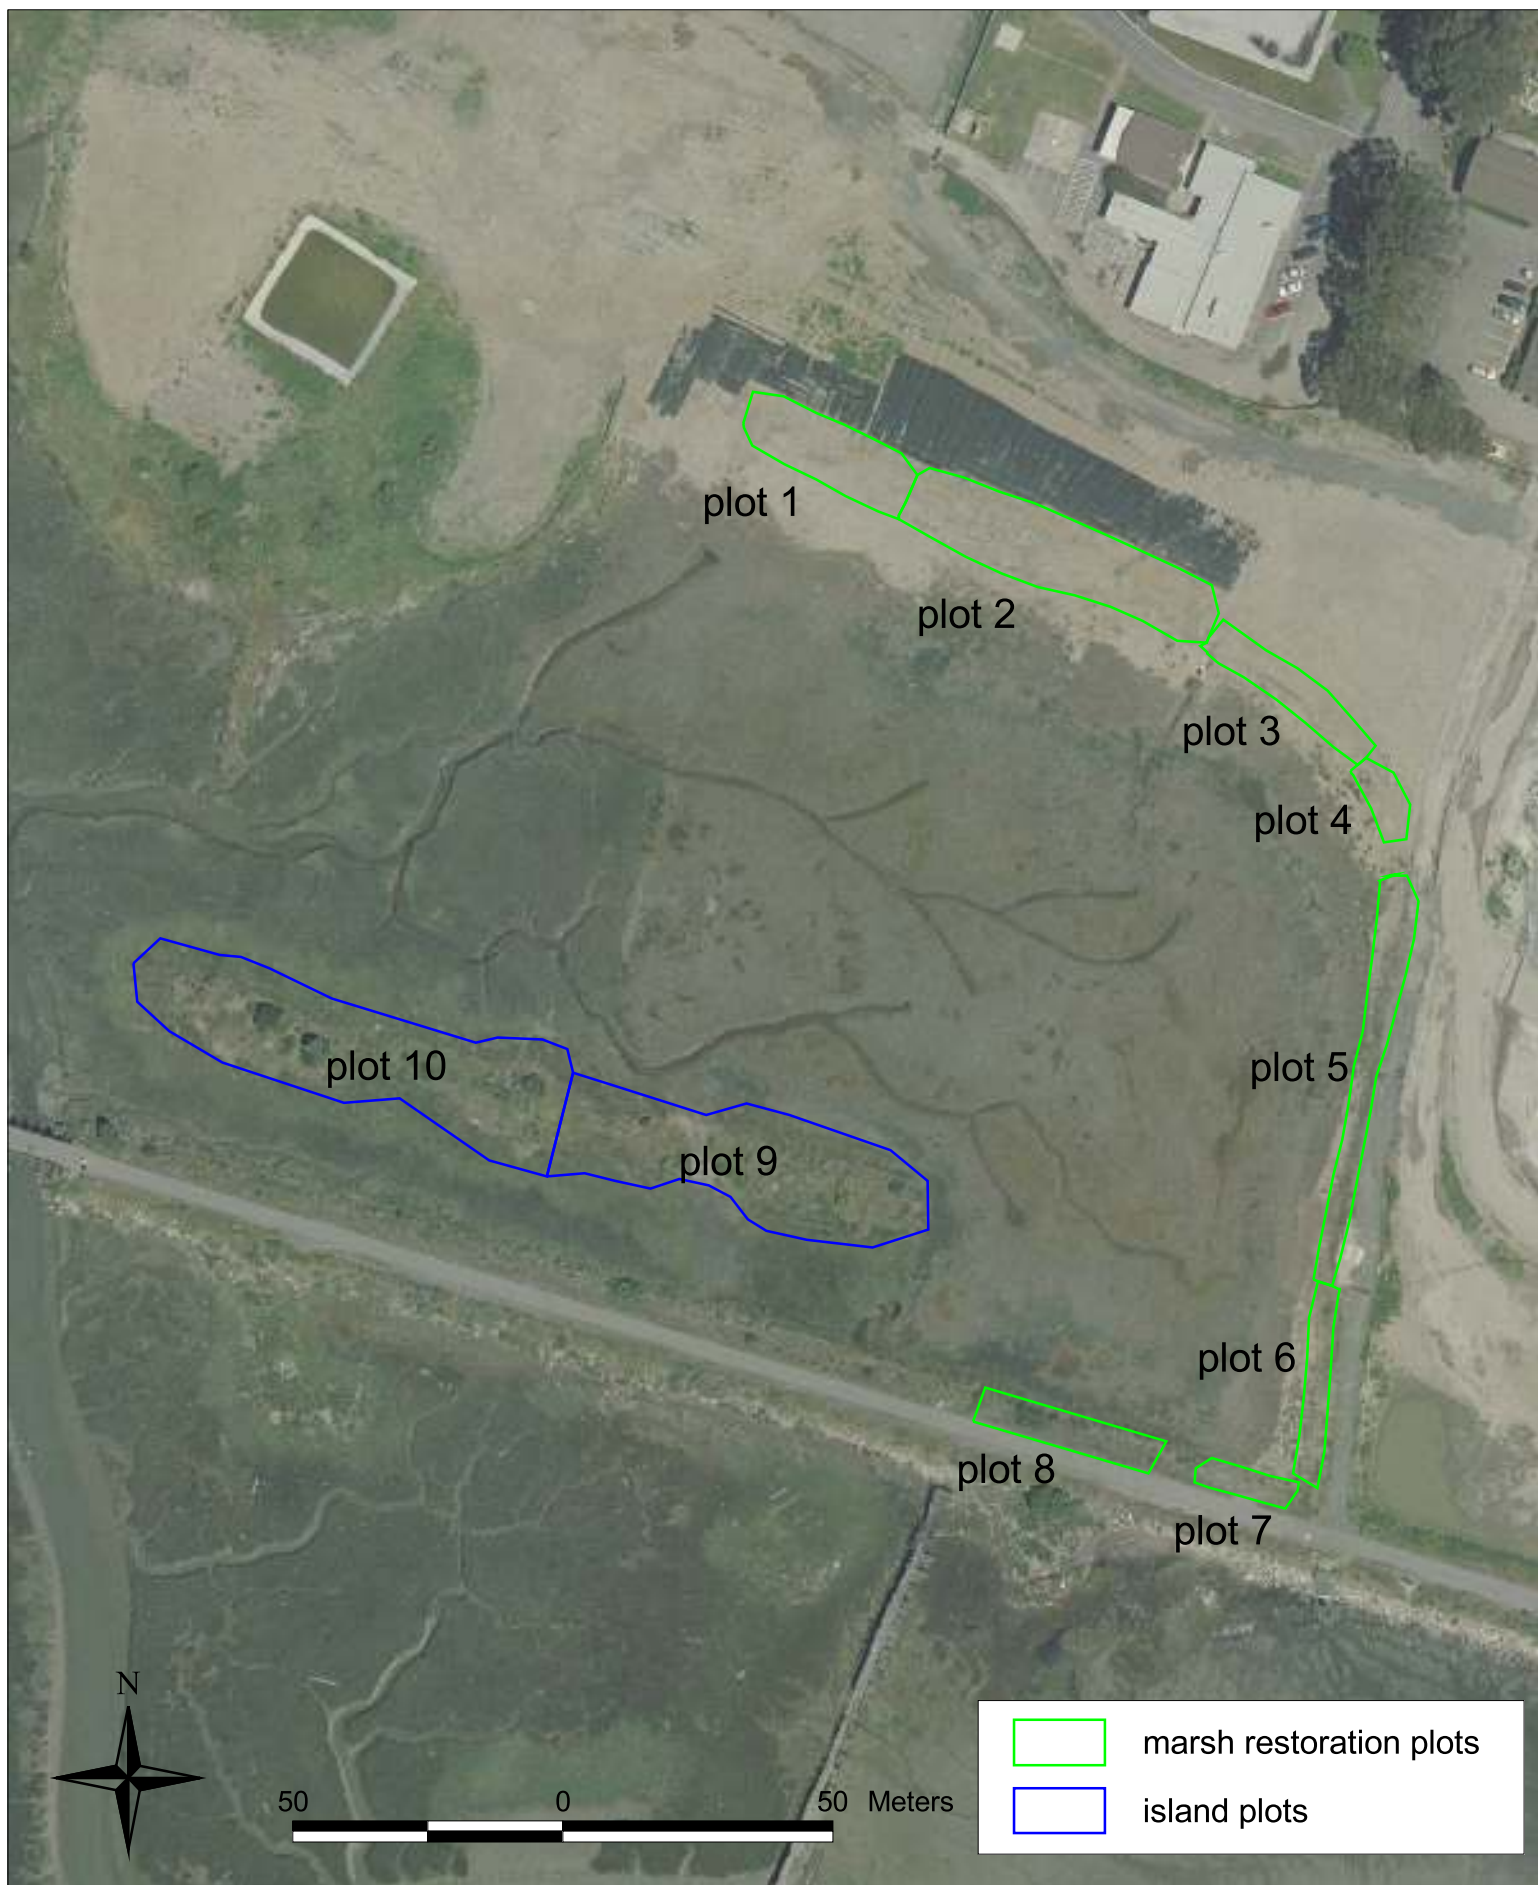
# Marsh Restoration Plots Richmond Field Station, UCB

Plot	sq m	Plot	sq
11	1109.6	13	576
11a	287.81	13a	177
11b	187.5	13b	111
11c	316.88	13c	111
11d	316.88	13d	177
12	1014.00	14	267
12a	211.25	14a	59
12b	295.75	14b	100
12c	211.25	14c	100
12d	295.75	14d	100
Grand total: 2966.9 sq m
