WETLANDS ASSESSMENT REPORT

NORTHERN REGIONAL LIBRARY FACILITY, PHASE IV
UNIVERSITY OF CALIFORNIA, BERKELEY (RICHMOND BAY CAMPUS)
RICHMOND FIELD STATION
RICHMOND, CA

April 13, 2018

Rana Creek Habitat Restoration
27875 Berwick Drive
Carmel, CA 93924

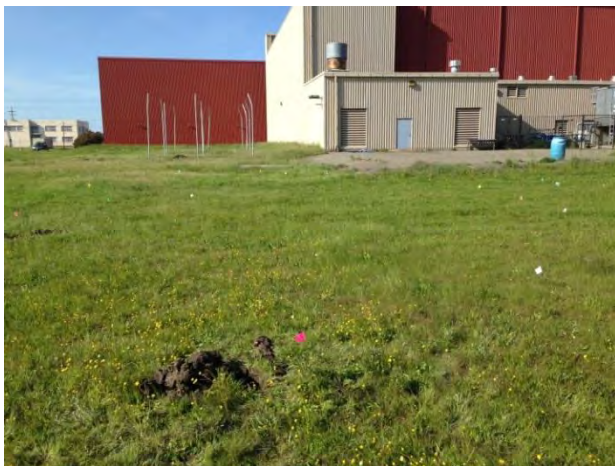
Photo 1: Sample point A-02

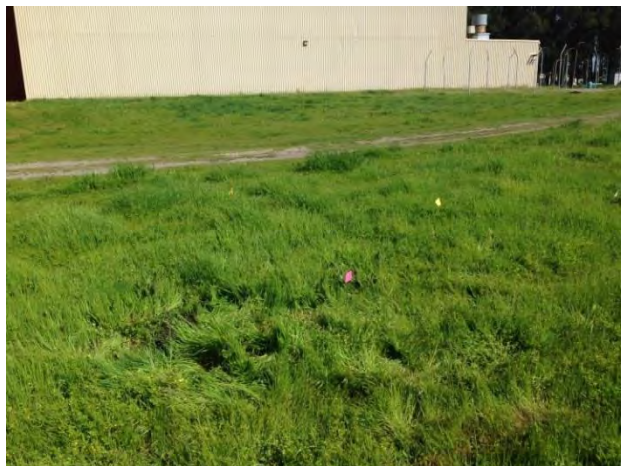
Photo 2: Sample point A-04

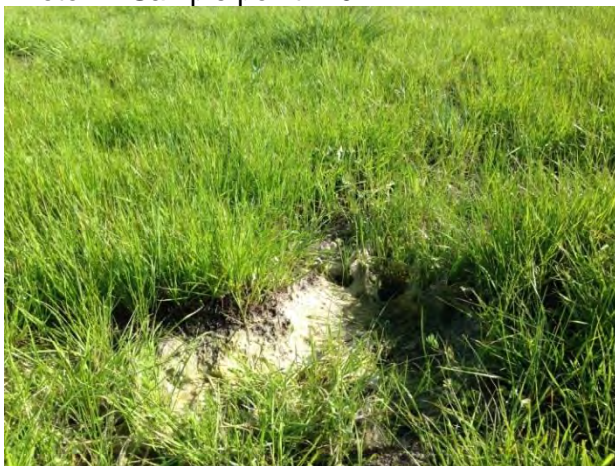
Photo 3: Remnant algal mat near sample point A-05

No hydrology indicators were present at sample points A-01 through A-04 or in the rest of the area covered by the visual assessment. The only hydrology indicators were found within the small wetland feature at sample point A-05. These included biotic crust (B12) in the form of remnant algal mats, oxidized rhizospheres along living roots (C3) observed in the soil sample, and a pass of the FAC-neutral test (number of OBL, FACW species > number of FACU, UPL species).

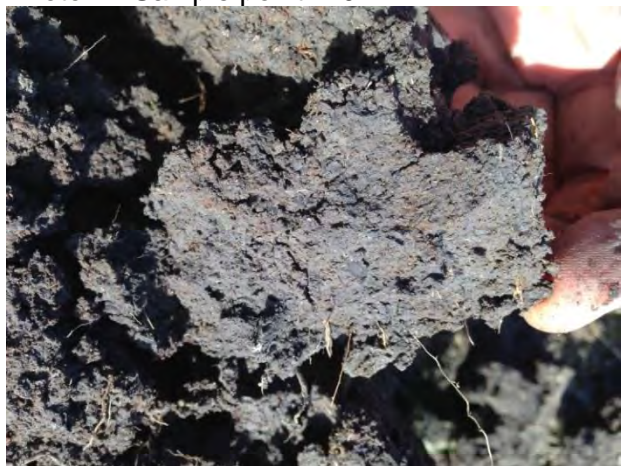
Photo 4: Soil from sample pit at A-05. Note small reddish brown redox features

Soils at sample points A-01 through A-05 were clay loam and clay and were moist to damp. No high water table or soil saturation was observed in any of the soil pits. Soil color at these locations does have low chroma, but also a low value ranging from a dark brown to very dark grey. The deeper clay layer has a slightly higher value and is a dark greyish brown. Some faint redoximorphic features were observed in soil matrix collected from A-01, A-03, and A-04, but were not of sufficient concentration or in thick enough layers to meet hydric soil criteria. Prominent redoximorphic features in pore linings were present in a greater thickness within the soil profile collected from A-05 and in combination with the matrix color met the criteria for hydric soil F6, redox dark surface. This result is not surprising since sample location A-05 also contained 100 percent dominance of hydrophytic vegetation and possessed three hydrology indicators.

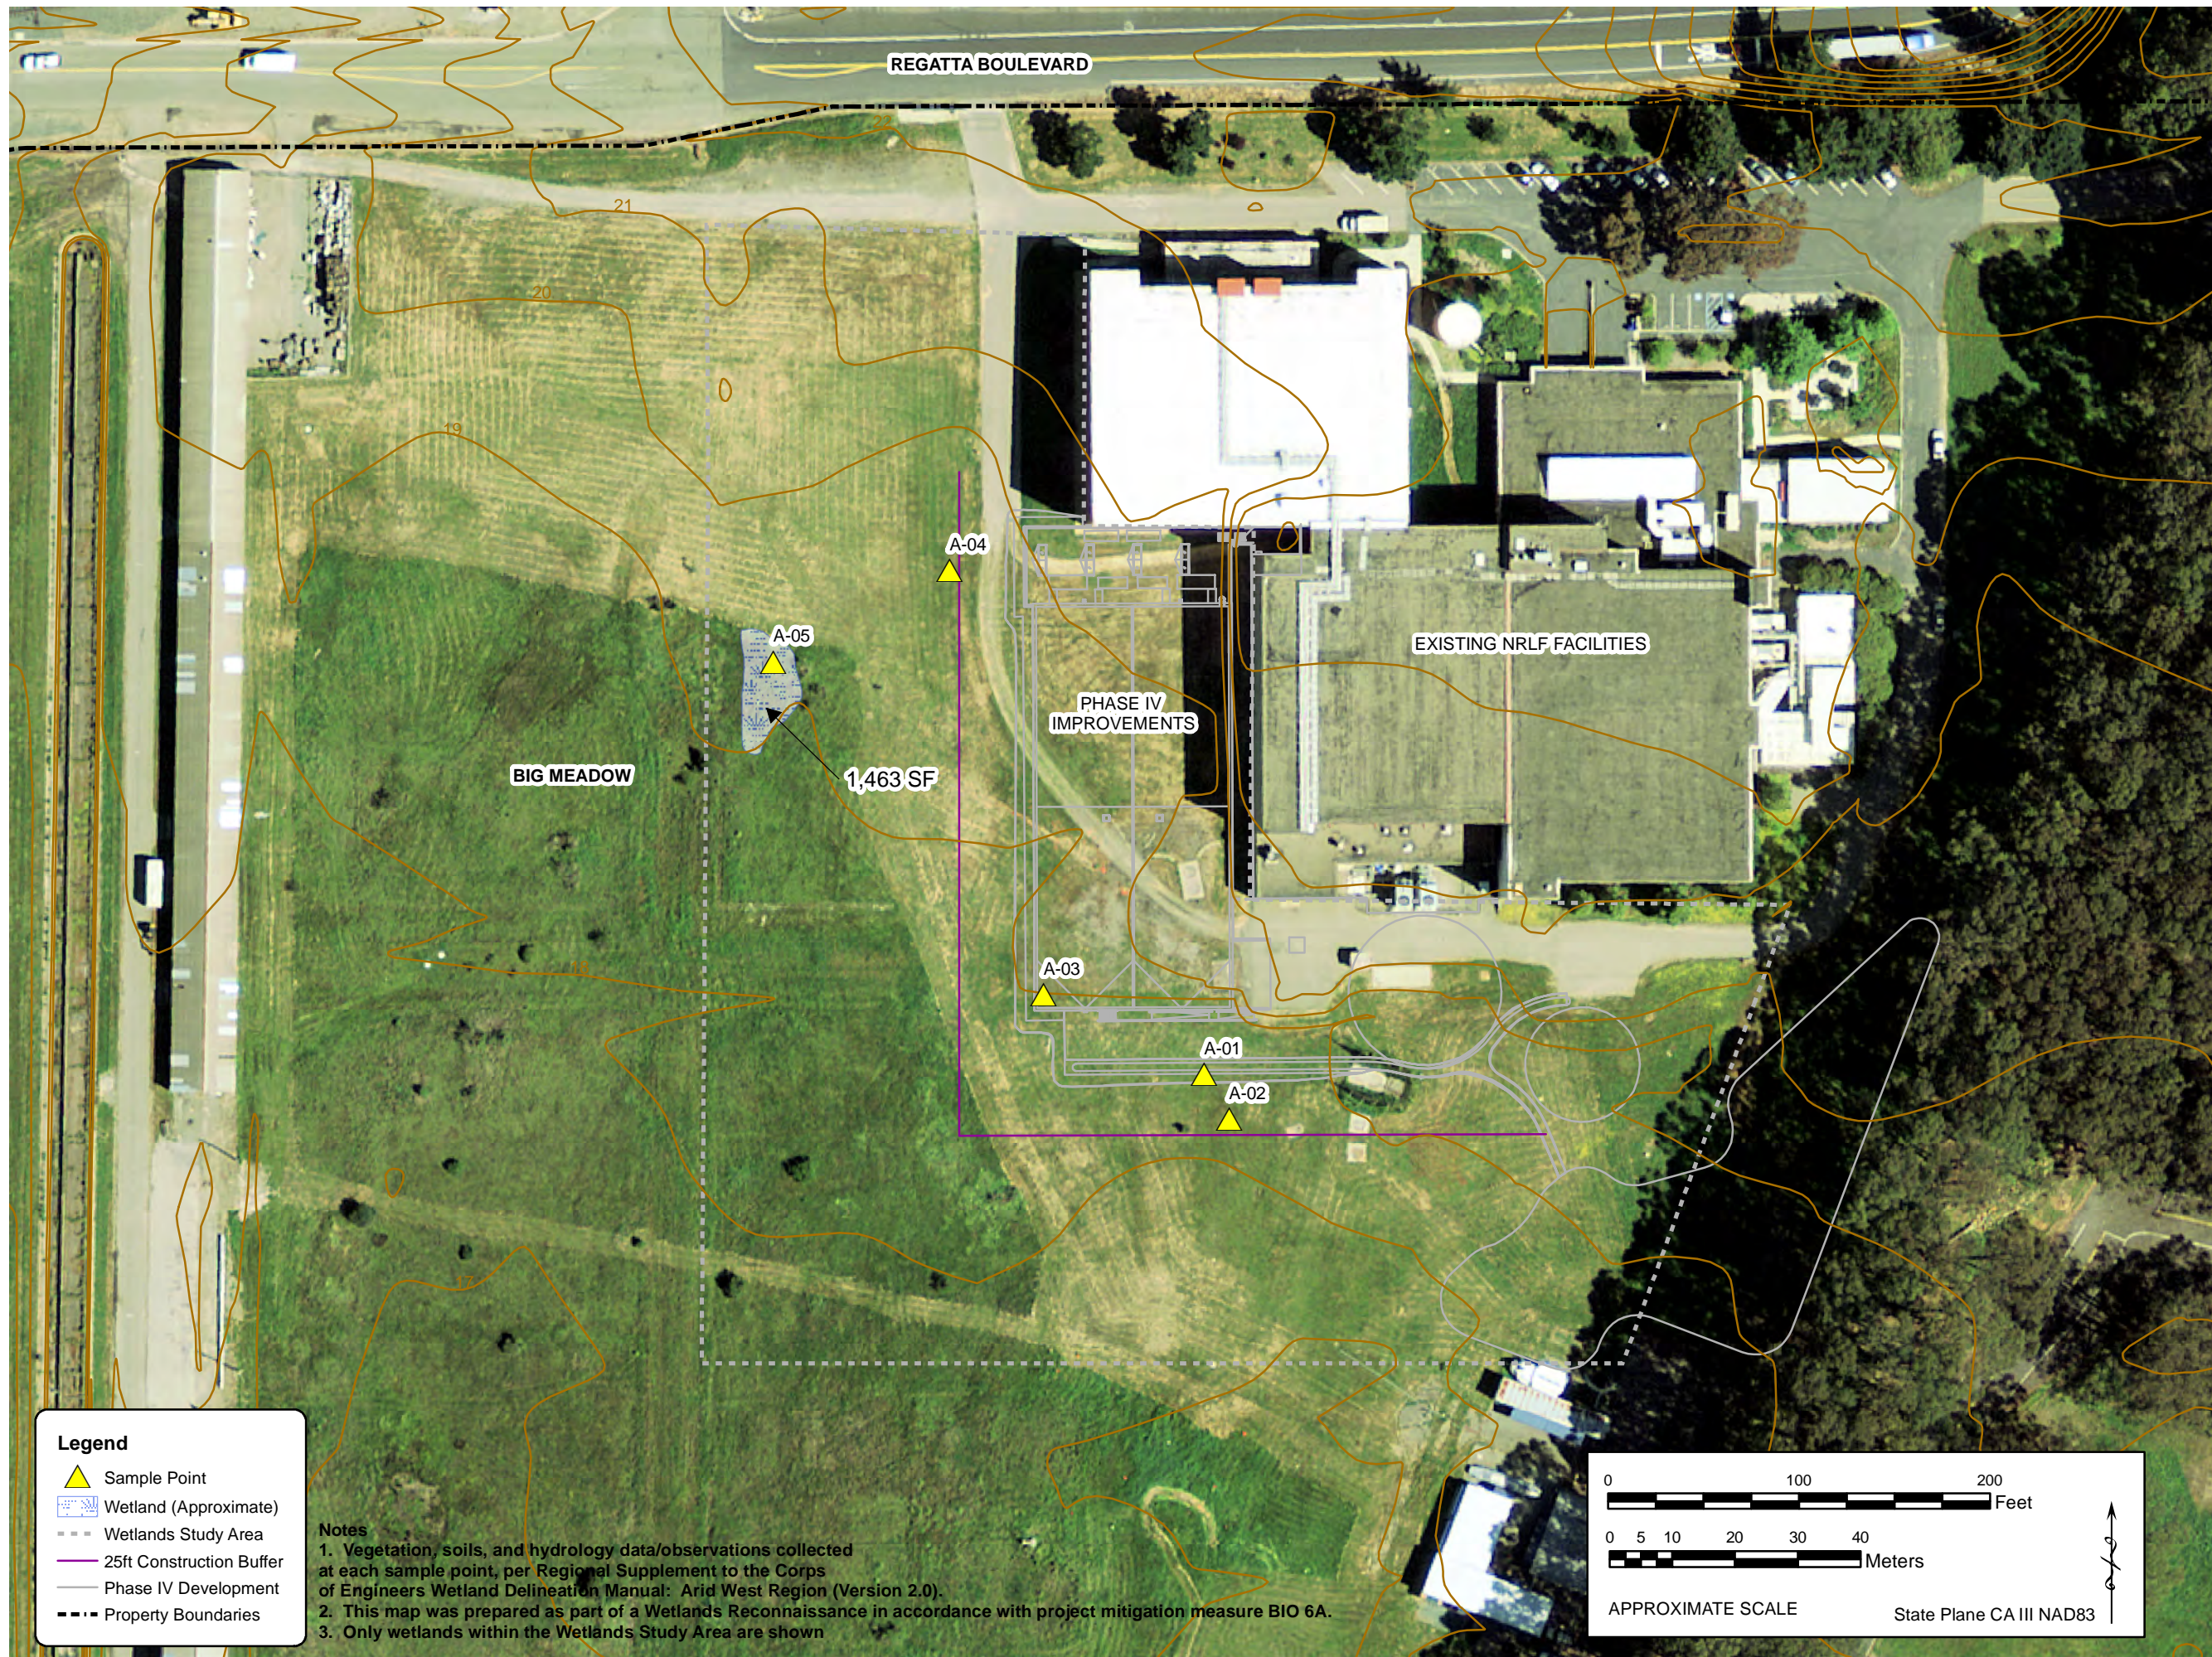
SHEET TITLE:
MAP 2
WETLANDS ASSESSMENT
**SITE PLAN &
SAMPLE LOCATIONS**

Although the locations sampled at A-01 through A-04 are situated within topographic depressions, had some facultative or facultative wetland plant species present, and have been observed by U.C. Berkeley staff to periodically contain ponded water, the inundation/saturation is not of sufficient frequency or duration to create hydric soils or to cause dominance of hydrophytic vegetation. Sample point A-05 did contain confirm positive indicators of dominant hydrophytic vegetation, hydric soils, and three hydrology indicators. This sample point is located within a small depression 85 feet west of the development area buffer zone and is approximately 1,463 square feet in size (**Map 2**). **Table 2** provides a summary of the sampling points and results.

Based on this assessment, there are no potentially jurisdictional wetlands or waters of the U.S. present within the Phase IV development area or the 25-foot buffer. There are potentially jurisdictional wetlands present beyond the Phase IV development area and the 25-foot buffer. If in the future, new work is planned that could potentially extend into these other areas, a wetland delineation would need to be completed and submitted to USACE for verification. It should be noted that only the USACE can make the final jurisdictional determination of any wetlands or other waters of the U.S.

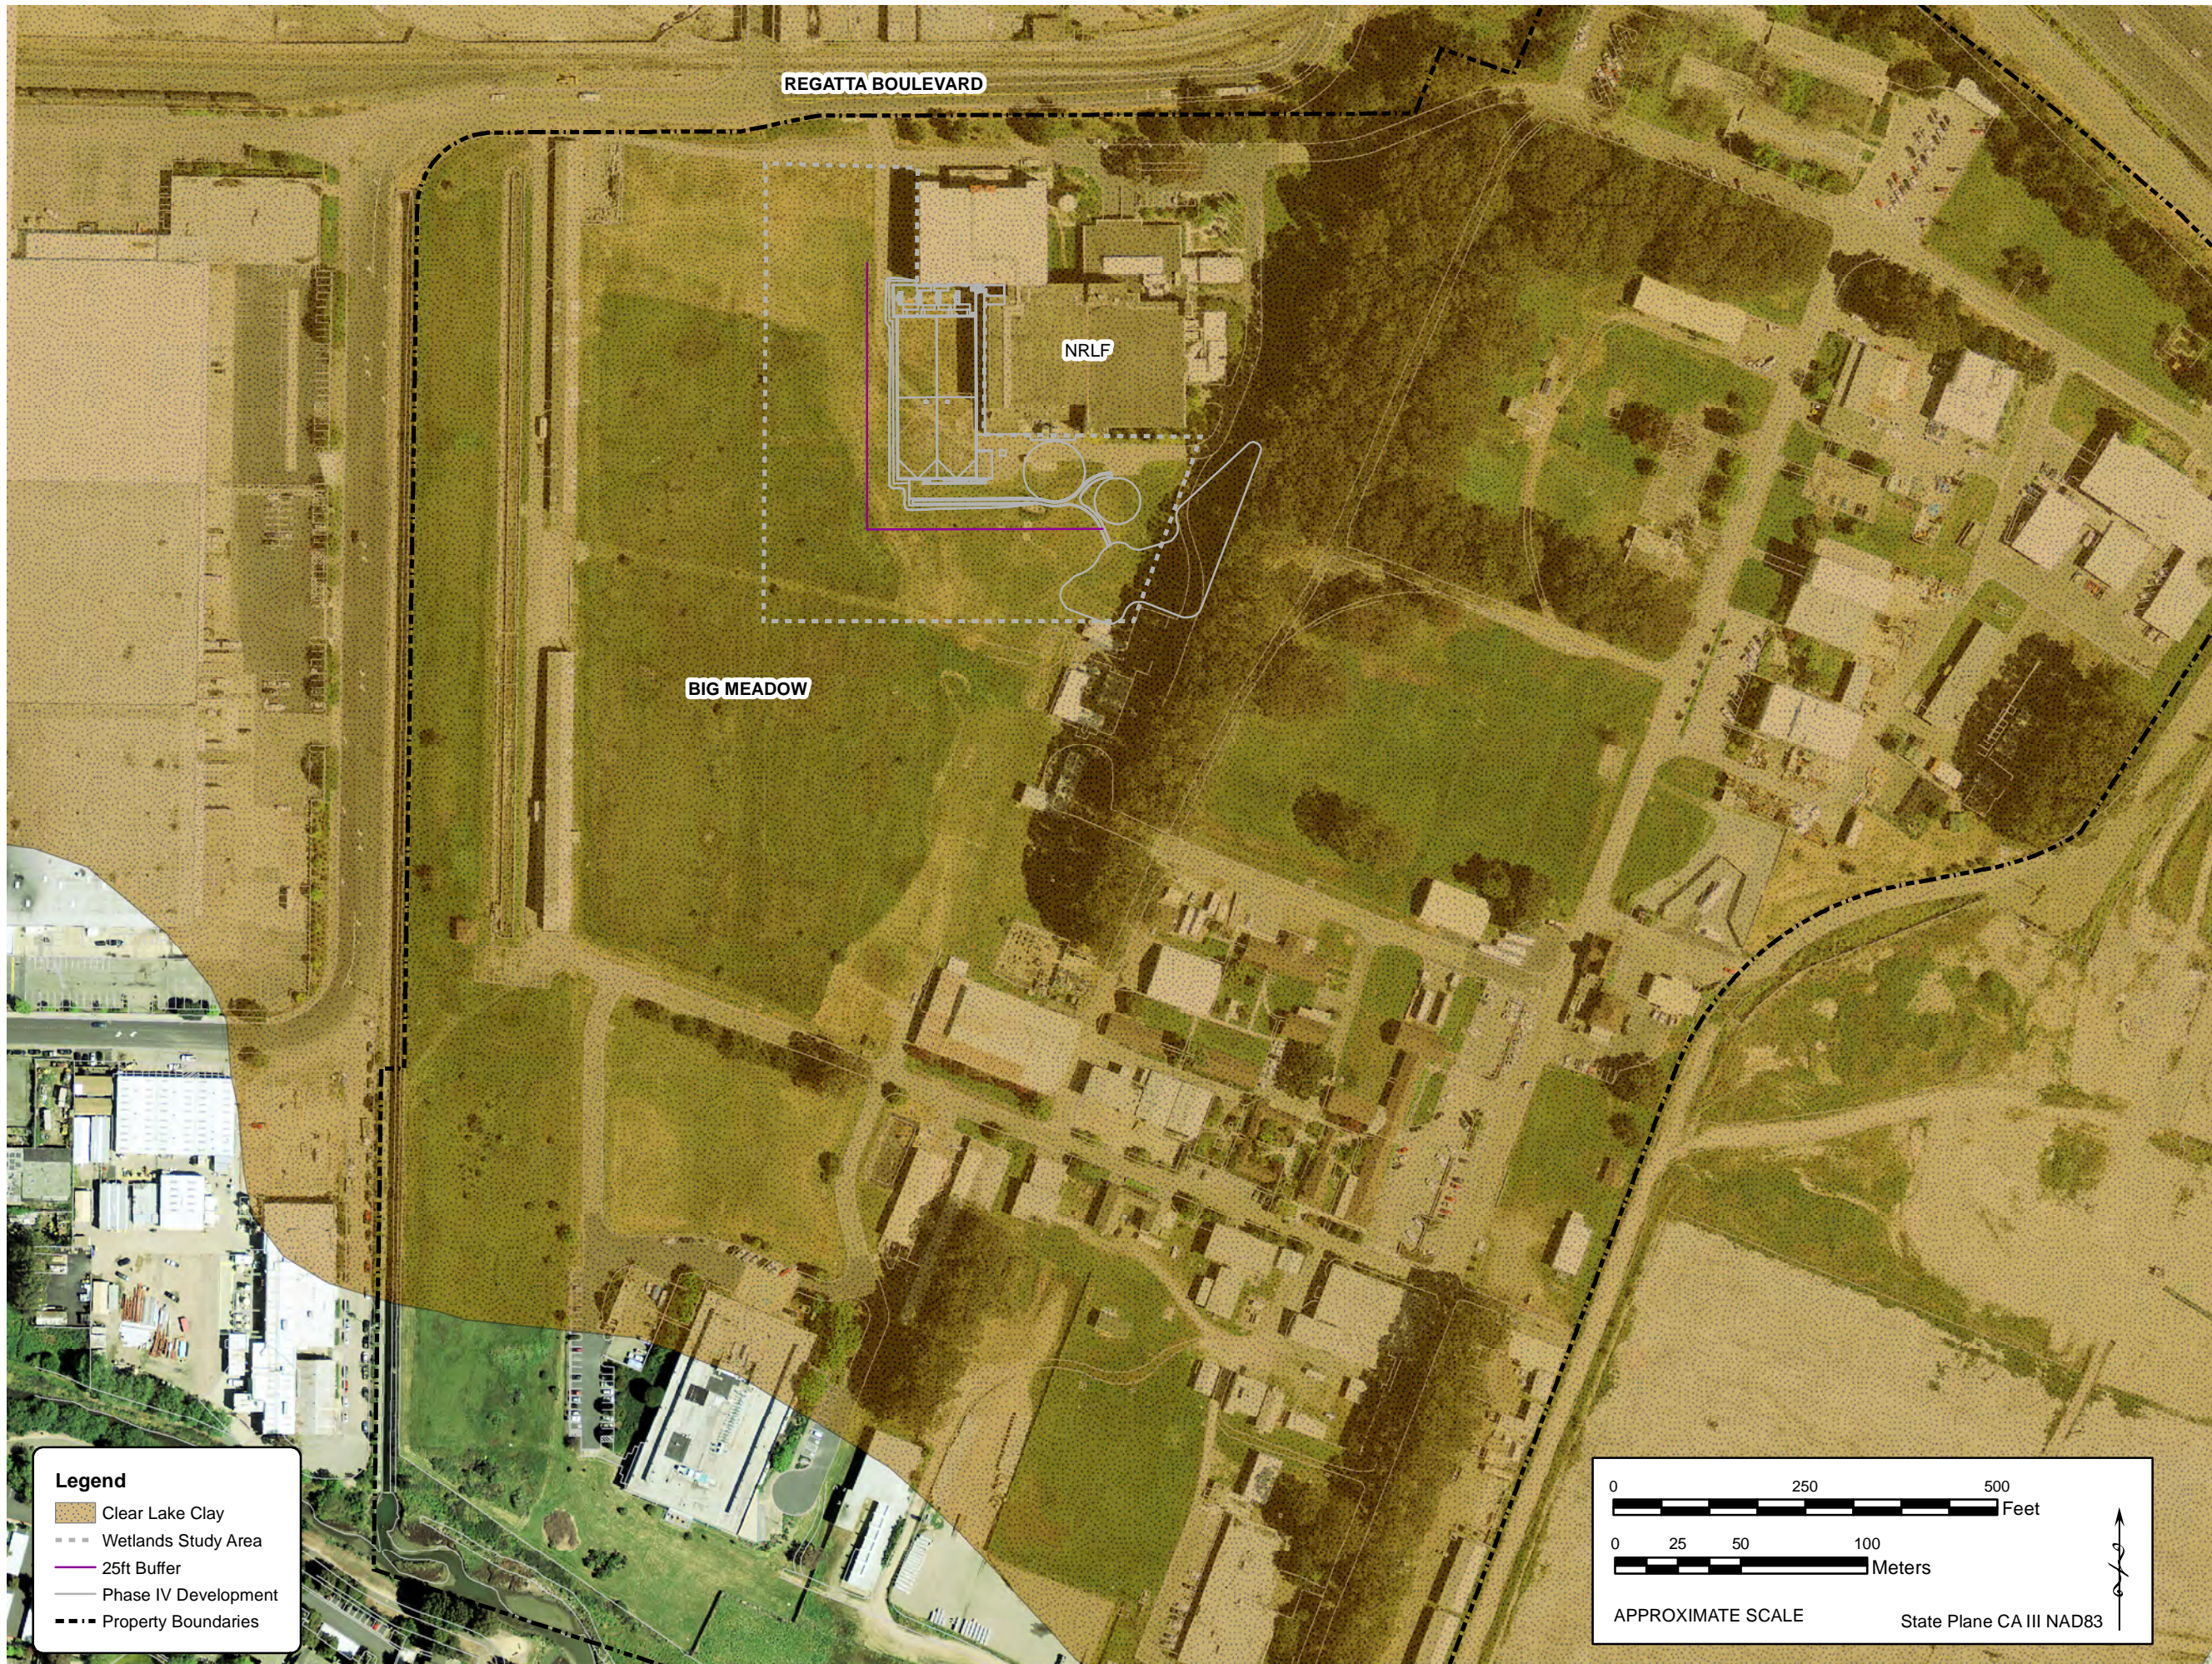
MAP 3
WETLANDS ASSESSMENT
SOILS MAP

Soils within the wetlands study area and Big Meadow consist of Clear Lake clay (**Map 3**). Clear Lake clay is derived from clayey alluvium associated with metamorphic and sedimentary parent material, forms 0 to 15 percent slopes, is poorly drained, and experiences frequent ponding. The shallow soil profile consists of clay from 0 to 60 inches deep (NRCS, 2018). During this wetland assessment, soil pits were dug at each sampling location to a depth of 20 inches below ground surface in order to evaluate for hydric soil properties. In general, soils observed in the
